Mariners' Alerting and Reporting Scheme

MARS Report No 363 January 2023

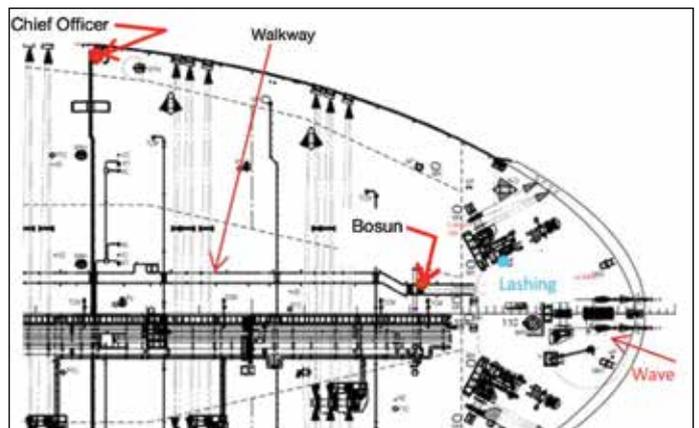
Soon after, the Master saw a wave near the bow that appeared to be somewhat larger than the others. He warned the Chief Officer by VHF radio but seconds later, huge amounts of water washed over the bulwark. Visual contact with the Bosun and the Chief Officer was lost.

The Bosun was seen lying on the walkway near the port anchor winch, but the Chief Officer was still not visible. The general alarm was sounded and an announcement was made. The vessel was slowed yet further and manoeuvred to have the waves astern, at which point a rescue team went forward. The rescue team found the Chief Officer and Bosun as indicated on the diagram and the victims were brought to the ship's hospital.

The investigation found that a wave, significantly higher than the observed waves, hit the vessel while the Chief Officer and the Bosun were at the bow. The investigation also found, among other things, that communication by portable satellite phone was not possible from the ship's hospital. Radio Medical Advice (RMA) was received by satellite phone on the bridge, but the hospital was five decks below. Immediate and critical medical treatment of the victims based on communications with RMA had to be relayed verbally from the bridge satellite phone to the caregiving personnel in the hospital either by internal phone, or in person. The report did not speculate on whether having communications directly to the ship's hospital would have made a difference in saving lives.

- Even when a wave pattern is coming from what appears to be one direction, it can combine with other wave patterns and occasionally create a wave that is significantly higher than the observed average.
- When observed average wave height is approximate to the vessel's freeboard, extreme caution should be taken when going on deck. An errant wave could sweep the deck with terrible consequences.

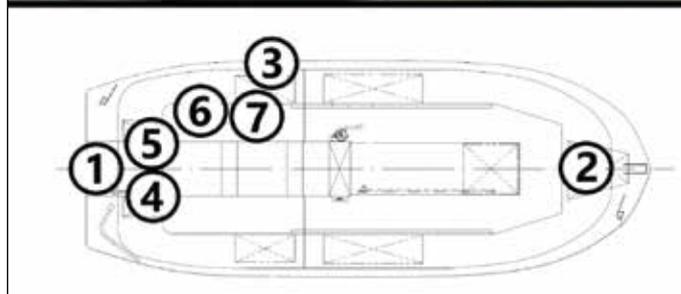
Three people ended up in the water, while the four others were able to cling to the lifeboat, which was now lying with a heavy list to port and half filled with water. Everyone was quickly rescued by nearby small boats and no one on board suffered injuries. The diagram below and the accompanying description show positions at the time of the accident:

- 1 Instructor (fell into water immediately).
- 2 Person standing, legs wide apart, with the upper body coming out through the forward hatch.
- 3 Person sitting down with the upper body out of the port side hatch. (Dived into water immediately).
- 4&5 Persons standing up in order to let Person 7 pass.
- 6 Just climbed down from the helm: standing on the floor to let Person 7 pass.
- 7 New helmsman standing ready to climb to steering position seat.

The lifeboat complied with applicable IMO stability requirements. Nevertheless, the investigation shows that, under certain conditions, this type of lifeboat has limited reserve stability. Consequently, relatively small forces are able to generate large angles of heel. Under certain conditions, for example when lightly loaded to about one quarter capacity as in this case, lifeboats of this type can take on water and heel over if the side hatches are open. It is reasonable to assume that other lifeboats of similar types and sizes may have similar stability properties.

- This event illustrates the importance of rigorously complying with the manufacturer's instructions for use. In this case, the occupants of the lifeboat were not sitting in their respective places nor secured with their seatbelts, contravening manufacturer's instructions of use.
- International performance standards for emergency gear on vessels are a bulwark for safety but even these can and do require improvement when deficiencies are revealed.
