# Mariners' Alerting and Reporting Scheme

MARS Report No 357 July 2022

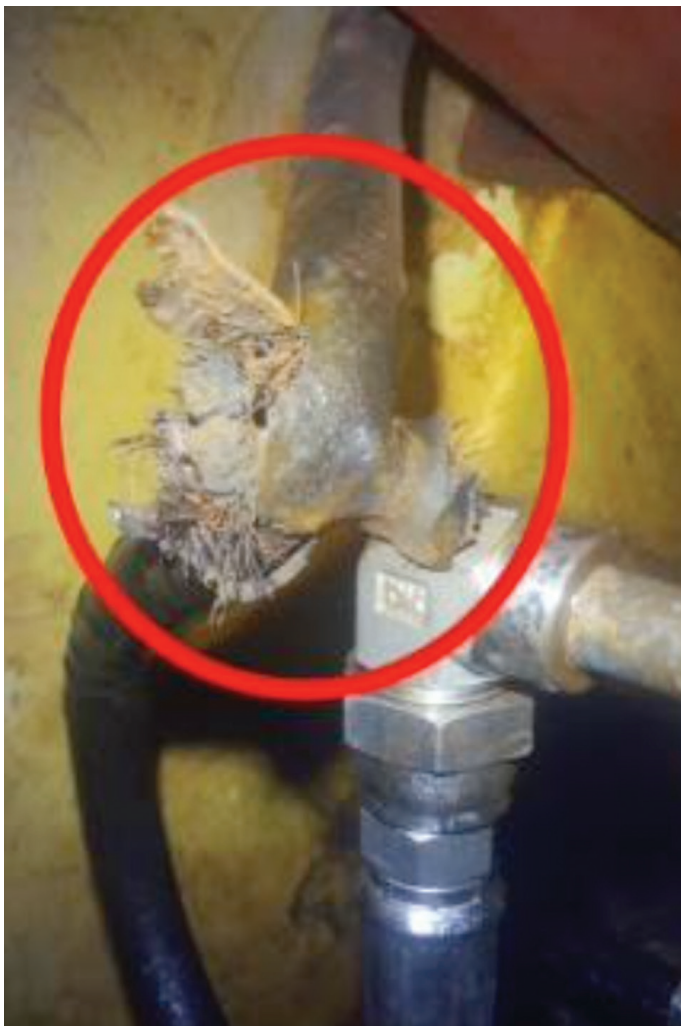
→ A deck officer was tasked to escort an accredited technician to inspect the free fall lifeboat air cylinders while the vessel was in port. The technician requested that the officer assist him by opening the air cylinder valves one by one to check the pressure. The first valve was opened without incident but when the second valve was opened, the high-pressure hose burst near the officer's face. Compressed air, dust and particles from the damaged hose hit his eyes, causing irritation.

This incident is a good example of why protective eyewear should be in common use on board, much as hard hats and steel-toed boots already are.

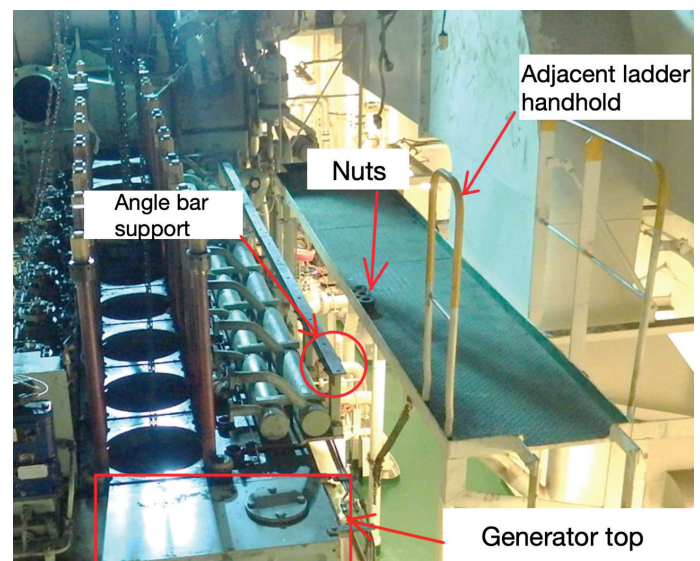
As the work progressed, one of the engineers was standing on top of the generator. There was a walking platform adjacent to the generator top, at the same height but separated by a gap of 40 cm. The engineer required some nuts that were lying on the platform, but were out of his reach. He attempted to step onto the platform from the top of the generator. He steadied himself with his right hand on the adjacent ladder handhold and stepped onto the platform with his right foot. As he brought his left leg forward he slipped. His leg struck the edge of an angle bar supporting the exhaust manifold with some force.

The blow resulted in a cut 15 cm long and 3 to 5 cm deep on the calf of his left leg. He was given first aid and later disembarked for shore treatment. He was declared fit for work about three weeks later.

- We are often tempted to overreach when accomplishing a job. Better to have help.
- Proper PPE is important. In this case, the engineer was wearing only a light cloth coverall. It is likely a more robust coverall would have afforded better protection.
- Permits to work and workplace inspections before beginning work are good risk reduction measures but they cannot remove all risks. Careful attention to our actions and common sense are needed throughout the task.

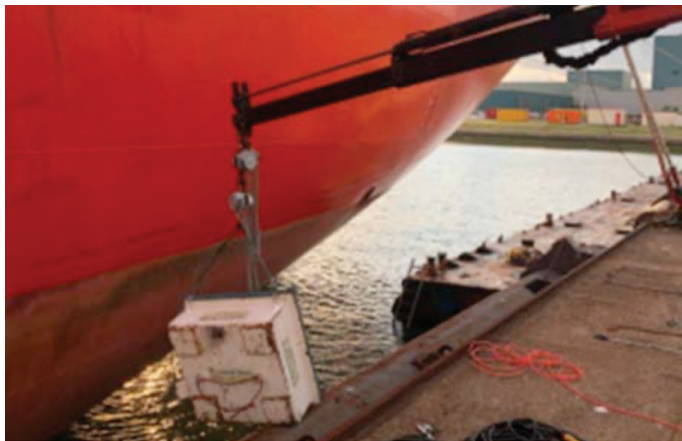
The investigation revealed that heat from welding could have caused deformation of the ship's side plating, causing the cofferdam to lose watertight integrity. Also, the flat cofferdam did not form a perfect seal with the hull due to a slight curvature at that location.

Cofferdam being positioned

- The task was executed by an external team, resulting in limited crew participation. Close coordination and supervision of contractors by crew provides an added layer of safety.
- In an emergency, pumping bilge water and ballast directly overboard is allowed within MARPOL and the International Convention for the Control and Management of Ships' Ballast Water and Sediments.

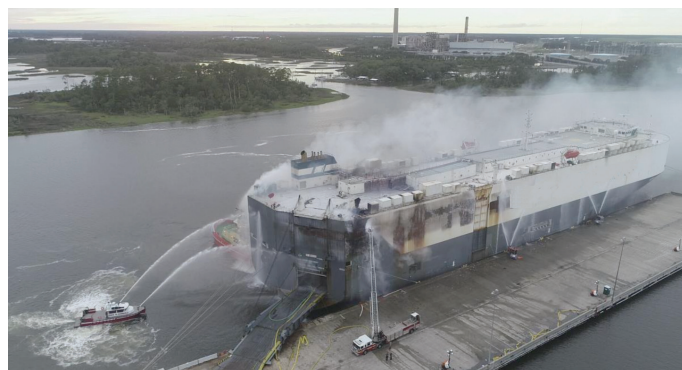
The CO<sub>2</sub> was ineffective for a number of reasons; not least that the dampers for decks 7/8 were ineffective or not adequately secured. This gave the fire continued access to oxygen, negating the effectiveness of the CO<sub>2</sub>. The fire continued to spread to higher decks and the accommodation. Shoreside firefighters entered cargo decks with fire hoses in an attempt to douse the flames. Suddenly, an explosion occurred and nine firefighters were injured, five of them seriously. Responders subsequently adopted a defensive strategy, cooling external exposed surfaces. The fire was finally extinguished eight days later.

The fire was likely caused by an electrical arc or component fault in one of the vehicles. The company's established vehicle loading and battery securement procedures call for a properly disconnected and secured battery for all vehicles loaded on the vessel. These procedures were not followed by the longshoremen preparing and loading vehicles onto the car carrier. Neither vessel crew nor shore supervisory personnel corrected this deviation.

The company's 'Vehicle Lashing Inspection Procedure' identified the need to ensure that all vehicles loaded on board the vessel had disconnected batteries, but did not provide a process to do so.

- As with most accidents, there must be a failure of several layers of the safety regime for there to be negative consequences. In this case these failures were both ashore and on board.
- Procedures are meant to be an administrative barrier to negative consequences. They should not only describe the hazards but provide the process by which the hazards are actually mitigated.
- Extinction of a fire using a fixed extinguishing system such as CO<sub>2</sub> relies on two conditions:
  - 1) Timely release of the extinguishing agent before the fire can spread elsewhere on the vessel
  - 2) The securing of vents and ventilation so that the extinguishing agent can be effective and air cannot continue to feed the fire.

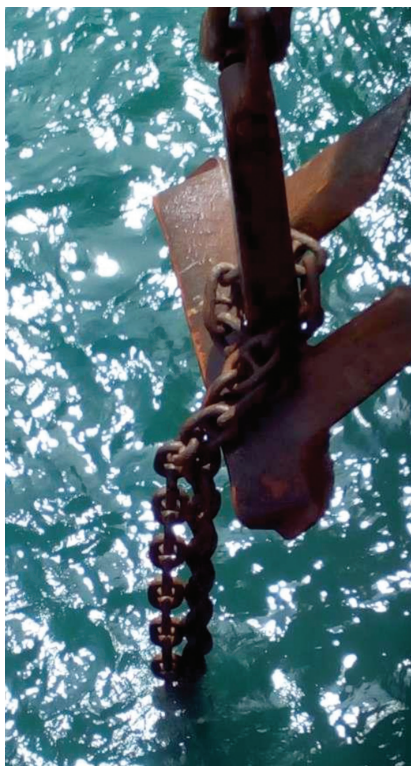
The port anchor chain was then heaved up. It was found that the anchor was not, in fact, lost; the bitter end had remained secured. However, when the port anchor was heaved up, it could not be secured because it had become entangled with the starboard anchor chain.

The company investigation found that the port anchor brake was not working properly; it did not move before the brake reached the 90% open position. If the equipment had been in good condition, the anchor chain could have been controlled.

Also, the investigation found that after the port anchor chain paid out uncontrollably, the actual condition of the port anchor was not correctly assessed/communicated to the bridge. Had this been done, the starboard anchor would not have been deployed and the incident would have been avoided.

- Anchor brake maintenance is a crucial element in safe operations. The uncontrolled descent of an anchor chain can not only pose a significant risk of losing an anchor, but also poses a lethal hazard to crew.
- During and after an incident it is sometimes difficult to assess and communicate the state of affairs – yet this is what is needed for ships' leaders to make the right decisions going forward.

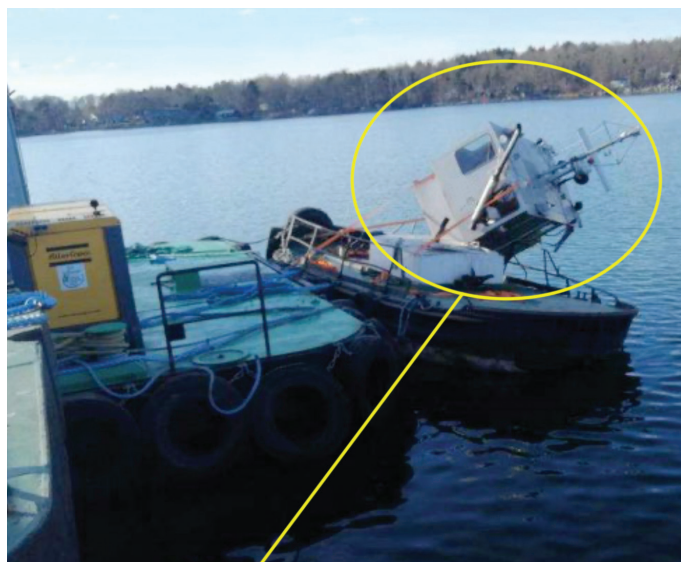
The vessel gained speed astern, and was closing on the dredging units. The officer on the quarter-deck warned the bridge team that the vessel was now 20 metres from the dredging units and continued to give the distances, which were closing quickly as the ro-ro was now making about two knots astern. At some point, full ahead was applied on the engine controls but the effect was too late. The stern of the ro-ro continued to sweep over the attending dredging tug. The tug wheelhouse was torn from its attachments, and was left hanging over the starboard side of the tug.

Tug wheelhouse torn from attachments

- Controlling a vessel that is moving in two directions (swinging and fore/aft movement) is harder than controlling a vessel that is moving in only one. The fact that the vessel was turning at the same time as it was reversing probably affected the bridge team's situational awareness.
