Inadvertent Release of a Freefall Lifeboat

Loss Prevention Bulletin

The Australian Transport Safety Bureau (ATSB) has recently published a preliminary report regarding the inadvertent launch of a freefall lifeboat from a geared handymax bulk carrier while on a ballast passage in the Indian Ocean.

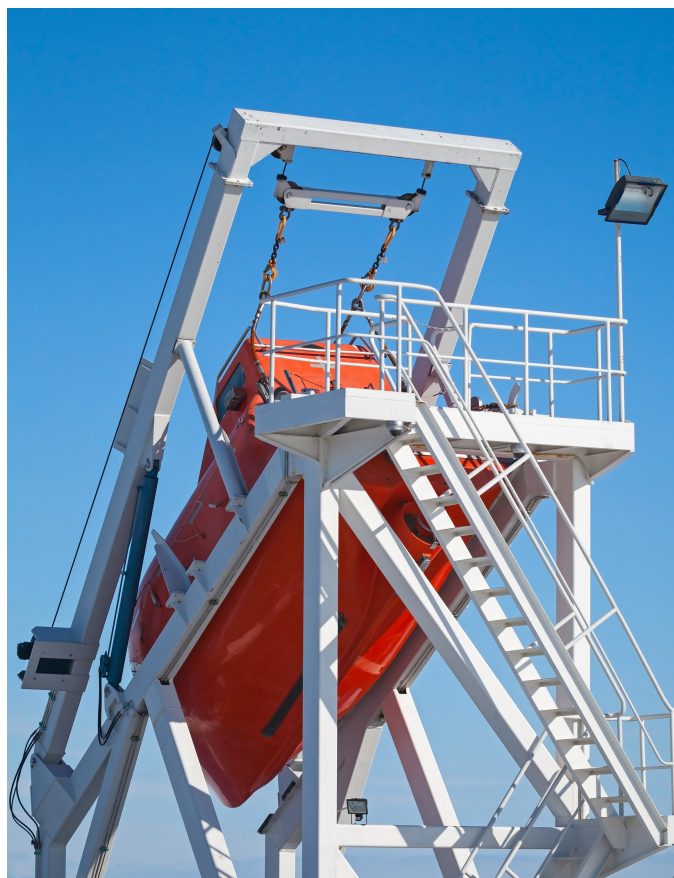
In the previous port the Second Engineer became concerned that the hydraulic hook release system of the freefall lifeboat was losing oil and topped it up. A few days later, after the Third Engineer and supernumerary Chief Engineer had completed their weekly lifeboat safety checks and returned to the embarkation deck, the Second Engineer entered the lifeboat once more to re-examine the hydraulic hook release system. He found that the oil level had fallen again and also noticed an oil sheen around the main hydraulic hand pump. After adding more oil and with no obvious source of the leak, he decided to pressurise the hydraulic system by operating the hand pump lever so that any outflow could be traced more easily. After leaning across the coxswain's seat and operating the pump lever a few times, the hook suddenly released and the boat rolled down the davit and over the stern. When the lifeboat started to move the Second Engineer realised what was happening and managed to sit in a seat, but he was unable to secure the seatbelt before the boat hit the water. The vessel turned back after other engineering staff present on the embarkation deck raised the alarm, and the lifeboat was eventually retrieved. As a result of the accidental launch, the Second Engineer sustained a fractured knee requiring medical treatment ashore and he was subsequently repatriated.

Freefall lifeboat and davit arrangement

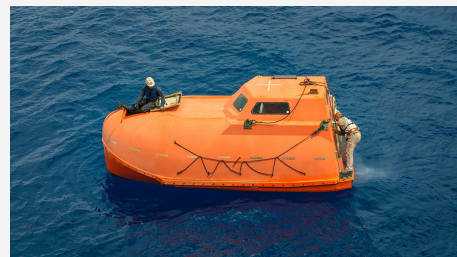
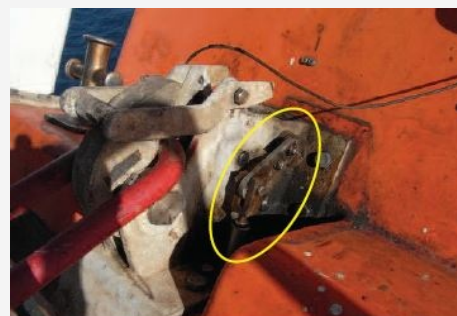
The freefall lifeboat was secured in the davit by a hook fitted to its stern. The hook was attached to the end of three long links which were fastened to a strong point on the vessel. Releasing the hook and launching the lifeboat involved operating the lever of the hydraulic hand pump situated inside the boat which activated a hydraulic ram. The hydraulic ram, via a link, rotated a cam which released a stopper block, allowing the hook to rotate and disengage the links (see picture). For the hook to detach, and on the assumption that the hydraulic ram would always be fully retracted, the manufacturer's manual advised that the hand pump lever would need to be operated approximately ten to twelve times. However, the ATSB's preliminary investigation found that it was possible to reset the hook and stopper block arrangement when the hydraulic ram was partly extended, thereby requiring fewer movements of the hand pump to trigger the release mechanism. The Second Engineer estimated he had pumped the lever only three or four times before the hook disengaged.

The release mechanism was fitted with a pin which passed through the hook and its adjacent cheek plates to prevent it from tripping. It was necessary to remove the pin in order to enter the lifeboat. However, since the pin was attached by a lanyard to the access door, it could not be re-inserted once personnel were inside.

Lifeboat hook arrangement secured to long link.
Note the hydraulic ram and link arrangement
(circled)

1. Resetting the hydraulic ram:

The vessel was fitted with a 27 person freefall lifeboat (JY-FN-5.8 type), davit (JYF55 type) and hook and release mechanism (model JX-4) all manufactured by Jiangsu Jiaoyan Marine Equipment Company. Vessels having the same or similar lifeboats or equipment are advised to ensure that the hydraulic ram is pushed back fully into its housing when resetting the hook following release. Marking the mechanism to indicate when the hydraulic ram has been reset correctly or adding other visual indicators may also be considered.

3. Anti-tripping pin:

If it is necessary to remove the antitripping pin fitted to the release hook in order to enter the lifeboat, and the arrangement prevents the pin being refitted once the lifeboat door is open, then a spare pin should be available and fitted to the hook to prevent inadvertent release.
