The use of ECDIS Alarms

Loss Prevention Bulletin

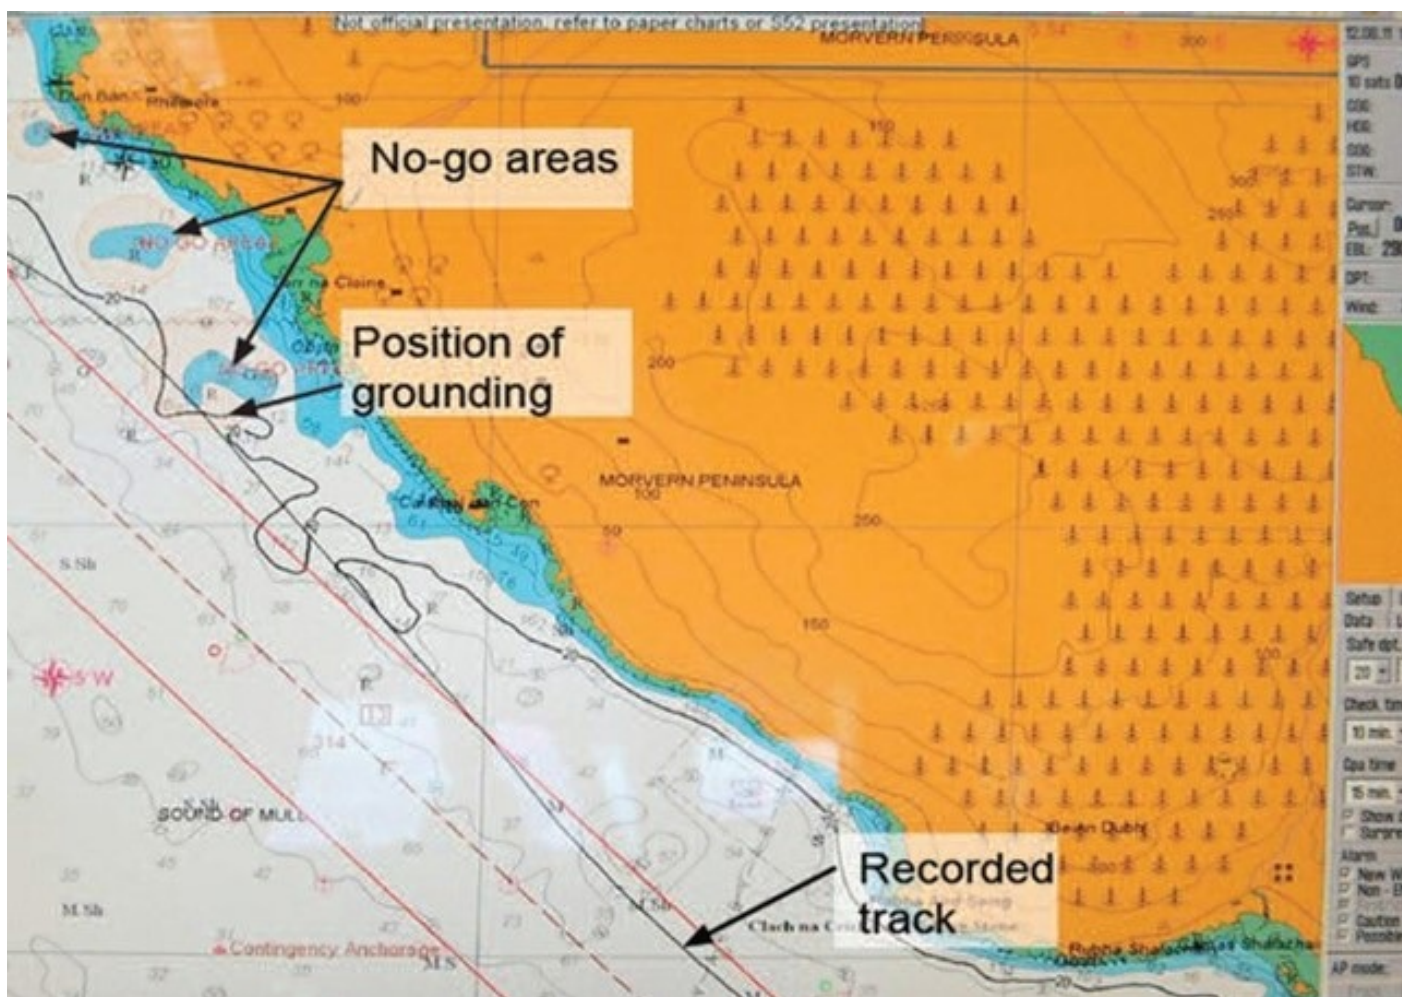
A 19,000 GT self-discharging bulk carrier was on a loaded passage through confined waters when the vessel grounded and sustained a 3 metre fracture in a ballast tank. The bridge watchkeeping officer had made a number of alterations of course to avoid a sailing vessel and another small craft. These collision avoidance manoeuvres forced the vessel away from the planned track and into shallow water where the vessel grounded at 12 knots.

The vessel had a maximum draft of 10.6m and may also have been affected by squat. It was subsequently found that the safety contour had been set to 10m which, even allowing for the rise of tide above chart datum, was clearly inadequate.

The alarm was triggered before the safety contour was crossed, but the only warning was a visual alert on the ECDIS screen. This was not noticed by the watch-keeping officer as he was engaged in collision avoidance and was not monitoring the vessel's position on the ENC. Although an audible alarm should have sounded in addition to the visual alert, the audible alarm feed had been disconnected.

The Master and deck officers had completed a generic ECDIS training course based on IMO Model course 1.27. However, the official investigation report concluded that their knowledge on the use and functionality of the ECDIS safety features was insufficient as they had not undergone any type-specific training. In particular, they failed to recognise that the safety contour setting was inappropriate for the voyage and were unaware that an audible warning should have sounded when the safety contour alarm was activated.

Photo: MAIB Report: Grounding of CSL Thames in the Sound of Mull. © Crown Copyright. Planned and actual track of 19,000 GT bulk carrier

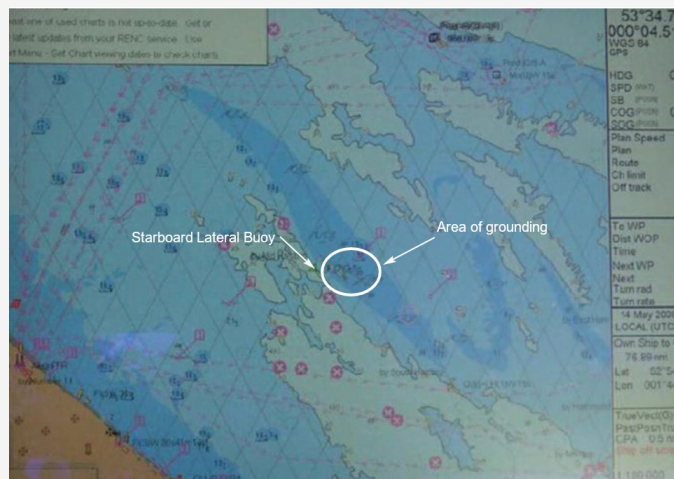
The passage plan was amended when the ECDIS was displaying the ENC at a scale of 1:100,000. Visual inspection of the route on the ECDIS showed it to be clear at this scale. The fact that the vessel would pass a starboard hand lateral buoy on the port side whilst following the direction of buoyage was not investigated further. Had this been checked, it would have been evident that the amended passage plan took the vessel over a sandbank with charted depths considerably less than the vessel's draft. However, this was not obvious to the deck officer who amended the passage plan, or to the bridge officer on watch at the time of the grounding.

The safety contour function on the vessel's ECDIS was fitted with a watch vector function whereby a time and angle for the predicted movement of the vessel needed to be set in order to trigger the safety contour alarm. Although the safety contour had been set at 30m, the alarm did not function as the watch vector had not been activated by the bridge team.

It was found that the Master and deck officers had received no formal ECDIS training. They failed to recognise the significance of the safety contour and did not know how to set a watch vector ahead of the vessel. They were also unaware of the need to check the ECDIS for violations of user defined limiting parameters (such as the safety contour) when adjusting the passage plan.

Chart view on 4,000 GT general cargo ship at a scale of 1:100,000 as used for amending the passage plan; note the lack of detail in the area of the grounding. Photo: MAIB Report: Grounding of CFL Performer Haisborough Sand North Sea. © Crown Copyright

- Alarm parameters are adjusted throughout the voyage to ensure that they are optimised for the prevailing circumstances and conditions
- Changes to alarm parameters are considered when preparing the passage plan for the next voyage
- Checks are made to ensure that user defined limiting parameters, such as the safety contour, are not violated when it has become necessary to adjust the passage plan after departure

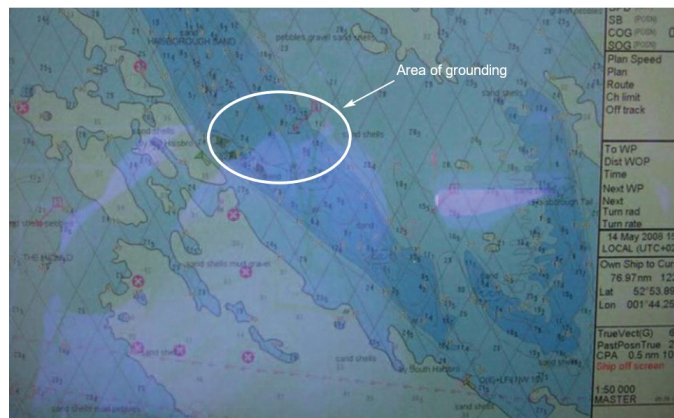
Chart view on 4,000 GT general cargo ship at a scale of 1:50,000; note the much greater detail in the area of the grounding. Photo: MAIB
Report: Grounding of CFL Performer Haisborough Sand North Sea. © Crown Copyright
