News 02 Jun, 2020

Engine Room Fire Onboard a Laid-up Bulk Carrier

Dmitry Kisil
Senior Loss Prevention Officer

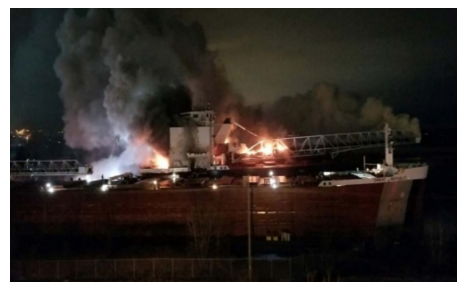
Fire damage extended to the engine room, the entire superstructure, the unloading belt throughout the conveyor tunnels to the bow, as well as to the cargo conveyor boom belt above the main deck.

The vessel on fire (Source: NTSB report)

'the ignition of combustible material in the vicinity of an engine room workshop likely due to the use of portable space heaters or smoldering smoking materials, which spread to other areas of the vessel. Contributing to the extent of the fire damage was the lack of operating procedures for continuous active monitoring of the vessel while in layup status.'
