News 09 Jun, 2022

Fitting and removal of temporary lashing points

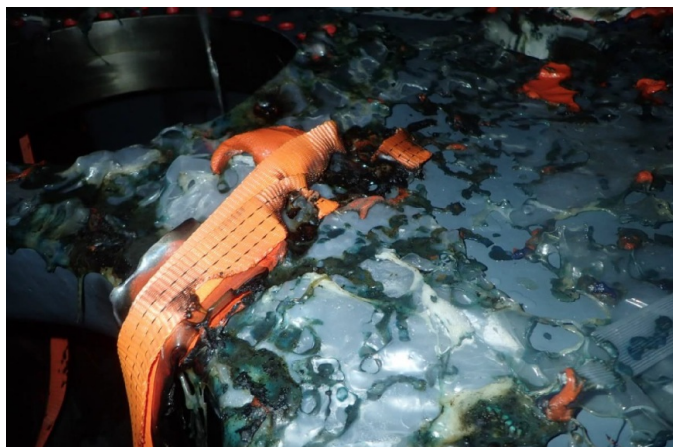
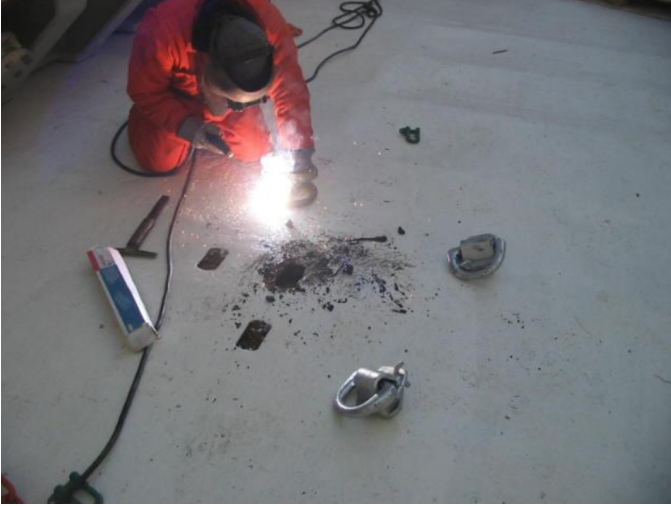
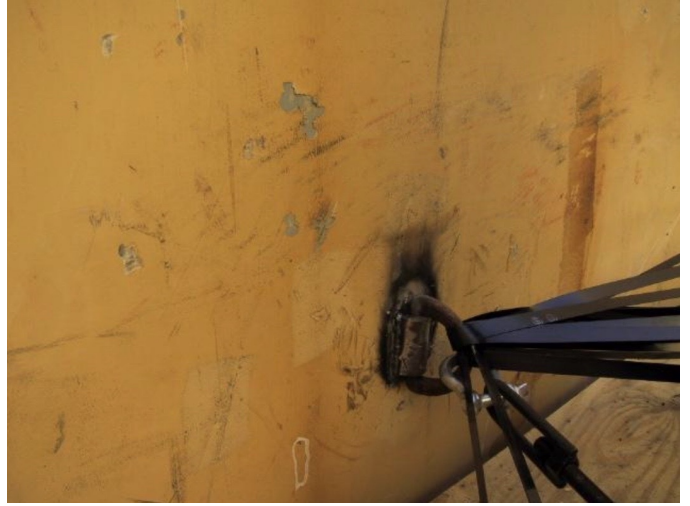
In some recent cases, hot slag/sparks have dropped into cargo holds and set fire to packaging or tarpaulins covering the cargo below. In addition to the direct fire damage, further damage to cargo has occurred due to water damage from subsequent firefighting operations.

In another instance, where there was a mixed stow in one hold, bulk cargo in an adjacent hold decomposed due to heat transfer where temporary lashing points were being fitted to a transverse bulkhead for securing of general cargo.

In some cases, no fire watch had been arranged due to a lack of awareness that heat/sparks/slag can propagate through steel plating separating the point of work and cargo hold. In others, although a fire watch had been placed, it was not positioned correctly and/or there was too much reliance on fire retardant tape/blankets which were either poorly placed with no coverage at some points due to gaps or proved inadequate to deal with the high temperatures involved.

- Toolbox talks and hot work permits must be specific to the task at hand and recognise the risk of heat transfer/sparks/molten slag in all adjacent areas (above, below and to all sides), including cargo holds.

- Where protective coverings are used to protect cargo, they must be effectively placed and sufficiently robust – heavy duty welding blankets are readily available and should be used. More than one layer may be required. If possible hot work should only be made when holds are free of cargo.

- Oxy-acetylene cutting torches are frequently set to high pressure for fast cutting, leading to a wide spread of sparks and slag. Reducing the torch pressure can significantly lower the spread of sparks/slag, effectively reducing the risk, especially with a tight cargo stowage or when the securing points are within high-risk areas. Cutting will take longer, so it is important to explain this to those carrying out the works and for close oversight to be maintained throughout.

- Fire watches must be in place and need to be correctly located to see all possible hot zones. Watching for smoke from the hold entrance is not sufficient since the fire will already be well set at this stage.
