In this bulletin...

MARS 202601

High speed in fog courts disaster

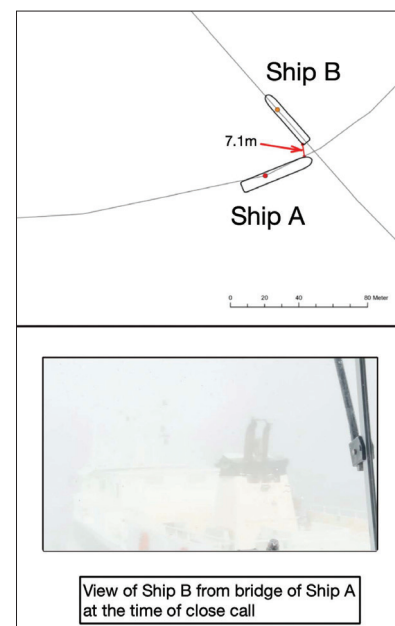
Ship B's crew saw that Ship A was on a southerly course and assumed that Ship A would pass port-to-port and then astern of them. But then, Ship A turned to port to an easterly course at about 35 knots, bringing it on a collision course with Ship B. When the Master of Ship B saw that Ship A was heading directly towards them, he turned to starboard in an attempt to avoid collision. The bridge team on Ship A saw Ship B at the last minute and were unable to make any changes to their speed or direction. They passed astern of Ship B at about 7 metres distance.

The investigation found, among other things, that the reason the speed was not reduced on Ship A was that the bridge team felt the conditions were excellent for radar, where even echoes from small objects appeared clearly on the screen. The bridge team thus felt that they had control of the situation despite the dense fog. However, the high

speed meant that the OOW and the Master had very little time to perceive, discuss, and analyse the radar image. They did not understand that they had lost their situational awareness of the surrounding traffic.

- Only good fortune prevented this close call from being a disaster. Given the high speed of Ship A and the fact that there were passengers on the foredeck, an impact with Ship B would probably have resulted in multiple fatalities.
- Once again, high speed in reduced visibility created a dangerous situation. Slow down in fog!
- Using a telephone app to help identify other vessels is not professional nor a recommended practice. Use proper navigation instruments to their utmost.

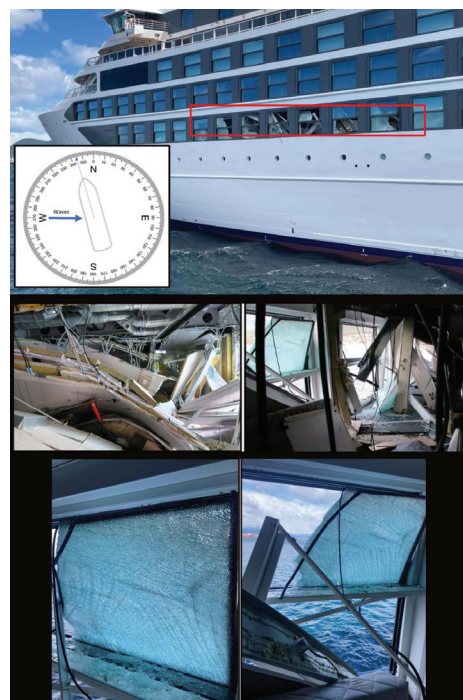
A clearer picture of the extent of the damage became evident, and as the damage appeared to be limited to a relatively small area and the emergency was considered under control, a general muster was not initiated. Passengers were instructed to remain in their cabins, except for the passengers in the damaged area, who were instructed to proceed to deck A. It was later found that seven cabin windows on the port side of deck 2, approximately 8 metres above the waterline, had shattered when the wave struck the ship.

The investigation found that the sea conditions at the time of the accident were within the sea states defined in the specifications to which the ship was designed, yet the wave forces acting on the windows were significantly higher than their design state.

- At the time of the accident, the crew did not have sufficient information to predict the risk associated with a strong breaking wave reaching high up on the ship side.
- The current design pressure requirements for windows on a ship's side appear to yield values that are too low to withstand real-world pressure loads from breaking waves.

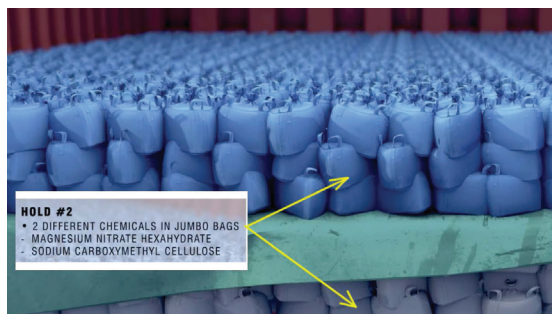
Screen capture from London P&I Club video

Serious problems can also occur when FIBCs are stored incorrectly with breakbulk or steel cargoes, which can damage the integrity of the jumbo bags and cause significant spillage. Steel cargo can also

be damaged by exposure to spillage from the jumbo bag.

- When developing stowage plans for FIBCs and other big bags, consider requesting advice from P&I's so that qualified industry experts can be consulted before loading.
- These cargoes may look harmless, but they can be potentially very dangerous if not stowed and handled appropriately.
- The London P&I Club made an interesting video on this topic that can be viewed here: <https://youtu.be/e0SEQkCFIbo>
