Mariners' Alerting and Reporting Scheme

MARS Report No. 318 April 2019

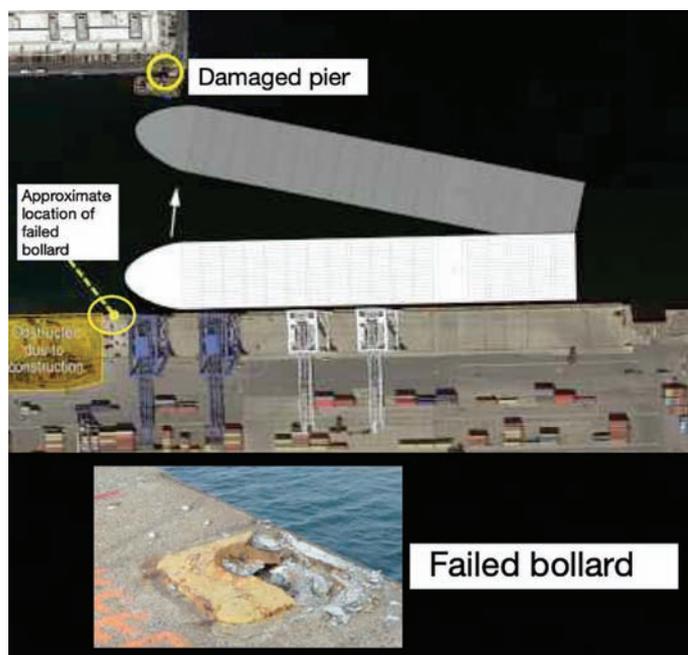
MARS 201923

Vessel goes adrift as forward bollard fails

Later, as the vessel was discharging cargo, winds increased as expected with peak gusts near 40 knots. The bollard forward with the five headlines was torn from its base. The forward spring lines parted followed in quick succession by the seven remaining lines. The vessel drifted off the wharf and the bow struck a nearby pier. An anchor was walked out, bow thruster and main engine were brought on line and the uncontrolled drift of the vessel was stopped some 30 minutes after the bollard failure. Shortly afterwards, tugs arrived and assisted the container vessel to anchorage.

- Mariners can never be sure of the holding power of a particular shore bollard. In this case, all forward headlines were on one bollard. Best practice is to spread the load to several bollards.
- Once one part of a mooring arrangement fails, there is a high probability of the remaining parts failing in relatively quick succession. Loads can be distributed in a way that is beyond the design capacity of the system.
- If high winds are forecast it may be necessary to take extra precautions, such as an anchor outboard, having engines and bow thruster ready, or having tugs on standby.

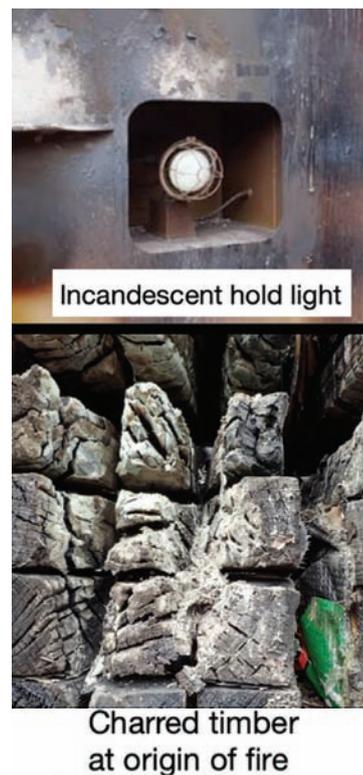
MARS 201924

Incandescent cargo hold lights a hazard

- The fire was caused by heat radiating from an incandescent cargo hold lamp. The lamp set fire to packs of timber that had been stowed within 45–50mm of the lamp.
- The ship had no written procedure or checklist for ensuring the cargo hold lights were switched off before flammable cargo was loaded against cargo light recesses, or when loading was complete and hatch lids were closed.

- For a fire in a cargo hold, fixed CO₂ is usually your best option. Release, wait and boundary-cool. Monitor temperatures and do not open hatches too soon.
- The responsibilities of command structure when shore firefighters are on board should be clearly documented and understood by the various authorities involved in responding to the fire.
- High-temperature-producing cargo lamps are inherently more risky than LED lamps, which are now available at affordable prices.

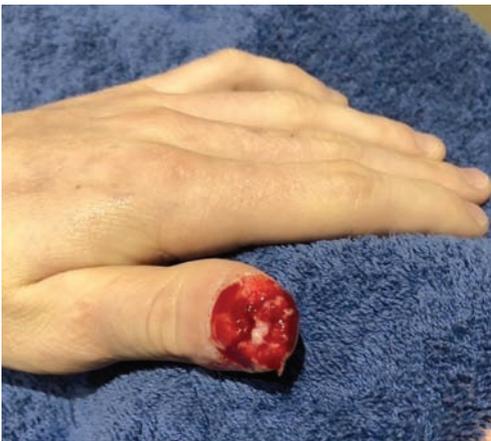
MARS 201925

Thumb caught while hooking on

➔ On a large yacht, the beach lander was to be recovered at the port-side shell door. The beach lander was positioned under the davit hooks and secured fore and aft. The forward hook was lowered and a crew member attempted to attach the hook to the strop. At the same time, an unusually big wave that had lifted the beach lander up now was moving to its trough and the small craft descended rapidly, crushing the crew member's left thumb between the hook and the lifting strop.

- When hooking on in a seaway, ensure there is enough slack in the hook line to accommodate the rise and fall of the boat before attempting the manoeuvre.
- Proper work gloves might have mitigated the extent of injury.

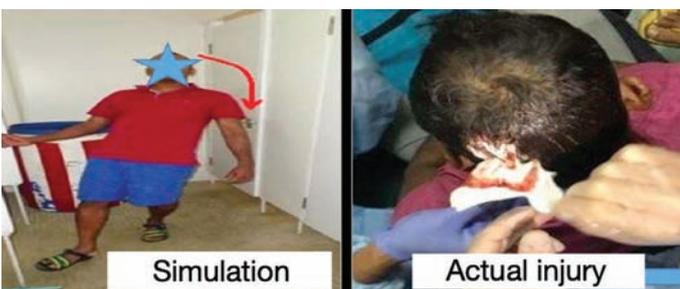
MARS 201926

Wet floor causes hard fall

➔ A crew member had gone to the common toilet. After stepping out from the cubicle, he slipped on the wet floor. As he fell backwards his head hit the handle of the cubicle door and he fell unconscious. Shortly after the incident another crew member saw the victim sitting in a

- Keep washroom floors clean and dry.
- Some lounge shoes or 'flip-flops' have very slippery soles when wet. These should not be used in areas that are likely to become damp.

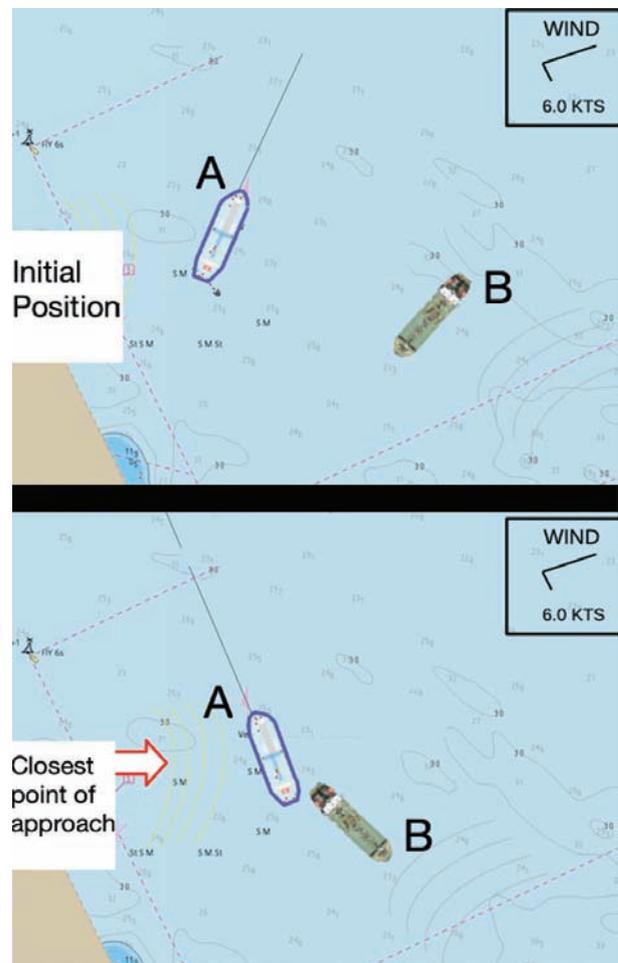
MARS 201927

Swinging at anchor – close call

➔ A large oil carrier was anchored in an area reserved for these vessels when another large tanker anchored about 0.3nm away at the same anchorage. Some time later, the vessels began to swing about their respective anchors due to the shifting tidal stream, but the effects on each ship were slightly different. The vessel's sterns began to approach one another. Concerned about a possible collision, the OOW on vessel A repeatedly attempted to communicate with vessel B but received no response.

- When going to anchor, place your vessel in a position that allows for a 360° swing on the anchor chain and still provides a safety margin with other anchored vessels that may also swing 360°.
- At anchor, just as when underway, it is important to maintain close monitoring of your position and of those vessels around you.
- If you have concerns about traffic, weather etc while at anchorage, keep your main engine available at short notice to help prevent any risk of collision.

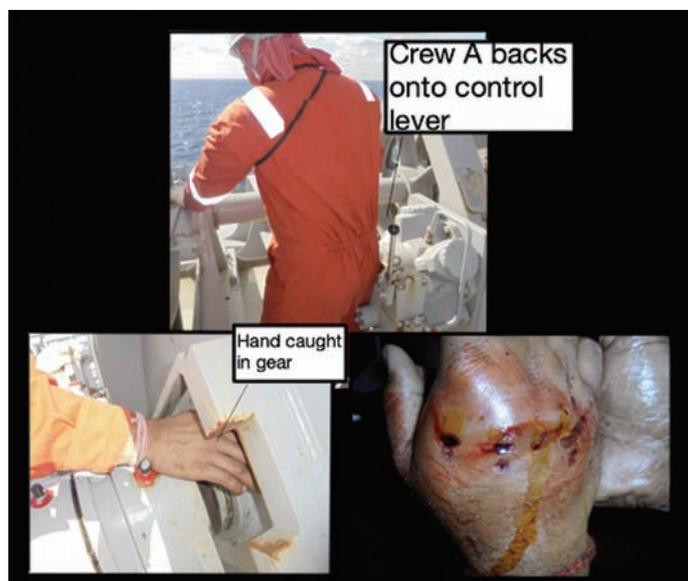
MARS 201928

Missing out on the LOTO ticket

The winch lever safety locking mechanism had not been engaged and at one point, crew member A accidentally touched the winch control lever with his back, which caused the winch to move in the heave-up direction. His hand got stuck in the winch gear engaging assembly and he shouted for help. Crew member B immediately stopped the winch and, after checking with crew member A, slowly moved the winch in the opposite direction to clear his hand from winch.

- Tool box meetings are serious affairs and should account for all known risks and reiterate PPE use. In this accident it is hard to imagine that the tool box meeting accomplished this end.
- If machinery is running, as in the greasing phase, at no time should parts of your body be close to the moving parts of the machinery.
- If body parts are to be close to machinery that can potentially move, as in the excess grease cleaning phase of this report, lock out – tag out (LOTO) procedures should be employed. In this case, the power supply to the winch should have been locked out before the grease clearing began.

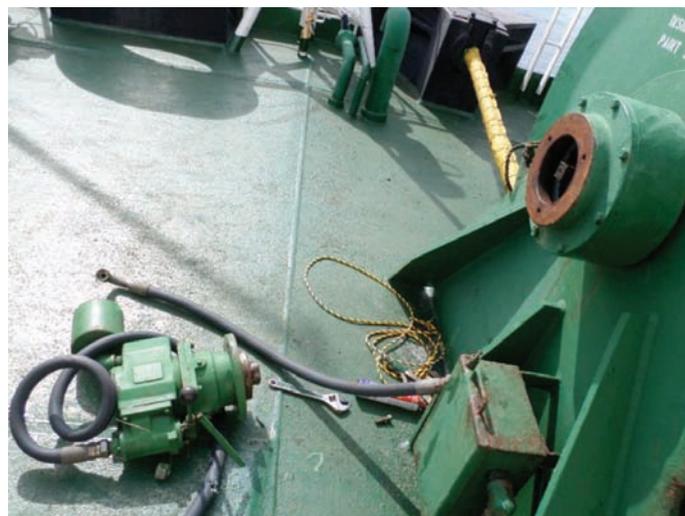
MARS 201929

Incomplete re-assembly causes serious injury

The motor, which weighed about 50kg, was dismantled and transferred to the engine room for lubrication and maintenance. Once completed, the motor was brought back on deck and re-installed using the three mounting bolts. The bolts were inserted but, for reasons unknown, were not tightened up completely.

The air supply valve of the motor had been closed and properly tagged during the maintenance, but now the valve was reopened to proceed with the test. As the air pressure turned the motor a strong torque developed and the motor began vibrating rapidly and unequally due to the unsecured bolts. The motor quickly came away from its mounting and struck the two crew members. Both were injured severely enough to require shore treatment and repatriation.

- Humans are fallible and a slip, lapse or mistake can happen. Always review and cross-check your work before testing a newly installed or maintained piece of machinery.
- Risk assessments should be completed for all aspects of a job and safeguards established against all identified risks.
