# Mariners' Alerting and Reporting Scheme

MARS Report No 361 November 2022

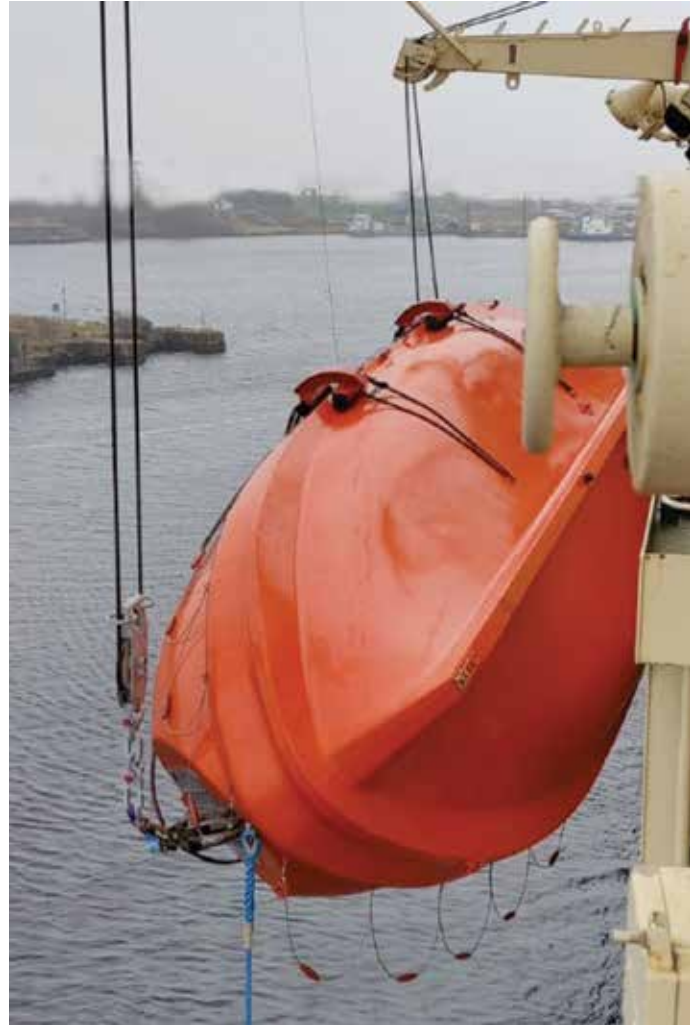
→ A vessel's lifeboat with crew on board was being lowered to the water when the remote control lowering wire suddenly parted. Poor winch wire spooling under the outer layers led to a wire kink, creating a weak spot that contributed to the wire failure. The consequences in this instance were not serious, as the broken wire simply meant the brake was re-applied. However, had this been a real abandon ship, the consequences could have been more serious.

The remote control wire was replaced with an extra wire found on board, and another test was carried out the next day. The lifeboat crew boarded and the coxswain used the remote control wire to lift the brake and begin the descent. Again, the control wire failed to spool smoothly, and an unexpected pay-out of the control wire led to the winch brake prematurely engaging. The lifeboat stopped lowering and swung erratically above the embarkation deck. Seconds later, the swinging motion caused the wire to regain tension. This lifted the winch brake arm and caused the lifeboat to lower again, still swinging. As the lifeboat swung, the skeg keel caught on the deck edge, and the lifeboat listed by more than 90°, as seen in the photo. A crewmember on deck quickly activated the winch brake lever to save the situation. Had the lifeboat inverted further the consequences could have been catastrophic.

Ship's crew should conduct a thorough visual inspection of lifeboat launching systems and perform a test lowering before carrying out operations with crew on board. Pay special attention to the following inspection points:

- Verify the proper spooling of the remote control wire, expand inspection as necessary.
- Verify that the remote control wire weight is in the correct position. If the weight is very close to the top of the lifeboat, this may indicate the remote control wire is too long.
- Verify the material condition of the shackle that connects the pull cable to the remote control wire within the lifeboat. These steel shackles can corrode and may be overlooked during weekly/monthly/annual inspections.

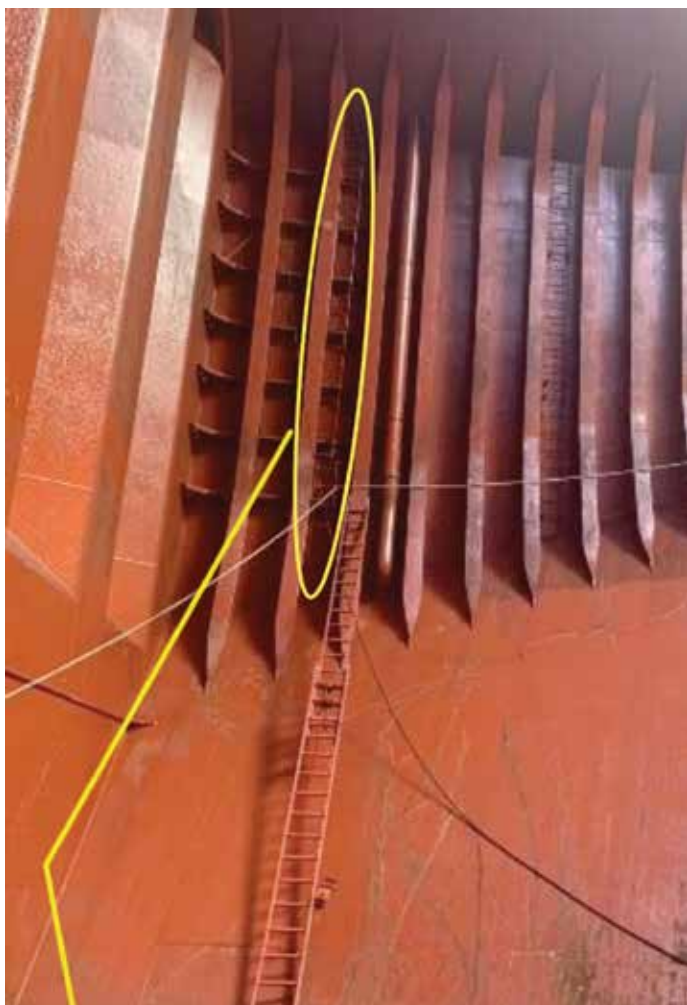
Area of work aloft

Two crew were working aft while the other crewmember aloft was forward, standing on one of the stiffeners at a height of about 7.5 metres above the tank top. He was using a power washer and a hand-held broom to wash off coal residues that had remained in this area.

Suddenly, the two crewmembers aft were alerted by a loud scream. They saw the victim had fallen from the stiffeners and was lying on the tank top, and rushed to aid him. The victim was conscious, bleeding slightly from the head, and complaining of severe chest and back pain. The accident was reported to the bridge and first aid was administered. The victim was then carefully evacuated from the cargo hold and taken to the ship's hospital, where his condition was continuously monitored. At the time, the vessel was approximately 150nm off the coast. Following communication with shore medical authorities, the Master altered course and proceeded towards the coast. The following morning

The victim confirmed during the post-accident interview that at one point just before the fall, both of his safety lines had been unsecured. The investigative agency found, among other things, that the actions of the victim were similar to several other instances on file where the need to 'get the work done' seems to override safety concerns, even where the situation was not an emergency. It would appear that if the person in question perceives that they have 'control' of the situation, this influences their decision making process and evaluation of risk.

- Qualitative risk evaluation is subjective and can be affected by factors such as the person's perceived control over the situation, the familiarity or even 'shock value' of the risk. Mundane tasks are a breeding ground for misplaced judgement, even those that present severe risks.
- Safety harnesses are equipped with two lanyards for the express purpose of always having one connected while the other one is repositioned. Make sure you and your crewmates use them correctly.

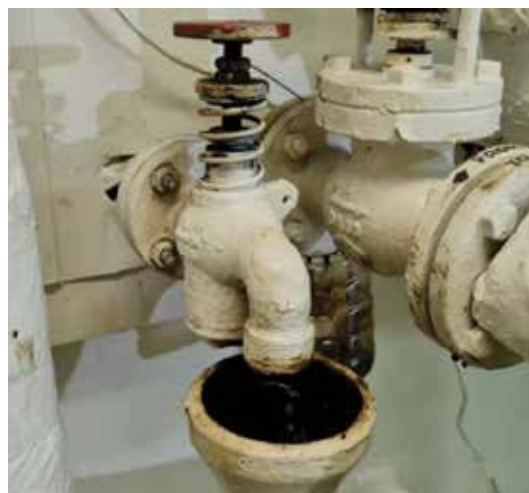
FOST-1 drain valve

The fourth engineer was directed to open the lower manhole of FOST-1 before starting the transfer, to verify that there was no sludge that could contaminate the bunkers. Before doing this, he checked the fuel oil gauge, and opened the FOST-1 drain valve. Both actions indicated that FOST-1 was empty, much as he and other engine crew had previously assumed. He noticed that the temperature in FOST-1 was elevated (about 78° C), which was unusual for an empty tank, but assumed that heat conducted from adjacent tanks accounted for this.

After the accident, it was found that the oil level gauge and its drain valve were partially clogged with sludge. Once cleaned, the oil level gauge worked correctly. The fuel level in FOST-1 was found to be at the lower edge of the manhole; a volume estimated to be nine cubic metres. It is estimated that eight cubic meters were lost into the engine room.

- Always try to be aware of confirmation bias in your daily work and life; question your assumptions and double check the facts.
- Fuel gauges and drain valves can become blocked with sludge and not indicate the correct level of fuel or drain as designed. Sounding pipes, which in this case were not fitted to the FOST-1, are an efficient and reliable double check on liquid levels within tanks.

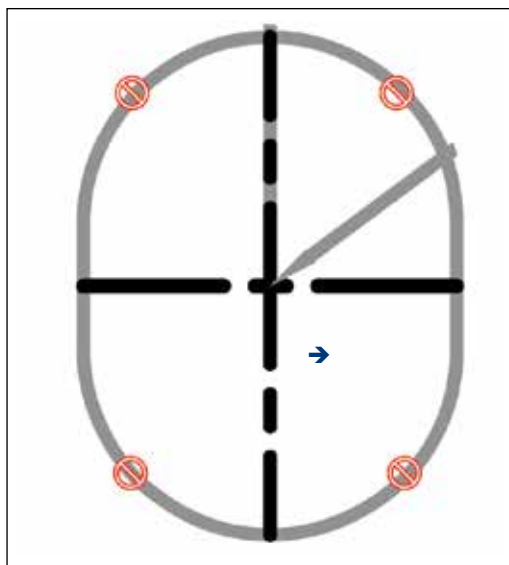
without incident, leaving four opposite each other still tightened, as shown in the diagram. The engineer proceeded to loosen these last ones, starting from the bottom nuts. At this stage, he noticed a small amount of fuel oil seeping out of the manhole. Assuming that this was the expected seepage of fuel oil which normally remains stuck to the tank sides, he continued undoing the nuts. As he loosened the last two bolts, fuel oil started to seep out in larger quantities. Now concerned about the increasing seepage, he attempted to reinstall and retighten the nuts. However, the flow and high temperature of the fuel oil spilling on his hands and torso were too much for him, and he had to abandon the area, as did the oiler helping him.

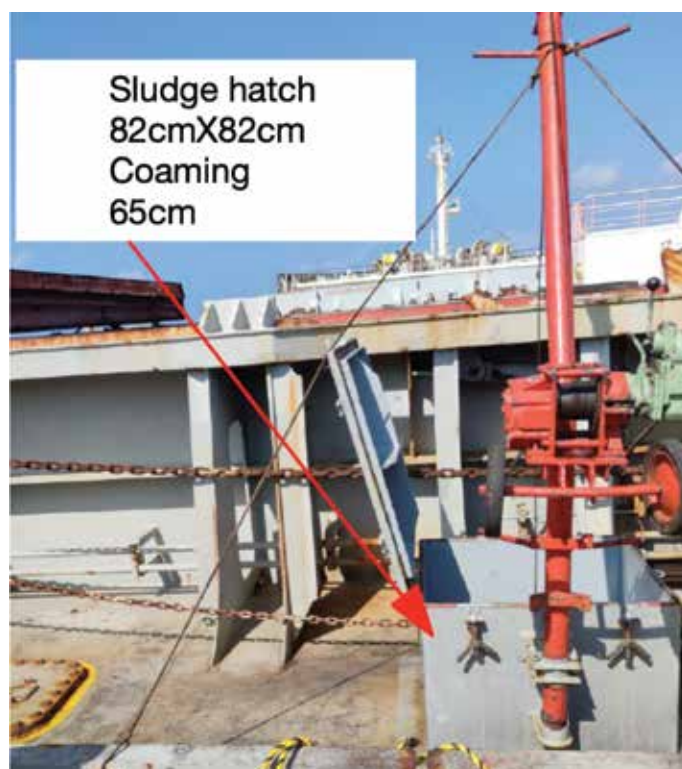
Sludge hatch and mucking winch

The bosun hoisted the wire back up and prepared a large bucket of tools weighing about 10kg to lower into the hold. The deck around the sludge hatch was dry and free of cargo residues or other debris – but the Bosun was singlehandedly attempting to attach a heavy load to a hook that was suspended over an open hatch. As the bosun was holding the bucket of tools over the open sludge hatch and trying to connect it to the hook he lost his balance. He fell through the hatch, falling about 18.5 metres to the tank top below.

- Certain jobs can lose the appearance of risk when they are commonplace to workers and/or have become repetitive tasks.
- Any workplace where a potential fall from height is possible should be treated with great caution and proper measures taken to mitigate falling.
- Trying to lift a weight that is on the limit? Ask for help.
