Mariners' Alerting and Reporting Scheme

MARS Report No 336 October 2020

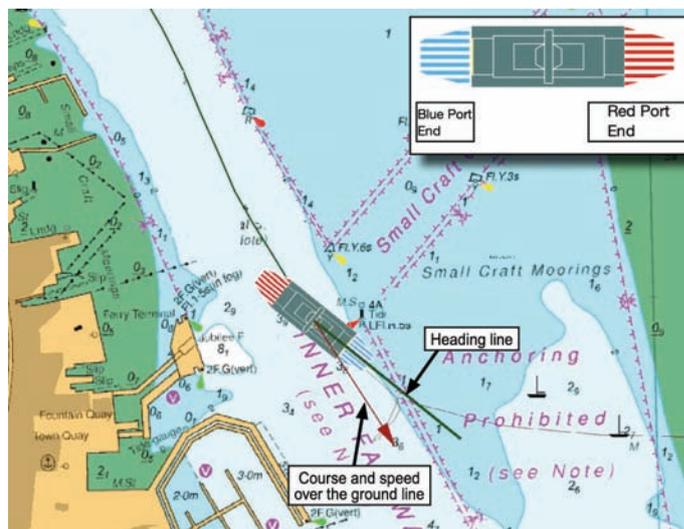
Diagram 1

As the ferry approached Blue port, the helmsman was having difficulty maintaining the required course, and the ferry started to swing to port in the channel. He immediately raised his concerns and the Master decided to take control of the vessel's steering and propulsion (diagram 1). As he did this, the visibility reduced to less than 200 metres. The assisting officer remained at the other end of the bridge and continued to relay positional information and messages from the deck lookout, whose radio calls were becoming more frequent and urgent.

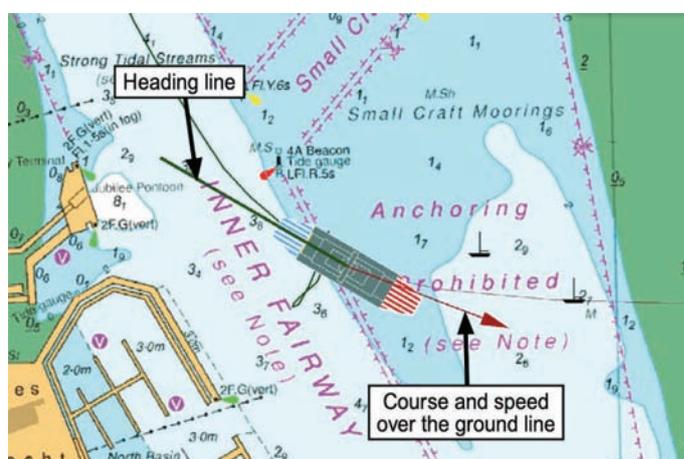
The Master managed to arrest the vessel's swing briefly but the ferry started to swing to port once again and the ferry left the inner fairway to the east. At this point the visibility reduced still further and the bridge team were no longer able to visually identify the shoreline or navigation marks. By now the vessel had turned through about 220° from its original heading and was stopped very briefly in the water, as in diagram 2.

Diagram 2 Ferry now turned 180° but heading indicator has not changed

- The electronic chart system relied on a manual switch to provide correct heading information (to properly show which end is the bow). This switch was not operated by the Master as he rushed from the Blue end console to the Red end console.
- Overcome by tasks and disorientated, the Master focused on the ECS and used the information displayed as a basis for his decision-making. The erroneous heading information being displayed supported the Master's belief that the ferry was headed back into the channel.

- Blind pilotage cannot be improvised and best results come only if these skills are constantly practised before they are needed.
- The essence of BRM is task delegation and teamwork. These were critically lacking in this instance.
- Another crucial element of BRM is to challenge, if need be, a decision taken by another member of the team, even the Master.

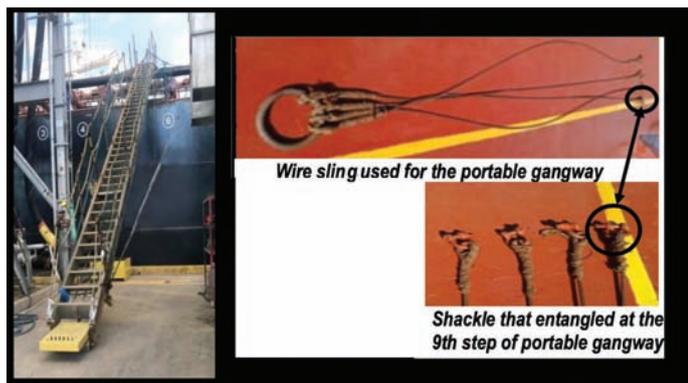
➔ A tanker was port side to at a dock and crew were installing the portable gangway. Once the gangway was in place between the ship and the dock, a crew member walked to the middle of the gangway and removed the four wire slings, motioning to the crane operator to heave up the rigging, which was connected to a single lifting ring. During the lift, one of the loose slings became entangled between the steps of the gangway resulting in its sudden movement. The crew member immediately signalled to the crane operator to cease heaving, which he did. The wire sling was removed from the step and the slings were recovered without further issue.

- Even the most common, banal tasks can harbour hidden hazards. Vigilance and attention to detail are your best defences against unwanted consequences.
- Good visual contact between a crane operator and the signaller is always a best practice.

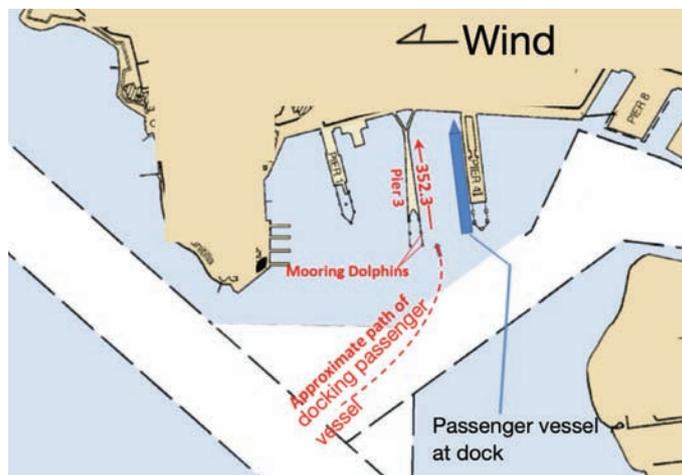
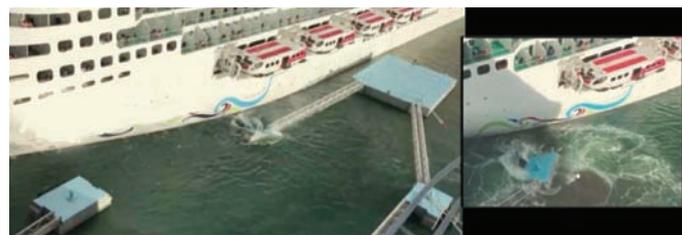
Two tugs were made fast on the starboard bow and quarter. As the passenger ship started the turn to port its speed was less than 3 knots and the Master, as planned, took the con for the docking. As the turn progressed, the pilot told the Master he would order the tugs to pull away from the dock to slow the approach. The Master was using bow and stern thrusters to manoeuvre into the space, as well as helm and the starboard engine, but sometimes these movements were in contradiction to the tug's efforts. Within about nine minutes of the Master taking the con the port side of the vessel touched the extended mooring dolphins at the south end of the pier and the catwalks that were in place there collapsed into the water.

The official report stated that the major contributing factor to this accident was a lack of communication and co-ordination between the Master and pilot.

- Difficult, tight manoeuvres are hard to accomplish at the best of times but especially when combined with a turning component. When conditions permit, vessel movements should be kept as lateral as possible.
- Although both the pilot and the Master were under the impression they had a clear, mutually understood docking plan, in reality they did not.

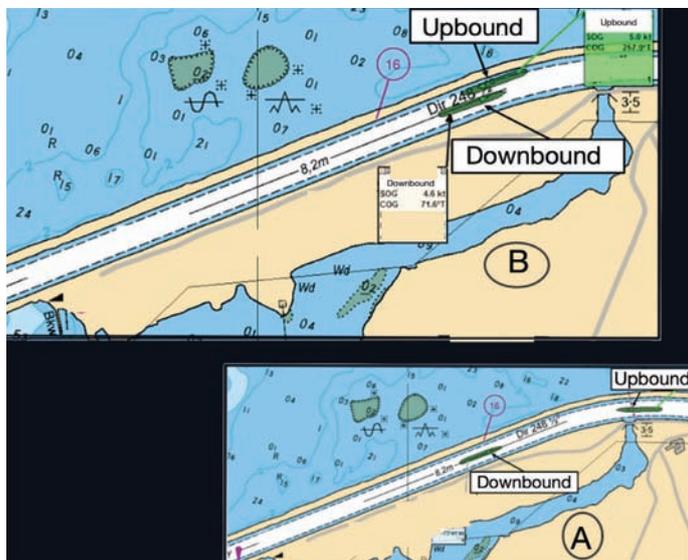
→ The bridge teams of two vessels, one down-bound and one up-bound in a narrow channel, had agreed to meet just upstream from a curve. Some time later, while rounding the curve, the up-bound vessel proceeded close to the north bank and then deviated towards the centre of the canal, as in diagram A. To correct the deviation, the bridge team altered course to starboard.

As the two vessels came abeam each other, as in diagram B, the up-bound vessel was slowly changing course to port, towards the centre of the channel. The down-bound vessel was still positioned close to the channel centre-line and maintaining its course. While manoeuvring, the up-bound vessel's starboard quarter came within approximately 7m of the north bank of the channel and made bottom contact.

- Meeting in very narrow channels takes special procedures whereby each vessel is on a steady course and almost pointed at the other. A successful meeting relies on bow pressure waves and hydrodynamics to keep the vessels apart.
- While it was mutually agreed to meet above the curve, the actual location of the meeting was arguably too close to the curve to give the up-bound vessel enough time to stabilise in a correct meeting posture.
- Once the stern of a vessel becomes close to a bank, hydrodynamic suction (bank suction) will bring the stern even closer and make bottom contact hard to avoid.

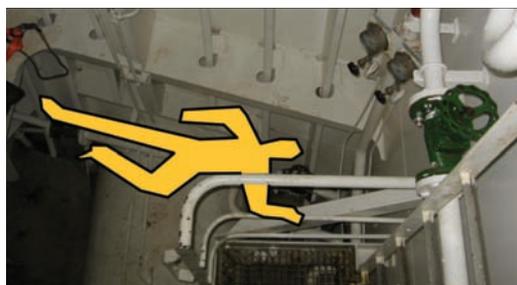
Representation of victim in BT compartment

- At the time of the accident, the bow thruster compartment's characteristics were similar to those of an enclosed space without being declared as such.
- The isolation of the bow thruster compartment's electrical supply resulted in the ventilation of that space being switched off, compromising the supply of fresh air inside.
- Although the autopsy was not available to investigators, suffocation due to lack of oxygen was deemed the most probable cause of this accident.

- Some spaces, although not officially an enclosed space, can assume those same dangerous characteristics if certain conditions are present – especially lack of air circulation.
- NEVER rush into a space that has a collapsed crew member inside. Muster the emergency team and enter with BAs.
- Practise confined space emergency procedures on a variety of compartments on your ship to determine which ones will be problematic.
