# Mariners' Alerting and Reporting Scheme

MARS Report No 333 July 2020

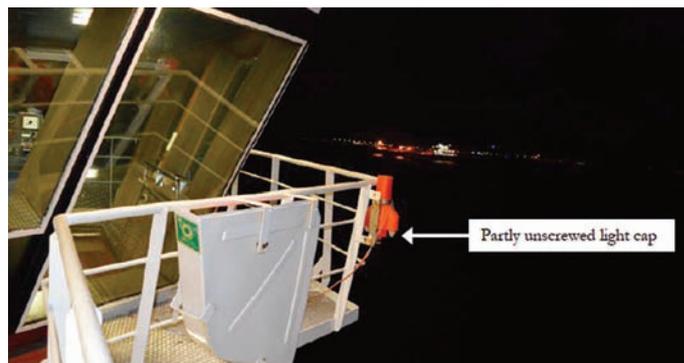
The investigation determined that the slipper that was found beside the starboard side lifebuoy release station belonged to the OOW. The other slipper was not found. The light cap on the lifebuoy was partly unscrewed. One of the light caps and two O-rings from the port side lifebuoy were found on the chart table on the port side of the bridge. The light bulb was mounted on the smoke signal and showed no sign of being defective.

The guard rail at the lifebuoy release station was 103 cm in height with two intermediate bars set at a distance of between 20 and 30 cm below. The buoy was mounted on a steel bracket by the passageway on the outside of the guard rail stanchion, which made it inconvenient to access. The only way to get a complete view of the lifebuoy was either to lean over the guard rail or to kneel on the grating to look between the intermediate bars.

The OOW was 173 cm tall, which would make it difficult for him to lean over the guard rail without stepping up on the intermediate bar. It is therefore likely that the OOW stepped on the intermediate bar and leaned over the guard rail in order to loosen the light cap to inspect the light. In doing this he most likely lost his grip and fell overboard.

The investigation found that there was no readily available way to check the functioning of the buoy without dismantling it from the bracket. The lack of instructions or guidance from the preventive maintenance system meant that the OOW had to use his own judgement to carry out this task. The OOW presumably decided to inspect the light and smoke signal in place as removing it involved a certain risk of dropping the lifebuoy overboard, particularly when working alone.

- As a matter of course, all maintenance tasks should be the subject of a risk assessment and the actions necessary for such maintenance should be documented in a procedure.
- Never work alone if there is even the slightest chance of falling overboard.
- Wearing slippers while on watch is not a best practice. Not only do they give less than adequate traction and protection, but an emergency could be declared at any time and a watchkeeper should be properly dressed and ready to respond.

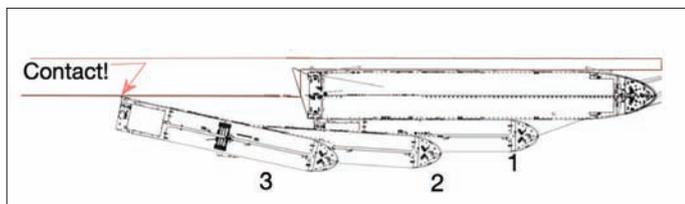
➔ A small tanker was port side to, secured alongside another larger berthed vessel (position 1). The tanker was to shift to the berth just aft of the larger vessel under the guidance of a pilot, a manoeuvre the vessel and crew had performed numerous times in the recent past. On the bridge at the time were the Master, helmsman, lookout, cadet and pilot. As the manoeuvre began, the vessel remained on the bow spring, with the rudder hard to port and the engine dead slow ahead in order to open the stern from the other vessel.

Once a gap astern was established the bow spring was released and the vessel started to go astern with the bow thruster running at 50% to starboard with engine dead slow astern and rudder midships (position 2). Suddenly, a gust of wind arose from the starboard side and the tanker’s bow was pushed towards the berthed vessel. In reaction, the bow thruster was put to full to starboard and the engine slow ahead and then half ahead with rudder 20° to starboard. However, the vessel’s stern was now too close to the pier and contact was made at about one knot (position 3).

- Use of tug?
- Allow more of a gap to develop between the vessels before coming astern?
- Less speed astern?

Hindsight is 20-20. Try and envision your manoeuvre before you undertake it, be conservative and expect the unexpected.

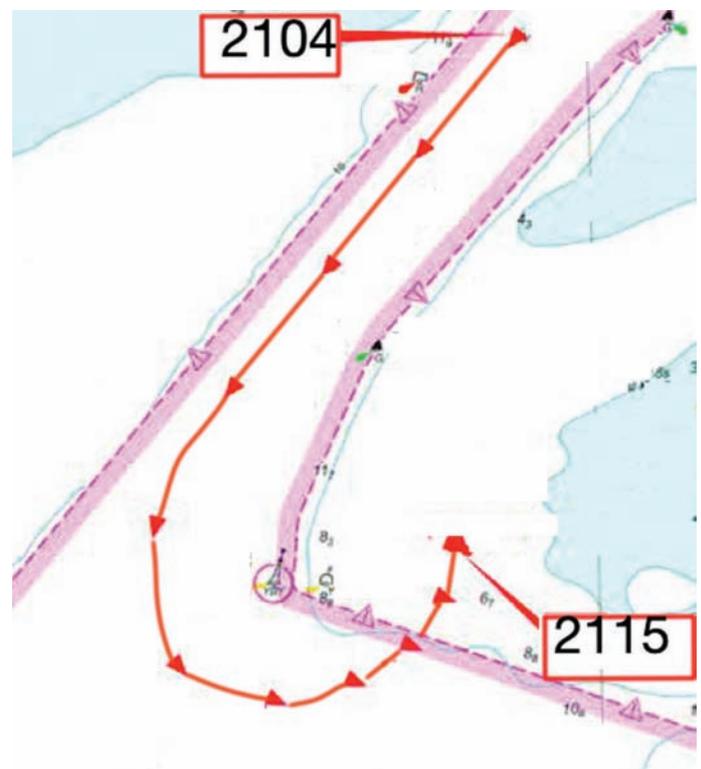
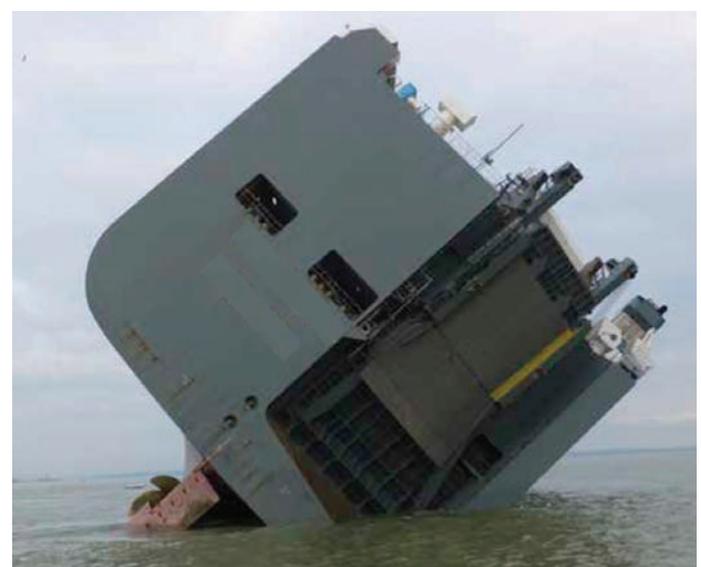
The pilot ordered 'hard a starboard' and 'stop engines'. He inquired about the vessel's GM but it was already too late. The vessel blacked out and the starboard list continued to increase as the ship swung to port and grounded, (top left) its rudder and propeller now clear of the water (bottom left). Rescue and salvage operations were subsequently undertaken.

- The vessel had inadequate residual stability to survive the port turn at 12 knots and did not comply with IMO stability requirements.
- The vessel's actual cargo weight and stowage were significantly different from the final cargo tally supplied to the ship.

- The investigation uncovered evidence that suggests sailing without a finalised and accurately calculated GM is a practice that extends to the car carrier sector in general.

- Without proper training it is likely that unsafe practices will become the norm.

- When unsafe practices become the norm, it is only a matter of time before an accident occurs.
