### MARS 202629

Collision in fog in a TSS

## TSS collision in fog

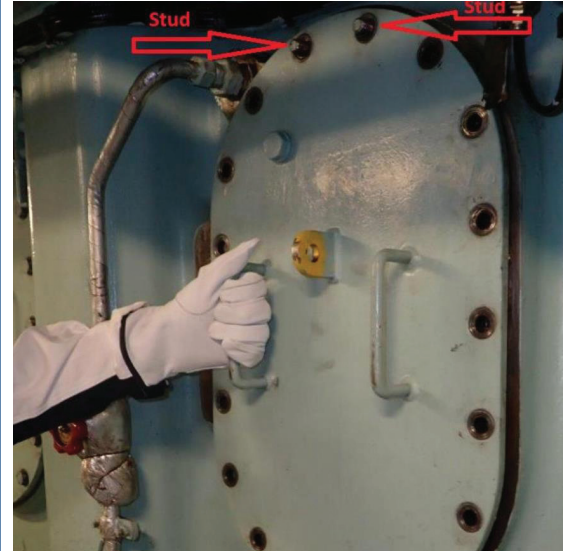
**Suggested risk reduction measure –  
upper studs as anchors**

The company investigation found, among others, that the hazard posed by the heavy inspection cover was not identified in the risk

assessment or toolbox talk. The requirement for two-person lifting was not specified. Lack of warning signage near the cover contributed to unsafe practices.

- Heavy covers always should be dismantled and mounted by two persons, regardless of whether crewmembers are using a chain block or not.
- Ideally, there should be two long studs mounted at the top position of every cover to keep it in position during dismantling/mounting.
- Work permits and toolbox talks should reinforce safe lifting techniques and roles to prevent solo handling.
- Stop Work Authority should be exercised by all crew if perceived unsafe actions are observed.
- Supervisory presence is crucial during potentially hazardous tasks.
