# Mariners' Alerting and Reporting Scheme

MARS Report No 335 September 2020

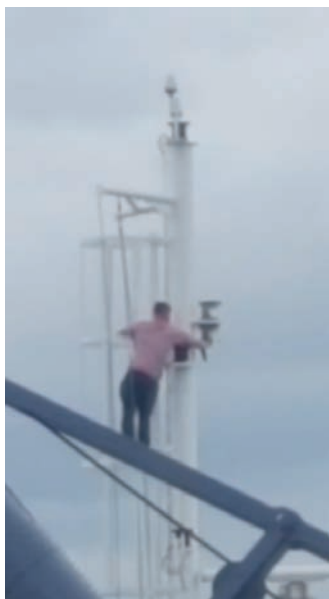
→ While in port, an observer from another ship sent the photo right. We can see a member of the ship's crew standing on the outside of the 'back scratcher' of the main mast ladder without fall protection. According to the observer, he stretched from this position to change a lamp on the forward side of the mast. He descended the ladder then returned; on both occasions, once he reached the top he climbed through the back scratcher to access the lamp.

On inserting the new lamp and without the appearance of having communicated via radio, the light immediately illuminated. That probably indicates that the light's electrical system had not been locked out. On the first occasion, another crew member was standing at the starboard bridge wing door watching. He did nothing to stop the job and seemed to be taking an observer/standby role.

- Obviously, one should never exit the confines of a back scratcher unless fully secured by some other means of fall protection.
- In this case, the back scratcher may have been fit for some other purpose – but not for changing the front-facing lamp.
- If you see an unsafe act being carried out on your own vessel, intervene immediately.
- Even such banal tasks as changing a light bulb should be preceded by a lock-out procedure of the electrical source, especially in wet and outdoor environments.

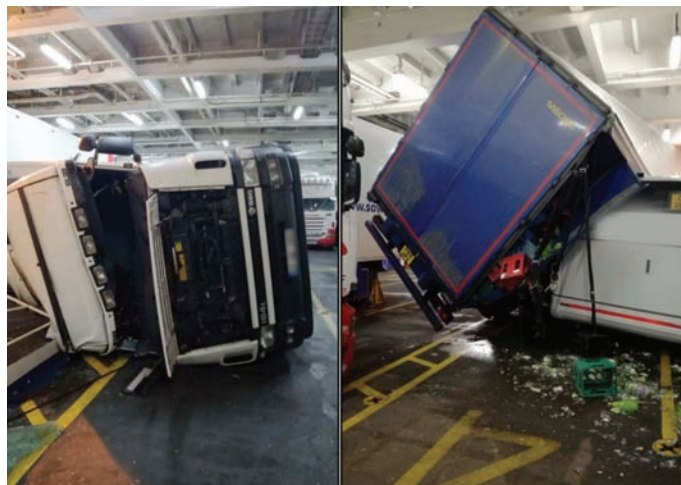
Soon after leaving port the vessel experienced several large rolls. The wind was blowing between 40 and 50 knots gusting to 60 knots; the waves were very large from the same direction, causing the ship to roll and yaw. Following a discussion with the Master, the OOW altered course to port and brought the ship on to a course of 055° with the aim of easing the motion. A few minutes later the OOW altered course to starboard and brought the ship on to a course of 060°. A little later the vessel rolled 20° to starboard, then yawed violently to starboard, achieving a rate of turn in excess of 100° per minute. The ship then took a larger roll to port of just over 30°. During the 30° roll several of the freight vehicles and unaccompanied semi-trailers on the vehicle decks moved and some toppled over. In the engine room, a lubricating oil low-level trip activated on one of the ship's four main engines, causing it to shut down.

The OOW altered the ship's heading to 057° and very quickly the Master arrived on the bridge, followed shortly afterwards by the chief officer and the day Master. The OOW briefed the Master while the chief officer used the ship's CCTV system to assess the condition of the cargo on the vehicle decks. The chief officer saw that several vehicles had toppled over and informed the Master. The ship was placed into hand-steering and brought round to starboard to a course of 085°. The OOW handed the con to the Master and went to assist on the vehicle deck. Within 90 minutes the vessel had been brought to shelter and docked.

- The passage plan was not altered to minimise the potential effects of the prevailing and forecast weather conditions and the night Master's intent to continue on the altered course was not clearly communicated to the OOW. Either action could have avoided heavy rolling.
- The freight vehicles, secured with one lashing on either side, were not lashed in accordance with the guidance provided in the MCA's guidance, *Ro-Ro ships: stowage and securing of vehicles code of practice*. For the conditions experienced four lashings either side would have been required.
- Passengers remained in their vehicles during the passage, endangering themselves and compromising the safety of other passengers and crew. This practice is not unique to this company and requires industry-wide collaboration to eliminate it.

- Passage plans need to be revised according to weather; Mother Nature is the boss.
- Best practice dictates that passengers and truck drivers exit their vehicles before transit.
- MCA guidance for lashing freight vehicles is as follows:

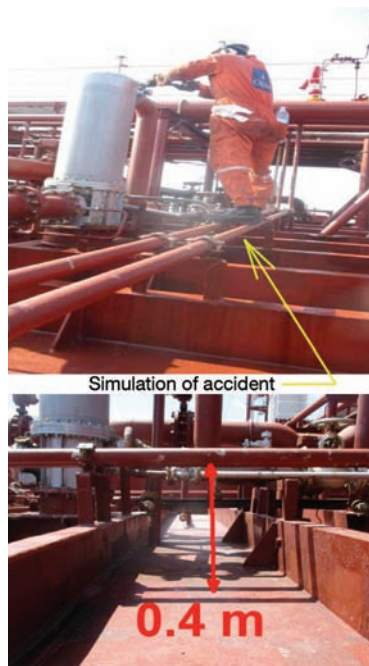
➔ A tanker had loaded and left port while crew were still securing the deck for sea passage and making preparation for heating the cargo. One crew member was assigned maintenance duties on the deck heat exchangers. To perform these duties he was standing on hydraulic lines located some 40cm above deck and using a spanner to make the necessary adjustments.

Suddenly, through a combination of ship movements and his precarious position, he lost his balance on the hydraulic lines and, jumping down, hit his back on a deck frame. The resulting injury required first aid and a hospital visit followed by four days rest.

- Slips, trips and falls are one of the leading causes of injuries for shipboard personnel. This another example of a hazard in plain sight that was still invisible to the crew.
- Always ensure you keep a sure footing while working and use fall prevention even if the height seems small.
- Routine jobs can contribute to a sense of control and hence complacency.

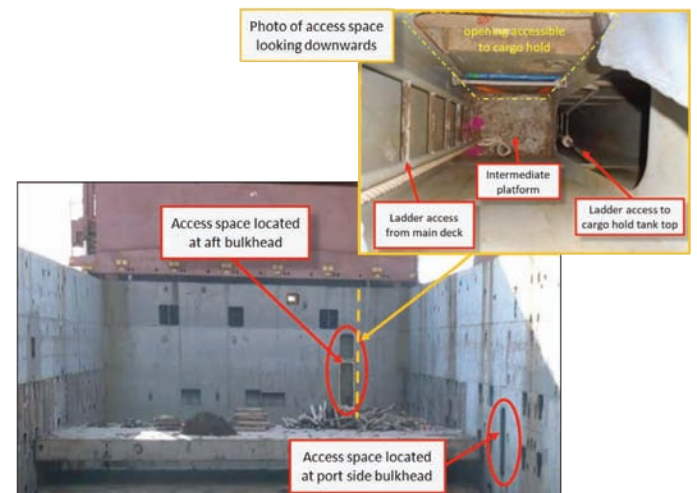
When pontoon 8 was about 4m away from the aft bulkhead and being gently moved into position, one of the hold crew asked the crane operator via the VHF radio to stop the movement of the pontoon so that he could climb out of the aft access space, walk over pontoon 7 and climb on to pontoon 8. Once the momentum of pontoon 8 had stopped (now about 3m away from the aft bulkhead), the crew member climbed on to it. Standing on the pontoon, he signalled to the crane operator to continue moving the pontoon towards the aft bulkhead. At the same time he shouted across to the other crew in the aft access space to stay within the protected area.

When the pontoon was about 1m away from the aft bulkhead, the other crew member suddenly exited from the aft access space, raising one leg to climb on to pontoon 8, which was now moving again. The crane operator saw the danger but could not stop the pontoon's movement in time. The crew member's chest was crushed between the edge of pontoon 8 and the aft bulkhead. The pontoon was cleared and the victim attended to but on the way to the hospital he succumbed to his injuries.

- The first crew member opted to enter the cargo hold before the pontoon was stacked in its final position. Despite being part of the same team to unhook the wire slings from the pontoon, there

appeared to be a lack of co-ordination and communication between the two crew members.

- Being new to the company, the victim probably followed the actions of the first crew member by instinct.
- Although a risk assessment was carried out in line with the company's SMS procedures, it did not cover the proper positioning of personnel during pontoon shifting operations, especially in situations where the access openings may be blocked by stacked pontoons.

- Working in a hold where heavy lifts are taking place needs excellent communication, co-ordination and control.
- Standing on a lifted and moving pontoon is not good practice.
- Rigging crew should be in a protected area until the load is in position and stable and the weight is off the hook.

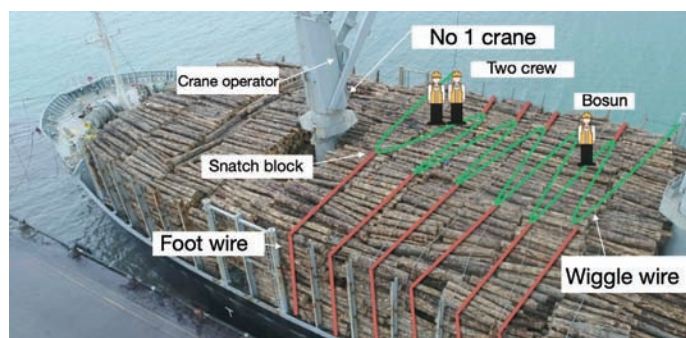
→ A vessel was in port and the crew were loading logs on to the hatch covers. The securing system involved the use of foot wires, snatch blocks and a wiggle wire (see image). Although it was dark, the deck was well lit by the ship's own floodlights and the floodlights on the wharf. The crew were wearing personal protective equipment (PPE), which included boot spikes to reduce the risk of slipping on the wet logs.

The number one crane was being used to tension the wiggle wire, and two deck crew were standing close by to check the tension in the wire. The bosun was communicating with the crane operator using hand signals. Tension was brought on the wiggle wire and then stopped at a signal from the bosun. The bosun started to walk towards the two deck crew in preparation to attach bulldog grips to secure the tensioned wire when a foot wire directly in front of the two deck crew suddenly parted. The rapid release of tension allowed a block and the wiggle wire to recoil towards the two deck crew.

Both crew were struck by securing equipment and/or wire; one sustained minor injuries but the other later died of his injuries.

The investigation found that the member of deck crew, whose role was to monitor the tension, had no way of determining how much tension was in the wire other than by feel, which was done by depressing the wiggle wire with their foot. This improvised procedure led them to stand in a hazardous area close to a wire under tension.

- Follow your cargo securing manual to the letter – there are good reasons for each step.
- Keep clear of any wires or ropes under tension – if they come under tension, stop all work immediately and get clear.

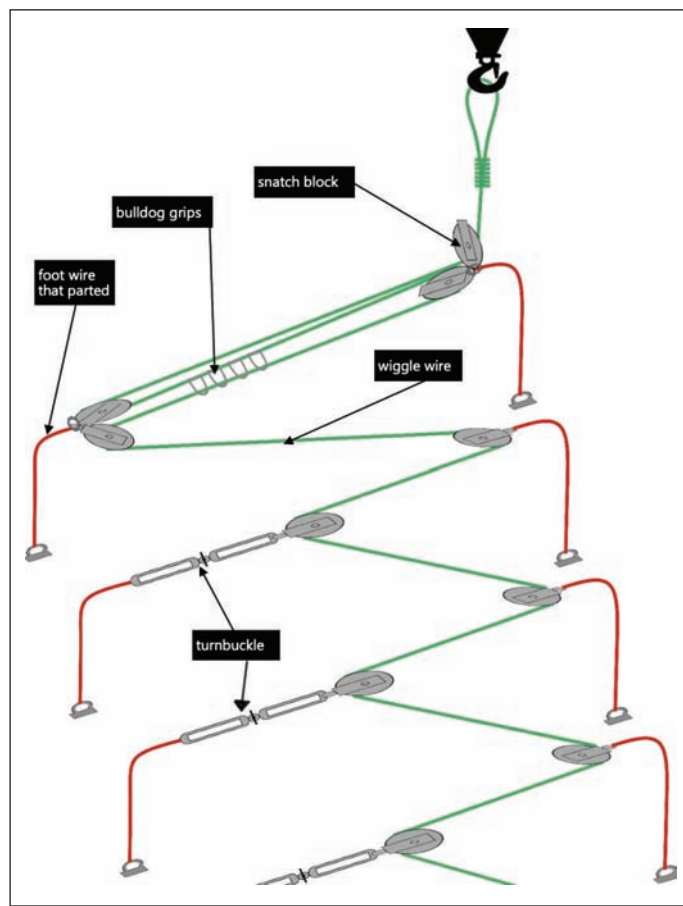
As it was, the investigation found that the foot wire parted as a result of over-tension. According to the vessel's cargo securing manual, only a nominal initial tension was to be applied to the wiggle wire since turnbuckles were supposed to be rigged between the wiggle wire and foot wires (see diagram in next column), to permit manual re-tensioning when needed. In this case the crew member had decided not to use turnbuckles but to try to tension the wire fully with the crane.

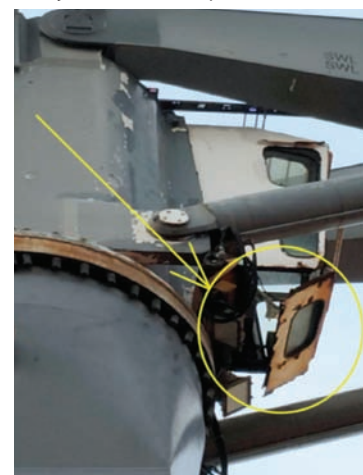
→ A container ship was in port to unload. A crew member entered the crane to work the cargo but as he put his weight on the floor of the crane cabin, it gave way. He fell from the crane cabin, a height of nearly 20 metres. He later succumbed to his injuries at the hospital.

It was found that the base plate (floor) was severely corroded. Although the company's planned maintenance system covered inspection of cranes, the corrosion of the base plate had not been detected.

- A crane cabin is essentially a 'work at height' area, with all the attendant risks of such a place. Every aspect of a crane cabin and ladder needs to be regularly inspected to ensure safety and integrity.
