Mariners' Alerting and Reporting Scheme

MARS Report No. 312 October 2018

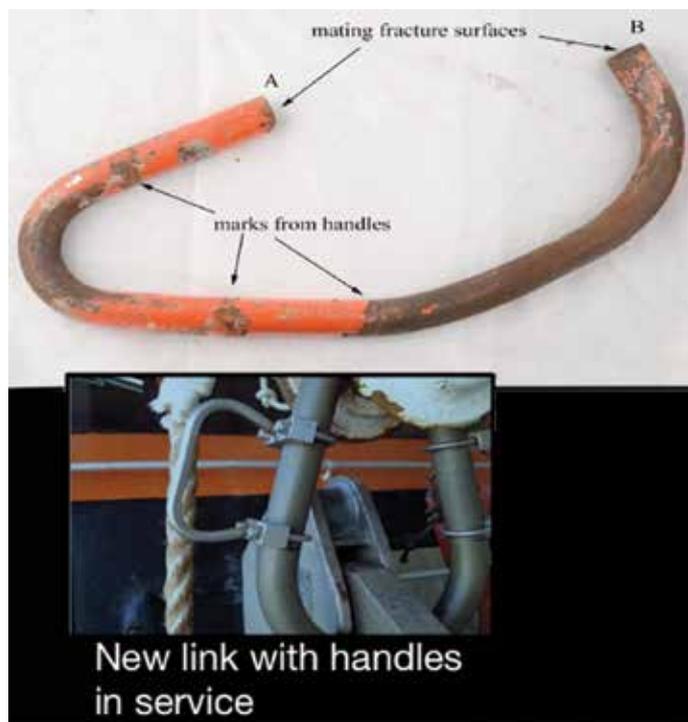
MARS 201862

The fall was caused by the catastrophic failure of the link that connects the fall block to the release gear hook. The investigation found that, among other things, the actual measured safety factor of the link was less than 5:1. This was well below the required minimum safety factor of 6:1 as specified by the LSA Code. Notwithstanding this less than adequate condition, the immediate cause of the failure was found to be a fatigue fracture.

The initiation of the fracture was attributed to the location of the stainless steel handle which was attached to the straight part of the link. The likely mechanism for the fracture was either corrosion fatigue (galvanic corrosion) or fatigue initiated from a minor indent at the surface.

- Non-destructive testing should be carried out regularly to verify the condition of gear such as links.
- Items such as bolted-on handles should be removed to ensure links can be given a full visual inspection.
- During inspections the dimensions of the connecting links should be measured to ascertain whether there has been any reduction in diameter as a result of corrosion.
- When possible, avoid connecting two metal parts that have different galvanic (sea water environment) values.

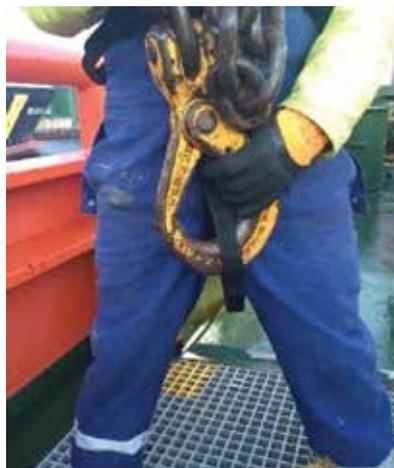
MARS 201863

→ A bulk hose was being transferred between a production platform and a platform supply vessel (PSV). The platform crane landed the hose on the PSV's deck and one of the ABs approached to release the hook from the lifting sling. As the AB released the hook it slid inside the bight formed by the crotch strap on his lifejacket. Once he stood up the hook was caught, but the AB did not notice, and he signalled to the crane operator to 'hoist'.

The AB was lifted above the deck and out over the side of the vessel. His immediate, intuitive reaction was to hold on to the pennant wire to relieve the crotch strap tension. The crane operator and a second deck crew member quickly became aware of the situation and were able to land the AB safely back on deck. The duration of the incident, from the AB being lifted and then returned to deck, was about 11 seconds.

- Ensure your garments and personal protective equipment (PPE) are not a hazard in and of themselves.
- Keep your situational awareness about equipment, yourself and your workmates sharp.
- Never signal to hoist unless you are sure all is clear.

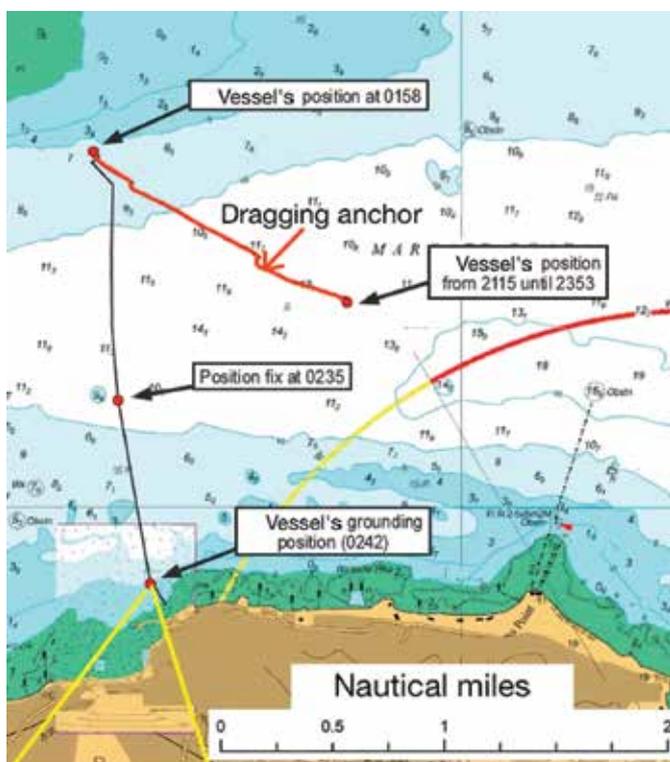
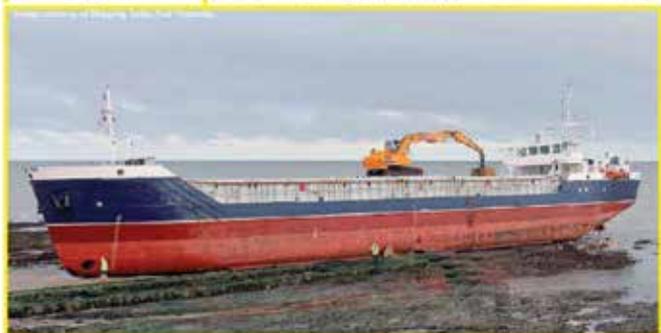
MARS 201864

The OOW was navigating visually, apparently without using the radar although at 02.35 he did put a position on the chart using GPS. When the OOW ordered the anchor dropped the vessel was already in trouble. At 02.42, the vessel grounded as it crossed the 0m depth contour. The vessel's Master was woken up by changes in engine noise and vibration. When the Master arrived on the bridge, he attempted to refloat the vessel by using astern propulsion, but his attempts were unsuccessful.

The wind was from the north-west at Beaufort force 6. While the vessel was at anchor, the predicted tidal stream set to the west and decreased from approximately 1.8kt at 23.50 to 0.8kt at 02.00 the following morning.

- When anchoring, enough scope must be given to accommodate a rising tide.
- Anchor watch is just as important as a navigation watch. An OOW's primary duty is to keep a sharp lookout, monitor the vessel's position and maintain situational awareness.
- If your vessel is dragging anchor, call the Master.

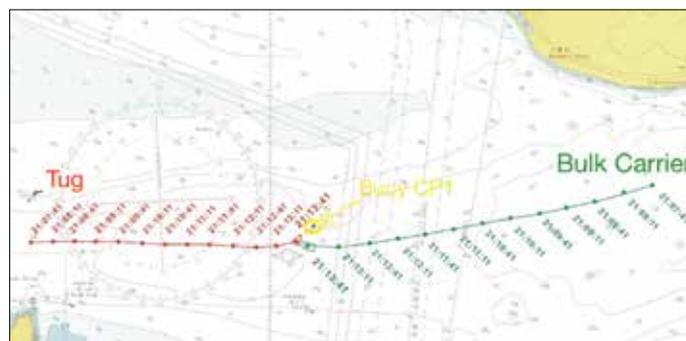
MARS 201865

Pilot A then gave a helm order of starboard 10, but the bow of the bulk carrier struck the starboard quarter of the tug. The collision impact was heavy and the bulk carrier was brought to a stop. Shortly after the collision the tug listed to starboard and sank. Seven persons were rescued from the tug, but 18 crew were trapped and drowned inside the vessel.

- Never make small course alterations when faced with an ambiguous meeting or crossing situation.
- Make your intentions known by using a large course alteration, preferably to starboard as per the collision regulations.
- When in doubt, slow down.

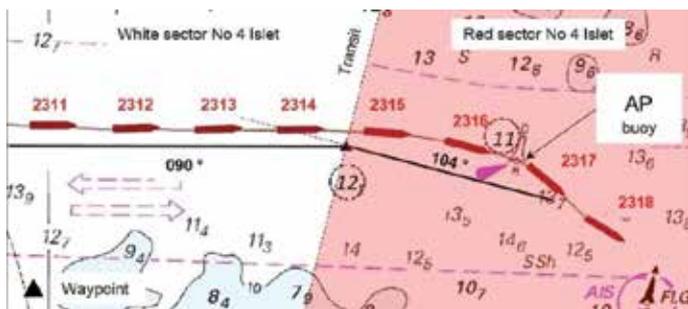
MARS 201866

The position plotted on the chart indicated that ship was about half a cable (100m) north of the charted track and the Master observed aloud that the AP buoy was right ahead. About 10 seconds later, the Master asked how the buoy was, followed 11 seconds later with 'will we touch the buoy?' The pilot said 'no' and shortly after ordered starboard 10°, followed 16 seconds later by starboard 20° and then 'hard a starboard'. In spite of some more helm applications the port quarter of the ship's hull contacted the buoy.

- Even though the OOW was somewhat integrated into the pilot's operations by informing him at 7 cables to each waypoint, neither he nor the rest of the bridge team possessed the same mental model as the pilot for the transit.
- There was a PPU on the bridge showing the vessel's position in real time, but the bridge team were not using this tool and were preoccupied with other aspects of the pilotage.
- In darkness a person's visual perception is not the same as in daylight, so objects may appear closer than they actually are. Because accurate depth perception is very difficult, especially at night, it is important that human abilities are always supplemented by the use of all other navigational and electronic aids.
- The Master's comments were too little too late. He was not in a position to challenge the pilot properly as he was using only his visual acuity to sight the buoy.

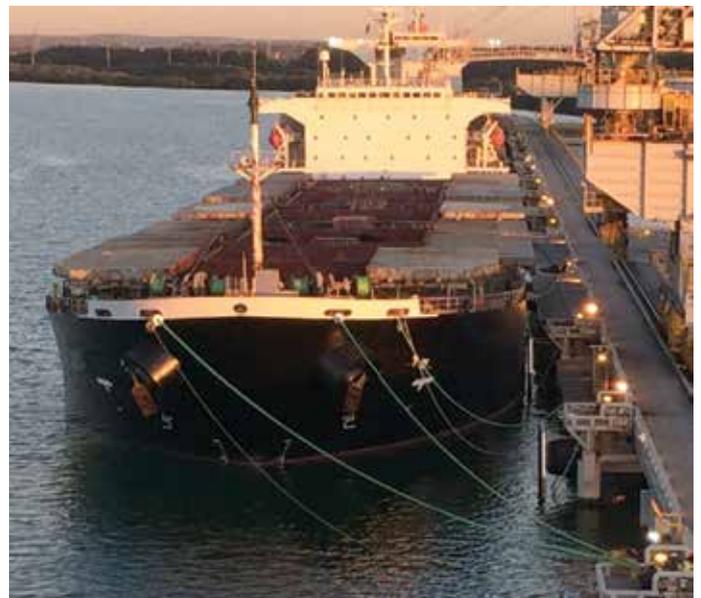
MARS 201868

➔ This photograph was sent to us by a mariner. Is this an accident waiting to happen? The mooring lines visible in the photo are quite slack and of unequal tension.

- Keep an eye on your lines and, when securing, equalise the tension in all lines.
