Mariners' Alerting and Reporting Scheme

MARS Report No 322 August 2019

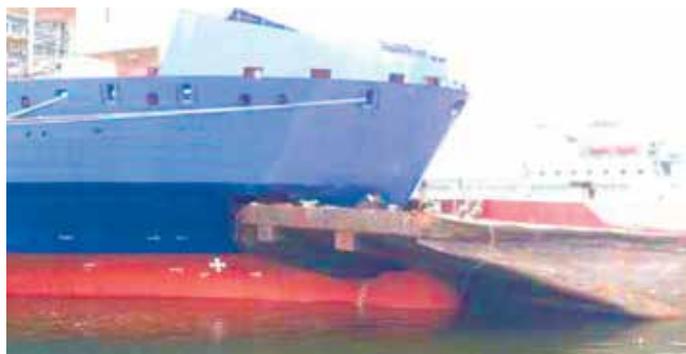
→ A specialised heavy-lift cargo vessel with wheelhouse and accommodation forward was inbound under pilotage. The Master, an OOW and a helmsman were also on the bridge. After the first course change under the con of the pilot, he commented that the vessel seemed hard to handle. The Master replied that the vessel was normally quite responsive. The pilot conceded that few vessels like this one, with wheelhouse forward, visited the port. He asked the bridge team to let him know if he oversteered or otherwise did anything they considered out of the ordinary, considering his lack of practice with this type of ship.

As they met an outbound vessel the pilot and Master went to the port bridge wing to monitor their proximity to a berthed ship on their port side. Looking aft, the pilot thought their stern would come too close to the berthed vessel. Wishing to swing the stern away, he ordered increasing amounts of starboard helm in quick succession. The orders were executed, but the starboard helm actually brought their stern close in on the berthed vessel. In looking aft, the pilot had given the wrong helm order and the bridge team had not reacted or otherwise caught the error. The stern nonetheless cleared the berthed vessel, but by now the swing to starboard was very rapid. Notwithstanding emergency manoeuvres, the vessel crossed the 245 metres of the channel and struck some barges on the opposite bank.

- The bridge team was unaware of the pilot's intention to move the stern away from the berthed vessel. Had they known what he intended, the error may have been caught in time. 'Thinking out loud' before acting is one way for a pilot to communicate their intentions and giving the bridge team a chance to provide input.
- Early indications of the pilot's unease with a wheelhouse forward design should have warned the Master that extra risk mitigation measures would be needed.

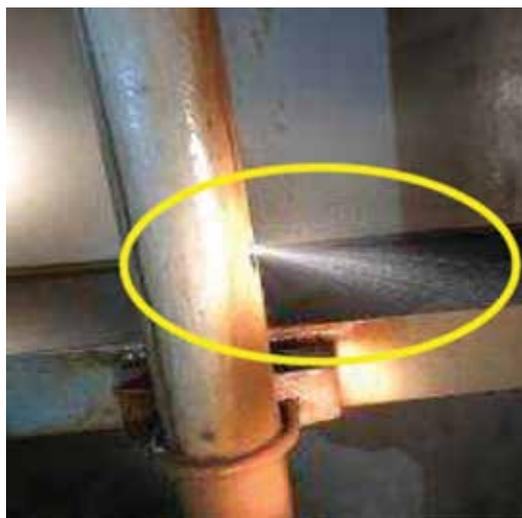
The investigation revealed that there was a crack in the drain line of the inert gas (IG) deck seal drain line passing through ballast tank 4S. Additionally, the non-return valve was not operating correctly. At the time of loading and during topping up, the main IG isolation valve was left open after the IG system was stopped. The gases from the tank leaked back through the inoperative non-return valve, allowing cargo vapours to reach the deck seal. The 'wet' type deck seal performed its function by not allowing cargo vapours to pass, and the vapours were subsequently flushed out through the drain line that passed through ballast tank 4S. However, the hole in the drain line released water and cargo vapours into the ballast tank.

Hole in drain line passing through BW tank 4S

- Visual inspections of IG lines and associated elements (deck seal, overboard line) may not be sufficient to detect all deficiencies. Such systems could be pressure-tested to ensure integrity.
- It should be standard practice to shut the IG isolation valve once the IG system is stopped.

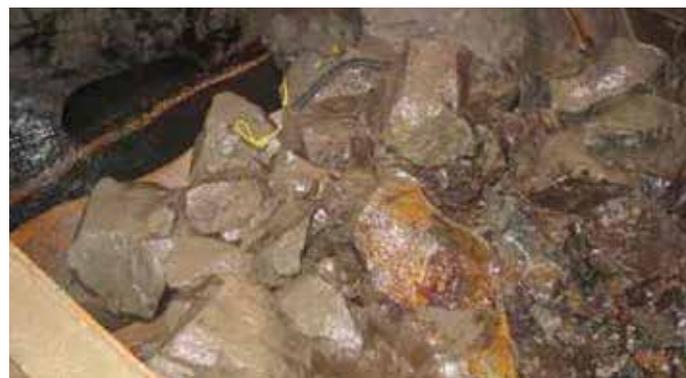
Both the pilot and the Master went to the port bridge wing to view the port aft section. The vessel passed within one metre of the docked barges, but did not strike them. However, the vessel scraped the rocky bottom near the wood-chip dock. There was water ingress in two tanks.

Rocks found in penetrated ballast tank

- During pilotage, incorrect helm application or incorrect helm order are two errors that are easily made. Bridge teams should always employ closed-loop communications but also visually counter-verify orders and executions as a matter of course.
- Good BRM means keeping the team in the loop.

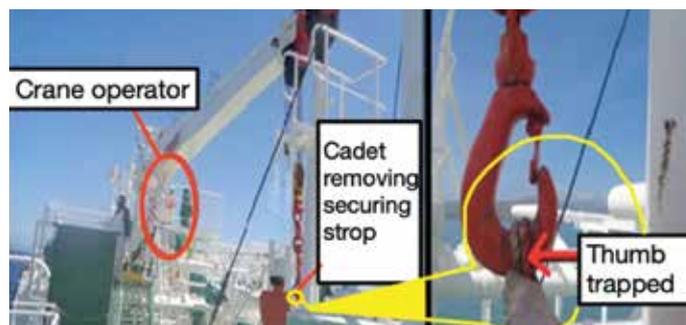
➔ A deck rating and a cadet were bringing the vessel's hose handling crane into operation. The first manoeuvre was to release the hook from its stowed position. The cadet was handling the securing stop on the crane's hook while the deck rating lowered the crane block.

As the cadet began to remove the securing stop, the rating noticed the crane wire getting too slack on its drum; he immediately heaved up on the wire without informing the cadet. The hook moved suddenly upwards, trapping the cadet's left thumb between the hook and the securing stop.

- Safe crane operations are essentially a three person job. One for the crane controls, one to manipulate the hook and strops and one to signal to the crane operator.

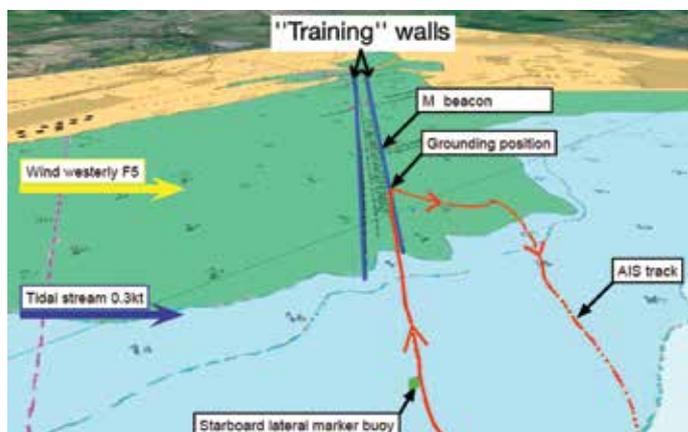
Within a few minutes, the ship left the dredged channel without the pilot or the bridge team realising. The vessel touched bottom and scraped along the top of the training wall for about 200 metres before coming to a stop in a position about 600 metres from the 'M' beacon (see diagram). The Master stopped the vessel's engine and ordered the crew to conduct a damage assessment. As there was a danger that the rising tide could cause the ship to scrape further along the wall, resulting in more damage, it was decided to refloat the vessel immediately. The vessel was manoeuvred east of the training wall and then south to deeper water. Pumps were used to stabilise the water ingress into the engine room.

- The pilot did not have full positional awareness when the vessel left the dredged channel and did not fully appreciate the risk of grounding on the training wall.
- No detailed pilotage plan had been made by either the ship or the pilot, and the Master/pilot exchange did not cover all hazards, including that posed by the training walls.
- Insufficient use was made of the vessel's electronic navigation equipment to monitor the vessel's position and assess its progress.

- When the pilot boards, the exchange of information should be comprehensive. If no plan is offered, by all means ask for one.

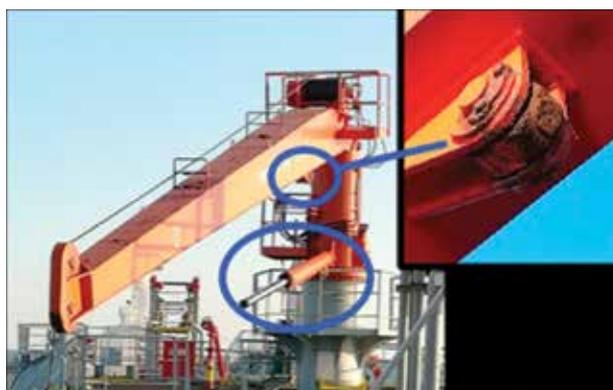
→ A tanker had loaded cargo and the crew were preparing to depart. The pilot was on board and the gangway (8 metres long and weighing 250kg) was to be secured for sea. It was hooked on to the deck crane, which had a safe working load (SWL) of 5,000kg, and lifted away from the ship's side, then brought slowly down to the stowed position. Just before the gangway was in the stowed position the topping cylinder broke away from the crane jib and the crane arm gave way. The gangway fell on to the deck, but as all crew had been standing clear there were no injuries and the gangway was only slightly damaged.

The company investigation found that the hydraulic cylinder eye attachment fitting had not been properly maintained. The fitting was situated in a relatively inaccessible part of the crane and greasing of this part had been neglected.

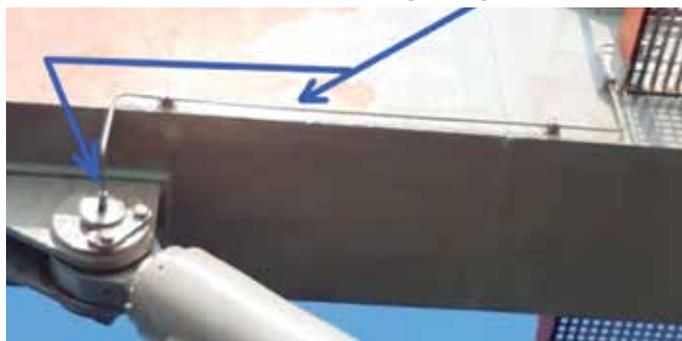
Fixed greasing conduit

In response to this accident the greasing point of the cylinder eye attachment has been fitted with a fixed conduit so the operator can perform greasing directly from the safety of a nearby platform, as seen below.
