# Mariners' Alerting and Reporting Scheme

MARS Report No 356 June 2022

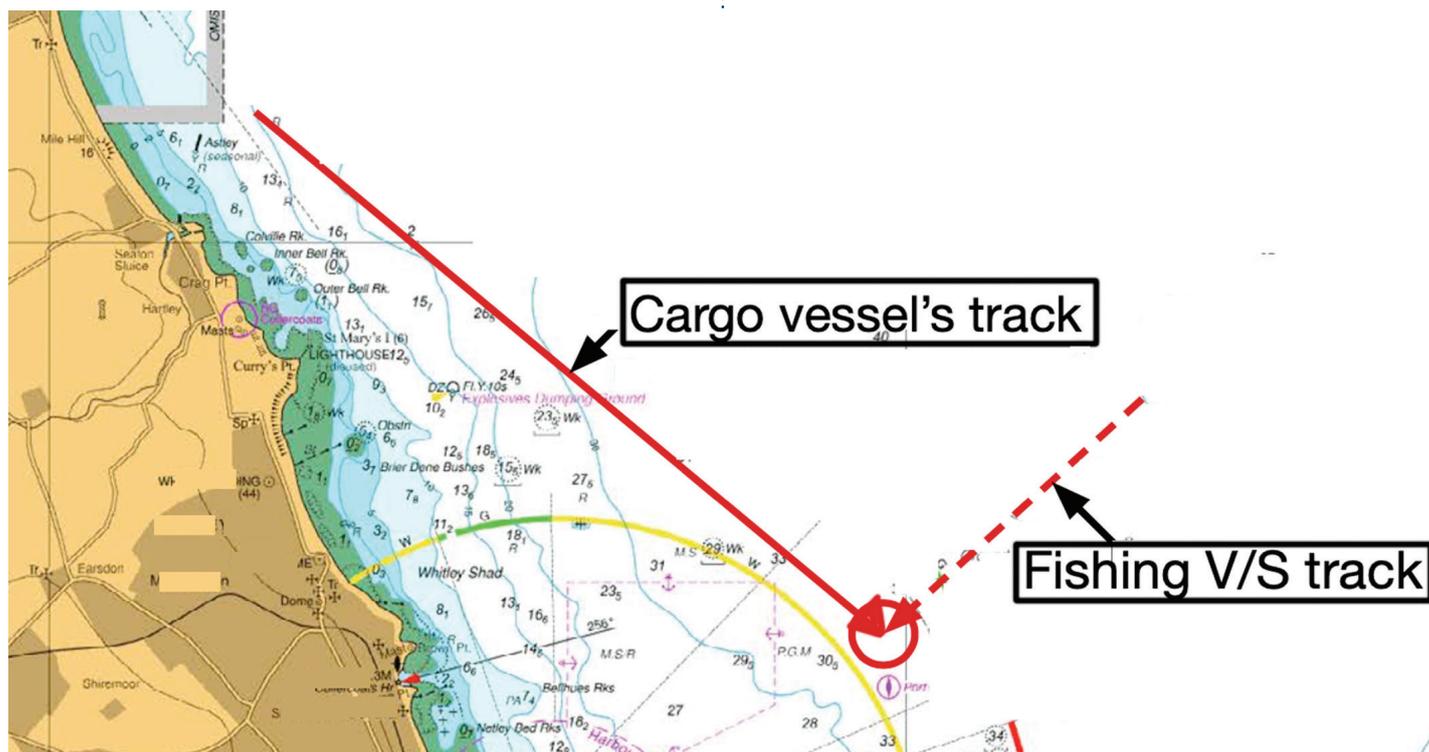
Suddenly, they both saw the fishing boat emerge from the fog, 30° on the port bow. The OOV sounded one long blast on the ship's whistle and then switched the helm to manual control and put the rudder hard-to-starboard. This action was too late, and the fishing vessel struck the cargo vessel's port side. The fishing vessel's captain and deckhand were thrown to the deck by the force of the collision. The crew of the fishing vessel were rescued, but the fishing vessel eventually sank due to an ingress of water.

The report found, among other things, that neither vessel was making sound signals, which could have alerted them to the other's presence. Of course, with the captain of the fishing vessel not even in the wheelhouse, an effective lookout was impossible on that vessel. The report also found that, due to administrative duties that distracted from his navigation, the OOV of the cargo vessel became aware of the fishing vessel's radar return only when it was less than 1nm away. At that range, and with a closing speed of about 11 knots, it gave him only about five minutes to assess the risk of collision and take avoiding action.

- Navigating in fog is not a time to undertake administrative duties in lieu of navigation.
- Some fishing vessels, especially those made of wood, can give poor radar returns. Constant attention to the radar is needed in poor visibility to detect small targets such as these as soon as possible.
- AIS is a useful tool for detection but not all vessels, especially fishing vessels, are so equipped.
- This lesson learned is a recurring one for MARS reports ... When in doubt, slow down.

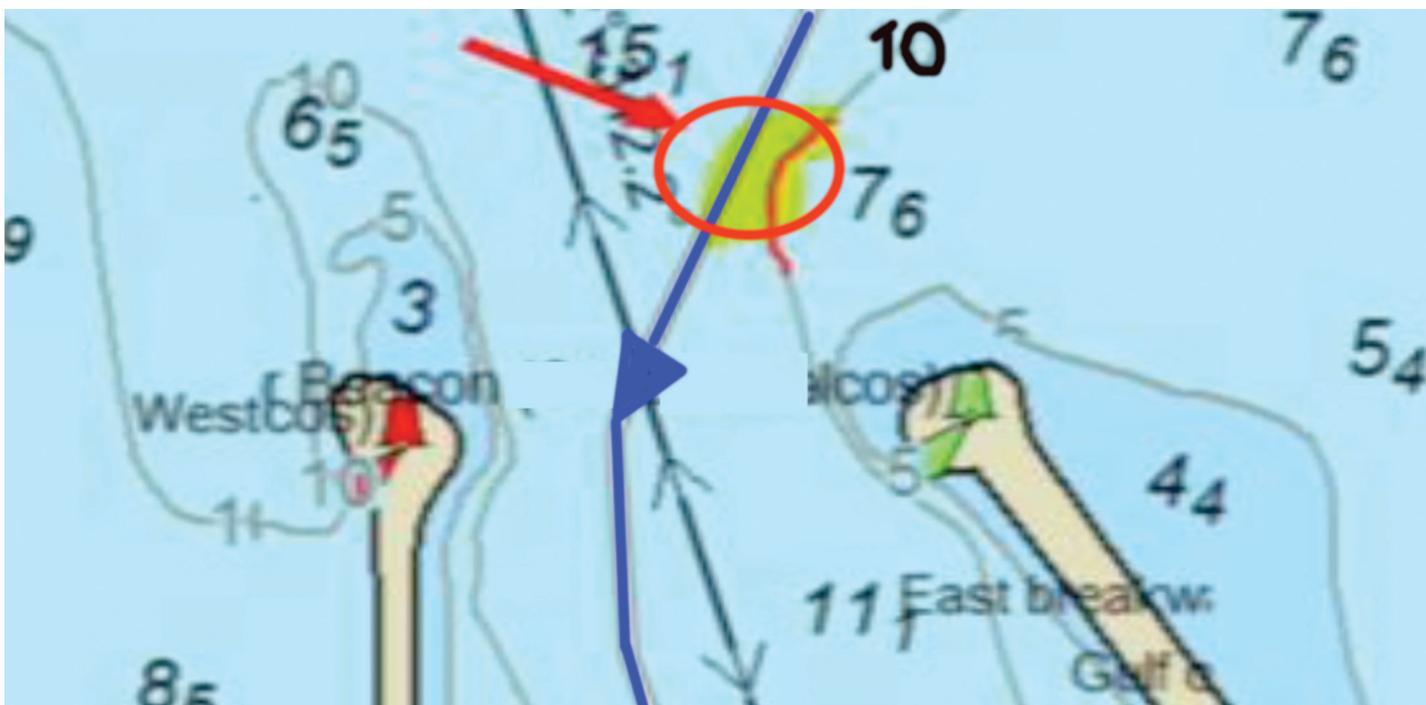
Almost immediately a strong vibration was felt throughout the ship and the vessel started swinging to starboard. The pilot ordered ‘Stop the engine’. The bridge team now knew they had touched bottom and the depth sounder was turned on. It showed 1m.

Tanks were sounded and water ingress was discovered in the port side ballast tanks.

- Once again we have the classic question of when and how to challenge a pilot. In this case the Master warned the pilot but it appears this was already too late. Being too far to the east of the port entry leading lights from the beginning was a red flag that should have been resolved before the vessel came close to the breakwaters.

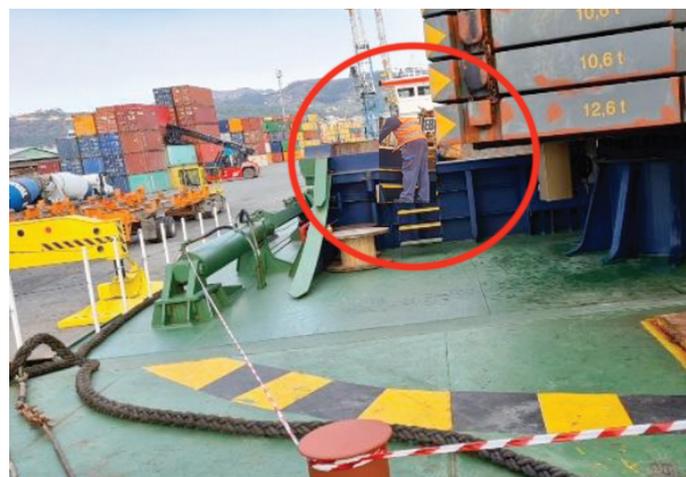
the crane operator had the crane's boom in line with the cargo hold and was picking up a boulder from the hold. Within a matter of seconds, the crane turned clockwise towards the breakwater, trapping the Master between the body of the crane and the cargo hold coaming. (Photo is a reenactment – the red and white danger tape was not present at the time of the accident.)

The investigation found, among other things, that although access to the forecastle from the port side of the cargo hold had been cordoned off by physical barrier system (a chain), access to the forecastle from the starboard side was unobstructed. Black and yellow 'hazardous area' markings were painted in a semi-circle on the deck around the crane, extending from port to starboard. But paint markings are a symbolic barrier system and therefore require interpretation to be effective (as opposed to a physical barrier system).

- While symbolic barriers are better than nothing, their effectiveness is debatable. Physical barriers are much better. And an excellent complement to physical barriers are administrative barriers documented in a vessel's SMS.
- MARS report 201851 documents a very similar accident but one with more serious consequences as the victim, new to the ship, died of his injuries. In that case, not only was there an absence of physical barriers but there were no danger warnings.

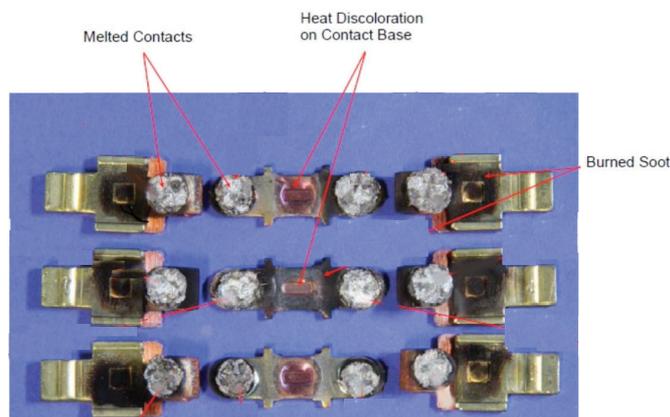
Disassembled contactor during forensic analysis (Image courtesy Chevron North America)

Metallurgical analysis carried out after the event found that the failure occurred when the winch control contactors fused together due to the duty rating being exceeded. Additionally, it appears that the contactors were not rated for intermittent cycling (repeated start/stop sequences) of the winch. After inspection on other installations, several contactors showed evidence of overheating and indications of welded and scorched contacts were found.

- Verify the condition of winch motor contactors and replace any contactors that show signs of excessive wear, overheating, or welding.
- Check the duty cycle ratings of lifeboat and rescue boat davit electrical components and compare those ratings to recommended and commonly-practised boat recovery procedures/processes.
- Confirm the design of the davit safety devices (ie, E-stop and limit switches) to see if they will secure electrical power to the motor in the event of welded contacts.
- Implement training for all personnel that operate the davits to ensure awareness related to electrical duty cycles and the actions needed to isolate power in the event of a welded winch motor contactor.
