Inadvertent Release of a Freefall Lifeboat

The Australian Transport Safety Bureau (ATSB) has recently published a preliminary report regarding the inadvertent launch of a freefall lifeboat from a geared handymax bulk carrier while on a ballast passage in the Indian Ocean.

This Safety Alert is based on a preliminary report into the [Unintentional release of the freefall lifeboat from the bulk carrier Aquarosa](#) published by the Australian Transport Safety Bureau. It is important to note that the ATSB's final report may contain findings and recommendations which differ from those in the preliminary report and in this Safety Alert.

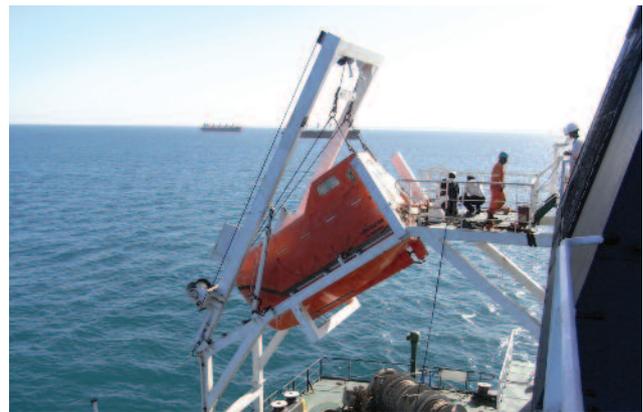
Freefall lifeboat and davit arrangement

via a link, rotated a cam which released a stopper block, allowing the hook to rotate and disengage the links (see picture). For the hook to detach, and on the assumption that the hydraulic ram would always be fully retracted, the manufacturer's manual advised that the hand pump lever would need to be operated approximately ten to twelve times. However, the ATSB's preliminary investigation found that it was possible to reset the hook and stopper block arrangement when the hydraulic ram was partly extended, thereby requiring fewer movements of the hand pump to trigger the release mechanism. The Second Engineer estimated he had pumped the lever only three or four times before the hook disengaged.

- 1. Resetting the hydraulic ram:** The vessel was fitted with a 27 person freefall lifeboat (JY-FN-5.8 type), davit (JYF55 type) and hook and release mechanism (model JX-4) all manufactured by Jiangsu Jiaoyan Marine Equipment Company. Vessels having the same or similar lifeboats or equipment are advised to ensure that the hydraulic ram is pushed back fully into its housing when resetting the hook following release. Marking the mechanism to indicate when the hydraulic ram has been reset correctly or adding other visual indicators may also be considered.

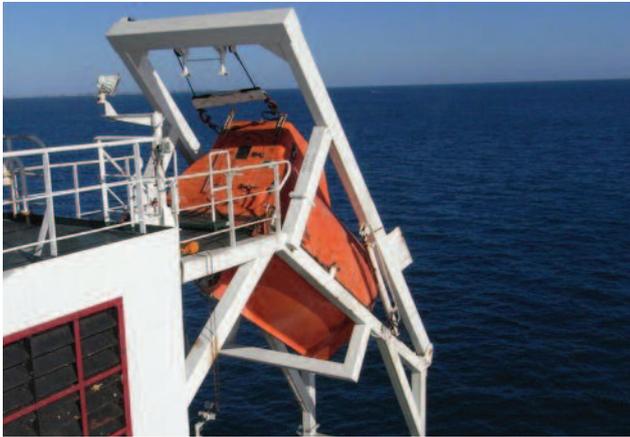
The release mechanism was fitted with a pin which passed through the hook and its adjacent cheek plates to prevent it from tripping. It was necessary to remove the pin in order to

Freefall lifeboat and davit arrangement

enter the lifeboat. However, since the pin was attached by a lanyard to the access door, it could not be re-inserted once personnel were inside.

- 3. Anti-tripping pin:** If it is necessary to remove the anti-tripping pin fitted to the release hook in order to enter the lifeboat, and the arrangement prevents the pin being refitted once the lifeboat door is open, then a spare pin

should be available and fitted to the hook to prevent inadvertent release.

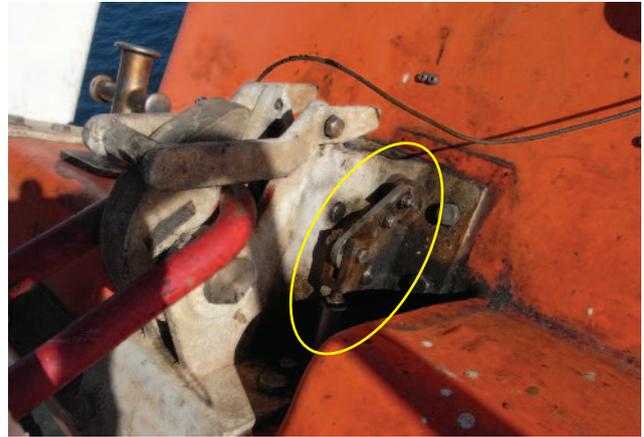
Lifeboat hook arrangement secured to long link. Note the hydraulic ram and link arrangement (circled)

- 2. Unauthorised use of the hand pump:** The lever of the hydraulic hand pump should never be operated unless launching the lifeboat or as part of a controlled test of the release mechanism, both of which should be authorised by the Master beforehand. Appropriate warning notices should be placed alongside each pump lever.
