Mariners' Alerting and Reporting Scheme

MARS Report No 331 May 2020

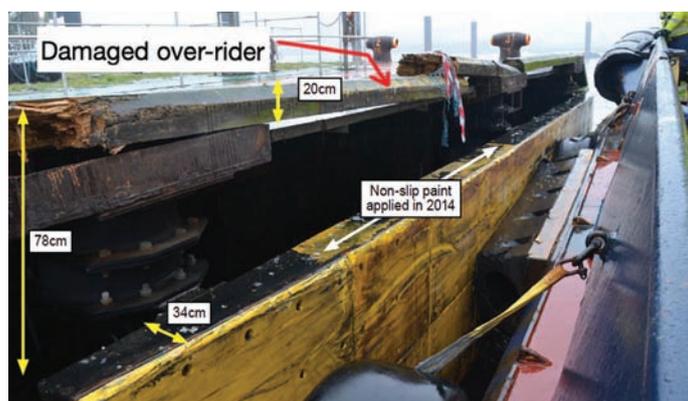
MARS 20202

Fatal fall into water

→ A tug was about to depart a berth that it often used. One crew member was on the dock to let go the lines. He was wearing a full set of personal protective equipment (PPE), including an auto-inflating lifejacket with a personal locator beacon (PLB) and crotch strap, which was fastened. Once the lines had been let go aft, he went forward and released them. He then walked back towards the tug's bulwark gate, which was now aligned with the centre of a berth fender. The over-riding was damaged, and as he stepped over it and lowered himself onto the top of the fender, he fell into the water.

- Concerns regarding safe access to and from the tugs at this berth had been raised at safety committee meetings and during company inspections many times prior to this accident.
- Non-slip paint was applied to the fenders in 2014, following tug crews expressing their concerns about hazardous boarding practices at the berth. This had the effect of legitimising these practices.
- The crew had not been fully prepared to deal with the emergency situation, and were unfamiliar with the use of the tug's MOB rescue-sling. The records indicated that this crew held only one MOB drill in the last year.

- Even a cursory view of the berth, with its uneven surfaces, broken over-riding and lack of hand-holds, indicates the area is not suitable for boarding. It would appear the crew were tolerating this situation against their own better judgment as this issue was raised at safety meetings. If you think something is unsafe, do not relent; make it safe.
- Beware of half-measures, such as the application of non-slip paint in this instance. When applying risk reduction measures, always make risks As Low As Reasonably Possible (ALARP).
- Practising MOB events develops critical skills you may need to save a life.

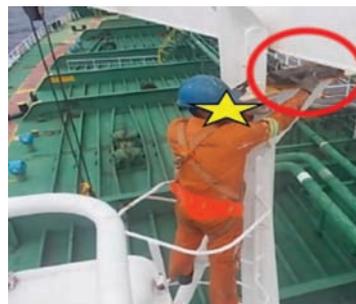
MARS 202026

Finger crushed

→ Two crew were tasked to secure the hose handling crane jib in its cradle support. One crew operated the crane while the other signalled. As the crane jib was lowered, the signaller attempted to manually align the wooden block over the jib cradle support. He held the block and signalled to the operator to lower the jib. He did not notice that his own finger was positioned under the block. When the jib was lowered into position, his fingertip was crushed between the crane jib and the wooden block.

- Crane operations are inherently risky. Excellent communications and situational awareness are essential for everyone involved.
- Crane operations need a dedicated crane operator and a dedicated signaller. If other manoeuvres are needed, a third person should be employed.

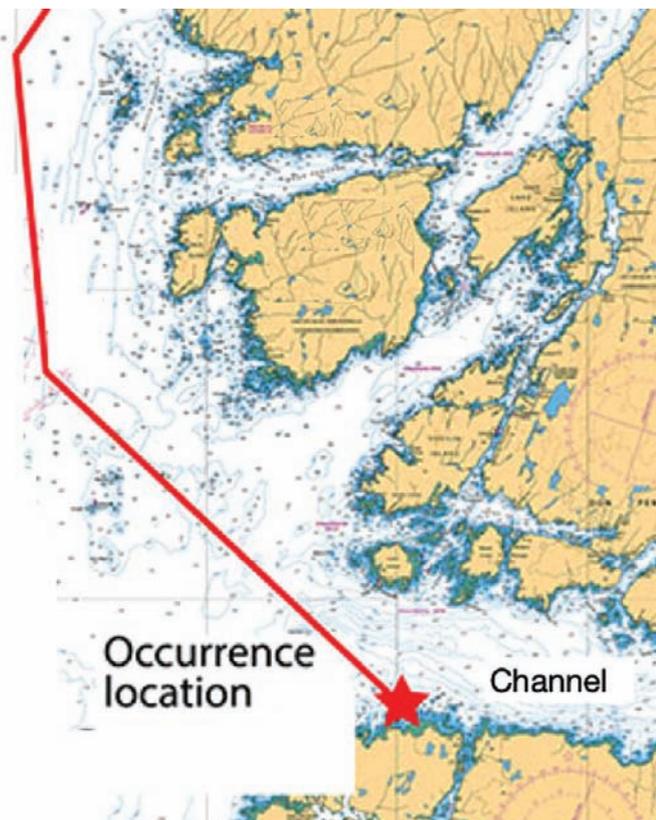
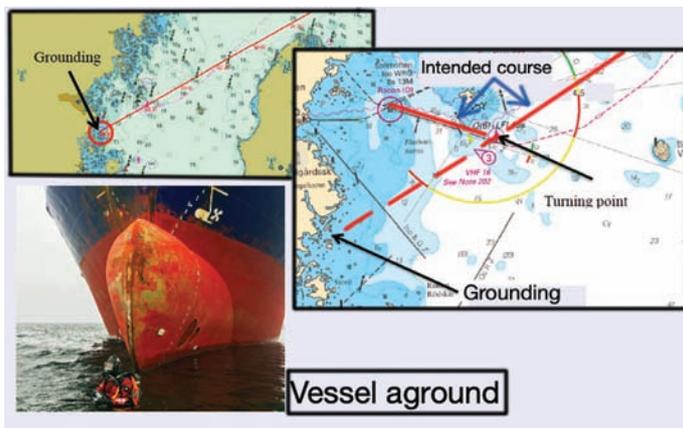
MARS 202028

More fatigue, another grounding

➔ A small vessel was on a short sea trading routine, making shuttle trips between two ports separated by approximately 12 hours sailing. On the ballast leg of the route, the Master had taken the night watch to allow the chief mate to rest, as he would be busy all the next day with cargo operations once in port. There was no lookout on the bridge during any part of the voyage because, according to the Master, the crew had worked so hard during the unloading period.

At one point the Master altered course toward the destination port. The next thing he remembered, he was woken by a call on the VHF radio. The call came from the pilot boat at the arrival port, asking if everything was OK because the vessel seemed to be in shallow water. The Master answered that everything was fine – but within a few seconds of the call, the vessel grounded. The vessel had passed straight by the arrival destination without turning to port and had continued on until it grounded.

- The BNWAS was not turned on;
- The Master was probably fatigued himself due to the two watch system;
- The Master was probably under the influence of alcohol during his watch;
- There was no lookout on the bridge during the transit.

- A 'dry' ship is a safer ship. Alcohol and ship work do not mix well;
- As in MARS202027, a BNWAS can be a helpful tool to help prevent sleep related accidents;
- As in MARS202027, being alone on the bridge at night is not best practice;
- Even though this vessel was manned according to its safe manning certificate, it was evidently understaffed for the job it was required to do in the time that was expected. So, why did the Master leave port if everyone was fatigued?

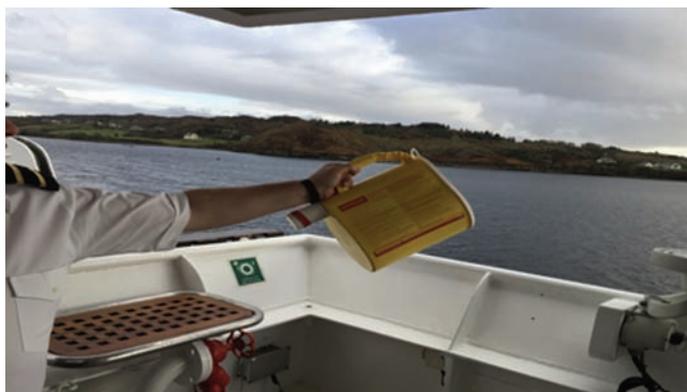
MARS 202029

Line Throwing Apparatus incident

➔ A vessel was at sea and holding position. As a training exercise, the ship's deck crew were discharging line throwing apparatus (LTA) on deck. Before the exercise, a toolbox talk was completed and the dangers discussed, including the importance of standing clear of the device when firing takes place. The device operating instructions were read out to the exercise participants.

After the first LTA was discharged, it was noted that there was a danger that the line could become fouled in the ship's propellers after falling into the water. As a solution, a senior crew member suggested catching the line on its descent to speed up recovery. Unfortunately the designated crewmember caught the line too early – on its ascent. The speed and trajectory of the line caused it to cut through the victim's glove and cause a minor friction burn to a finger. The victim was immediately given first aid treatment.

The victim was new to the ship and relatively inexperienced. The suggestion of catching the line on its descent was made by a senior member of the crew and taken as an order by the inexperienced crew member.

- Young or old, experienced or not, the practice of good seamanship is often just a matter of common sense. If a suggestion or order does not make sense then it should be questioned immediately.
- Senior or more experienced seafarers must remember that they have a responsibility to supervise less experienced crew members in the practice of good seamanship and be aware that suggestions can sometimes be regarded as orders.

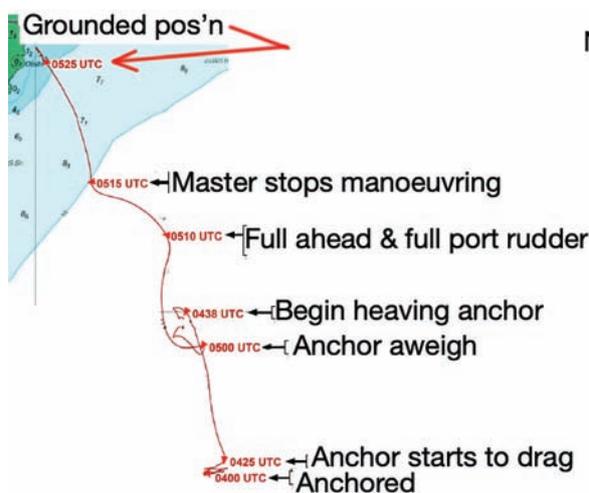
MARS 202030

Blown onto a lee shore

➔ A bulk carrier coming into port was low on bunkers, and because of payment problems the Master opted to remain at anchor overnight rather than go into port. The vessel anchored with seven shackles of chain in 17 metres of water one nautical mile off the coast. The weather forecast predicted southerly winds up to Force 8. The Master's night orders specified that in wind speeds in excess of 31kts, the main engine should be in immediate readiness. The Master also discussed the risk of the vessel dragging anchor with the bridge watchkeepers, and before going to bed emphasised his instructions regarding engine readiness.

At 2100, in view of the increasing wind speed, the OOW ordered the duty engineer to ensure that the main engine was in immediate readiness. By 0400 the following morning, the southerly wind was gusting over 52kts, the sea swell was between 4 metres and 5 metres, and the vessel had begun to yaw. Twenty-five minutes later, the vessel started to drag its anchor towards the lee shore at a speed of about 1.4kts. The Master was called to the bridge.

The anchor was brought in with difficulty. About 35 minutes after the initial dragging it was aweigh. The vessel started to fall beam to the wind and the Master's attempts to keep the bow into the wind and check the leeway by intermittent use of the engine were unsuccessful. When the anchor came into view an abandoned chain was seen snagged across its flukes. Once advised that the anchor was fouled by another chain, the Master stopped manoeuvring. An attempt to clear the chain by dropping the anchor and heaving it in again was unsuccessful.

By 0510, the vessel was approximately six cables off the coast on a heading of 274° and making over 2kts leeway to the north. Running out of sea room, the Master applied full port rudder and put the engine to 'full ahead' to try to turn the vessel into the wind. Five minutes later, the Master assessed that the vessel would not clear the point, which was only 0.5nm to the west, and stopped the engine. With the vessel within two cables of the shallows, the Master ordered the port anchor let go. The vessel grounded on the coast at 0525. The vessel was later refloated but had sustained significant damage.

- Anchoring on a lee shore with expected high winds should be avoided;
- The Master's decision process had possibly been influenced by the fact that the vessel was low on bunkers, another situation to be avoided;
- In situations such as these, fast and decisive action is needed. Better to lose an anchor than a ship.
