In this bulletin...

MARS 202623

Blind pilotage techniques in a pilot boat

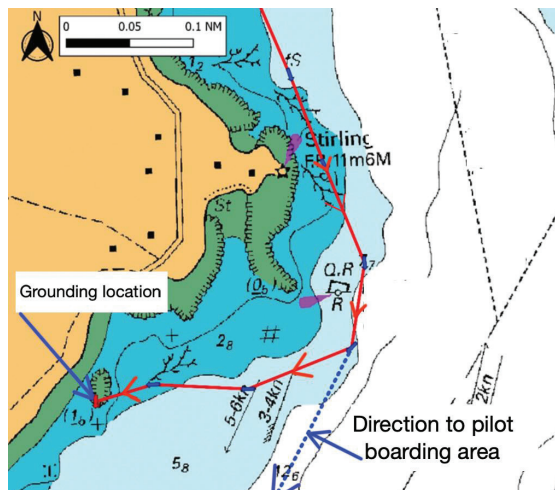
Shortly after the alteration of course to starboard, the deckhand noticed that the chart plotter and radar screens showed the vessel heading towards the land and he told the captain. The captain looked down to check the screens and realised that the vessel was not where it should have been. A few seconds later, the vessel ran aground with both engines still running. The captain attempted to back off by putting both engines astern, but realised that would be ineffective when they saw rocks on both sides of the vessel and astern.

- The Master's situational awareness was significantly reduced by the state of the visibility and their navigation methods. As a result, at a certain point the boat turned too far to starboard and the vessel ran aground.
- The vessel had sufficient electronic navigation instruments to support navigation in restricted visibility. At the time of the accident, these instruments were switched on, but the captain was not using them to verify the vessel's position and progress.
- At the time of the accident, the pilot boat operating company did not require assessment of the ongoing proficiency of pilot vessel captains. This omission meant that there was no formal verification that navigation practices on board the pilot vessel continued to meet industry best practice.

- Navigating using exclusively visual means in reduced visibility, even in well-known waters, is a recipe for an accident. See MARS 202154 for a similar situation.
- Speed through the water should be proportional to the quality of your situational awareness. This accident was in part due to ignoring this rule; that is, proceeding at high speed with a low situational awareness.

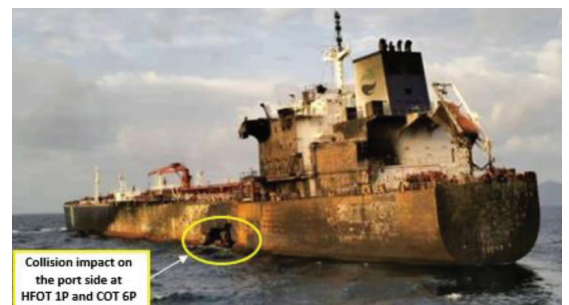
At about 0558, the OOW was still in the chartroom. The lookout pulled the curtain and called the OOW urgently. On his return, the OOW saw a large ship at anchor less than a cable ahead with the deck lights on. This was Target 46. The OOW immediately switched to manual steering and applied hard starboard rudder. Despite the manoeuvre, and still making 14 knots, a collision was unavoidable. At approximately 0602, Tanker A's bow contacted Target 46's port anchor chain. The anchor chain entangled with their port bilge keel drawing the vessels closer. Target 46's bulbous bow breached Tanker A's shell plating and caused a fire on both ships. Target 46's bow flare also struck the tanker's port bridge wing, partially detaching it. The Master of Tanker A arrived on the bridge to a near apocalyptic scene of fires on deck and a partially destroyed bridge. He broadcast a MayDay distress call requesting immediate assistance.

Damage to the vessel underway after collision and fire

The investigation found, among other things, that the OOW had had only about two hours of rest in a 38.5-hour period since leaving his home and joining the vessel, and was likely experiencing fatigue. This could have reduced his performance and judgement during the developing close-quarters situation. The investigation also found that the anchored vessel had attempted to warn the oncoming tanker with the ALDIS lamp and sound signals, but these were ineffective. Despite the escalating risk, VHF was not used as an additional means of communication, which could have supported situational clarification.

- Attending to any other duties except navigation while in charge of a watch is a recipe for disaster.
- With only about two hours of rest in a 38.5-hour period before the collision (due to travel to the ship among others), it is almost certain the OOW was experiencing fatigue, which negatively affects performance and judgement. At a minimum, travel time to join a ship should be counted as time on board for the purposes of work/rest calculations.

- Given that:
ISM requires companies to establish safeguards against all identified risks;
Sufficient restorative sleep is the only antidote for fatigue;
It follows that, over and above work/'rest' calculations, companies should endeavour to ensure, through manning levels, procedures and safety culture messaging, that their crew have had sufficient restorative sleep before working.

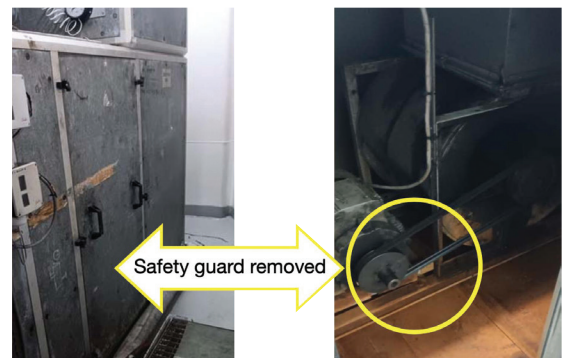
A vessel was underway in bad weather and was pitching and rolling. An engineer was tasked with a routine check of an A/C compressor. He removed the safety guard of the still running compressor, but the motion of the ship caused him to lose balance. He instinctively grabbed forward to steady himself, but his left hand came into contact with the moving belt of the compressor and was badly injured.

- Before any intervention, machinery should be fully stopped and isolated (Lock out/tag out).
- Effective risk assessment, work planning meetings, and toolbox talks are essential. They should include specific consideration of vessel motion, weather conditions, and human factors.
- Crew members shall be encouraged and empowered to exercise Stop Work Authority whenever unsafe conditions are identified.
