Mariners' Alerting and Reporting Scheme

MARS Report No 343 May 2021

MARS 202123

Aground, then punctured, a vessel turns sideways

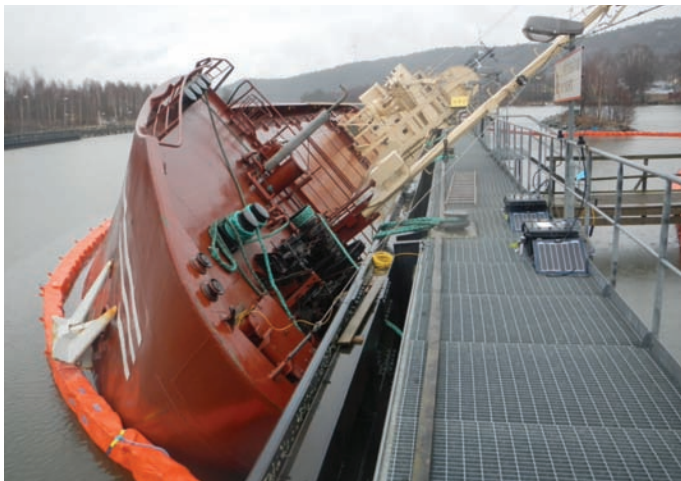
As the vessel approached the lock at about 4 knots, the Master initiated a reversing manoeuvre according to the pilot's instruction, but the reverse order did not work. The vessel's bow now pointed to the port shore. A new reverse manoeuvre was attempted. Reverse power began, but not in time to keep the vessel from grounding. With reverse power still at full, the ship came back into the channel relatively quickly. During this movement, the vessel's starboard side heavily contacted the cement support dolphins of the lock approach jetty. Unknown to the crew, this contact caused a hull breach just below the waterline.

The ship was quickly moored port side to, on the lock approach jetty. Shortly afterwards, the ship began to list to starboard. Due to the grounding, it was assumed that there was water ingress into one of the starboard double bottom ballast tanks, so the crew countered by filling port tanks. The ship had an estimated list of 15–17 degrees to starboard so ballasting on the port side continued as there was concern that the ship would capsize to starboard. The list to starboard was decreasing when suddenly the vessel flopped to port and lay against the jetty with a 20 degree list. The crew were brought on shore. The ship later rolled further to port and stabilised at about 54 degrees.

After nearly four weeks salvage work, the ship was declared a total constructive loss and was scrapped. The investigation found, among other things, that although the initial grounding incident was relatively minor, it quickly developed into a serious accident requiring a protracted salvage process. Water ingress was not into the double bottom tanks as initially assumed by the crew, but into the starboard dry-space tanks higher up, with the breach just below the waterline.

- If at all possible, leave a ship in its grounded position until a full assessment of the damage has been carried out.
- If damage to the hull is suspected, ensure your information as to water ingress is correct before initiating any counter action. Sound all tanks and first establish where the damage has occurred.
- Once you have established where the damage has occurred, initiate corrective action as per the stability booklet or stability calculations. Any unplanned or improvised actions could have unintended consequences.
- Commonly, provided the ship still has positive stability, damage stability tactics require filling the double bottom tanks on the damaged (lower) side first (or removing cargo higher up) to lower the CG.

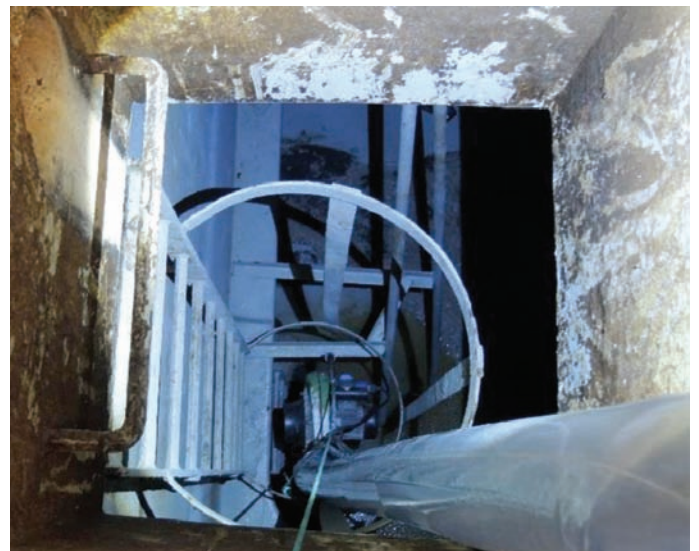
Access to silage tank

➔ A factory trawler was underway and being made ready for fishing. Crew had finished cleaning the factory and were preparing the silage tanks for cleaning. Silage tanks are special compartments that contain unused fish parts that are processed into silage and later pumped ashore (used to make oil and protein concentrate used in feed for farmed fish). The tanks had last been cleaned about five weeks earlier and there was still silage residue at the bottom of the tanks. Cleaning these tanks included preparatory work such as flushing the tanks by filling them with seawater and emptying them several times and then lowering a fan into the tank to ventilate. The usual method was to lower the fan into the tank using a rope.

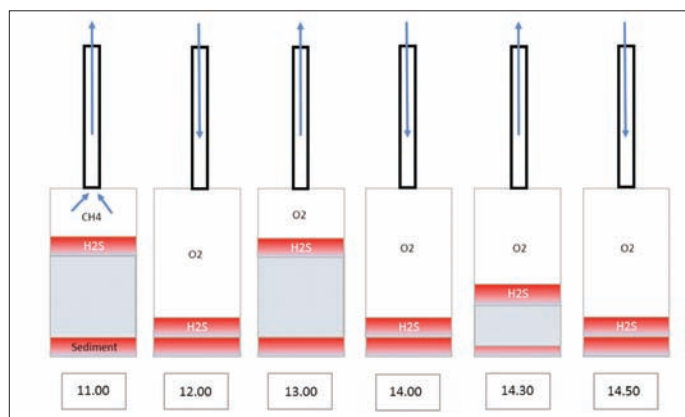
Flushing was accomplished as per the below diagram (not to scale). For the ventilation, a plastic hose was attached to the blower to channel the gases out into the open air. It had previously been a challenge to prevent the hose getting twisted when the fan was lowered, and it was decided to send someone into the hold to position the fan correctly, if safe. The oxygen level in the tank was measured by lowering an oxygen detector on a string, but it is not known how far down the tank it was lowered. The oxygen detector did not sound an alarm, and therefore it was deemed safe to enter the tank.

- The gas detector in use measured only the level of oxygen present. It was therefore not possible to determine whether the atmosphere was safe from other deadly gases such as hydrogen sulphide (H_2S) which is produced by bacterial decomposition of organic compounds containing sulphur such as, for example, the fish and fish waste in the silage tanks.

- The fisherman was probably exposed to a fatal dose (one or two breaths) of toxic hydrogen sulphide gas as he climbed down to the bottom of the tank.
- Efforts to rescue the victim from the tank were stymied by the lack of suitable equipment and training.

- SOLAS requires testing enclosed spaces with a multi-gas detector which includes H_2S prior to entry. Testing for O_2 content alone is not enough to allow safe entry into many confined spaces.

- For deep tanks, tests should be made and recorded for several levels including at the bottom.
- Another best practice is to have BA equipment ready for use at the enclosed space entrance before anyone enters that space.

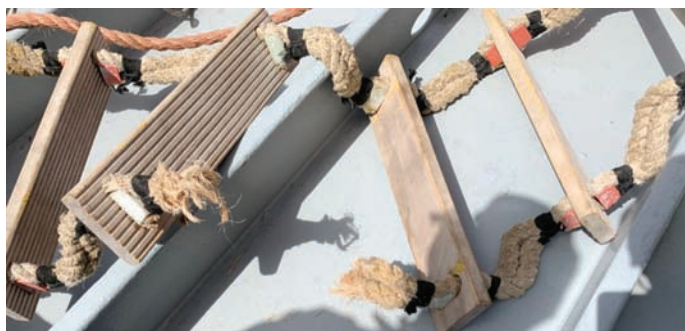
A vessel had been discharged and was ready to depart. A pilot had been ordered and had arrived via a small boat, boarding the vessel from the sea side. As the pilot stepped from the last rung of the pilot ladder onto the deck, one of the side ropes suddenly broke. Luckily, due to the fact the pilot had his weight and leg on the main deck, he did not fall.

Pilot ladder defects are, unfortunately, a fairly common problem even today. The lives of persons using such ladders depend on a reliable, safe equipment. Ladders should be scrupulously inspected at regular intervals and any hint of defect corrected or the ladder taken out of service.

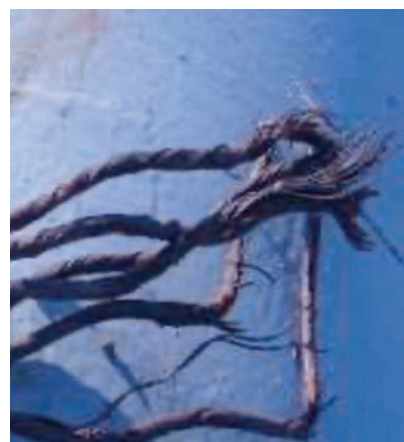
The vessel had finished berthing and the deck crew were deploying the starboard accommodation ladder for shore access. As the ladder was being lowered from its stowed position, the wire rope parted about two metres from its inboard end near of the outrigger's outboard guide sheave. The gangway fell and hung vertically along the ship's side. Fortunately, no one was injured and the ladder was recovered and secured. The wire had been installed 29 months earlier and had recently been inspected with no defects found. It was also reported that all rollers and moving fittings were able to turn freely without any signs of defects.

The company's post-incident investigation found that the wire's external condition appeared good. However, its internal condition was found to be poor, with corrosion evident.

- Inspecting wire rope for internal defects is especially difficult but can be achieved in many cases by opening the strands with a marlin spike.
- Particular attention should be given to splices and any 'hidden' points of the wire ropes, such as in the rollers, especially at points where little or no movement takes place under normal usage.
