MARS – Lessons Learned

MARS Report No 364 February 2023

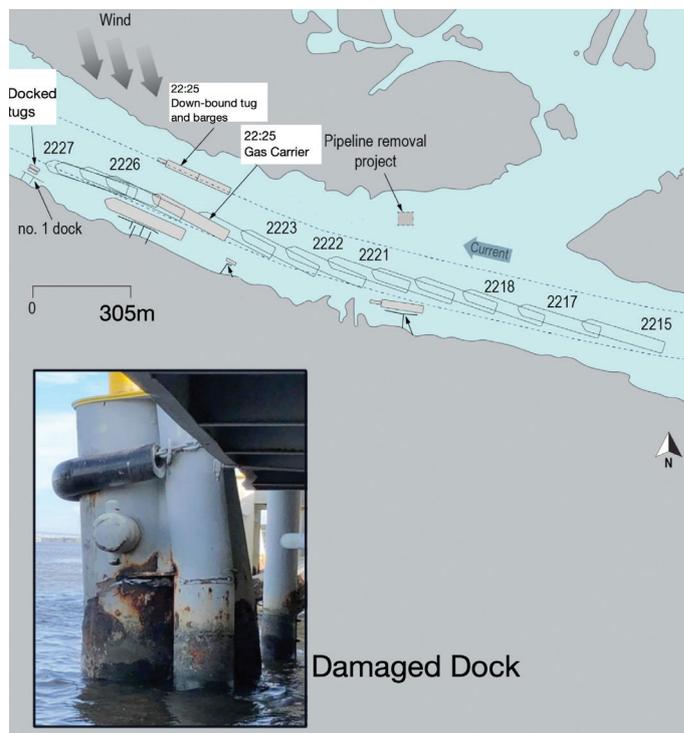
and requested the escort tug to give full thrust as well as various engine and helm orders. The gas carrier's bow was now moving toward some tugs moored at dock number 1 (far left of diagram), so the starboard anchor was released and engine emergency full astern was requested. Notwithstanding these last desperate actions the gas carrier's port bow collided with a berthed tug at dock number 1. Combined damage to the moored tugs and the dock were in the order of one million USD.

Although the NTSB found that the 'probable cause' of the collision was the low speed of the gas carrier causing a loss of rudder effectiveness in strong crosswinds, other factors also contributed. For example, down-bound traffic made for less space at a critical juncture in the narrow waterway. The escort tug secured astern could not effectively help the gas carrier's bow come away from the berthed tugs at a critical instance. Another factor was the darkness, which affects visual perception, acuity and depth of field. This in turn affects a person's responses and timing during manoeuvres. Finally, a following current will adversely affect a manoeuvre making a vessel's speed through the water less than its speed over the ground, thus inherently less manoeuvrable.

- It is often said that hindsight is 20:20. In this case we can see, after the fact, that given the winds and current, a meeting with the tug and barges may have been safer at a spot other than abeam the docked vessel.
- Factors that negatively affect a situation are not always evident at

first but as the situation develops they become risk multipliers. In this case darkness was a pre-existing negative factor. Combined with the winds, the following current, the vessel's slow speed to accommodate the pipeline removal project and the down-bound traffic at a critical juncture made for an almost untenable situation.

- In restricted waterways manoeuvres, it is an advantage that our foresight be as acute as our hindsight. Be mindful of accumulating 'risk multipliers' and act conservatively.

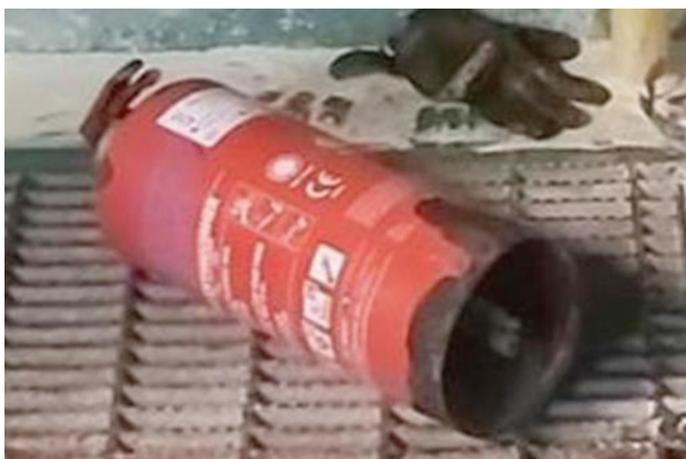
➔ A handheld (cartridge-type) dry chemical powder fire extinguisher was condemned during an annual third-party inspection due to corrosion issues. It was subsequently discharged, ostensibly for demonstration purposes. When the internal carbon dioxide cartridge was activated to pressurise the fire extinguisher, the unit ruptured at the base.

The person activating the extinguisher was struck in the head by pieces of flying metal which proved to be fatal.

- Condemned material should be discarded, not used for demonstration purposes.
- Cartridge-type fire extinguishers that utilise a cartridge to charge the main fire extinguisher cylinder shall be handled with care. The fire extinguisher should be placed on the deck at arm's length from the body. Point the top of the extinguisher away from the body while holding the handle and hose in one hand. Trigger the carbon dioxide charging cylinder with the other hand. Do not energise these types of fire extinguishers near the body.
- Consider using stored pressure type fire extinguishers as opposed to the cartridge type.

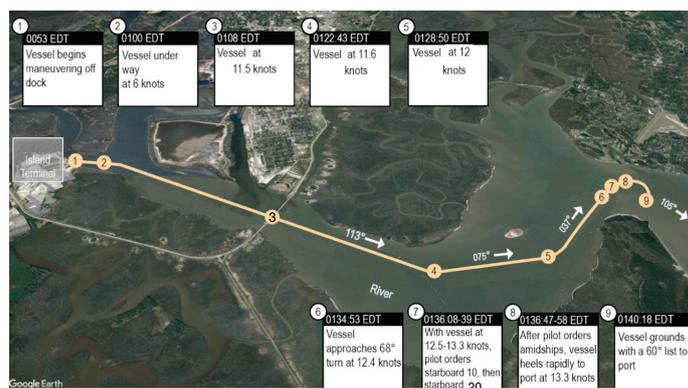
The car carrier's GM at the time of the heeling was not more than 1.8 metres, well below the 2.45 metre GM reportedly calculated in the stability computer. The investigation postulates that the chief officer had entered the data for the ballast tanks into the stability computer manually, and in doing so had made a data entry error. This in turn led to an incorrect determination of the vessel's stability. At a higher level, the investigation found that the vessel operator did not have a method in place (training and auditing) to ensure that the chief officer, although experienced, was proficient in using the shipboard stability computer.

- When only one person is responsible for a safety-critical task without a backup to help identify possible errors, single point failure can occur. Had the Master taken a more active role in reviewing aspects of the vessel's stability and the chief officer's stability calculations, he may have been able to identify the error.
- Given the critical nature of stability calculations on car carriers, it is of utmost importance that operators ensure officers are well trained in the use of the loading computers on board, and that they have adequate procedures in place to guide crew in ballasting practice and sequencing.

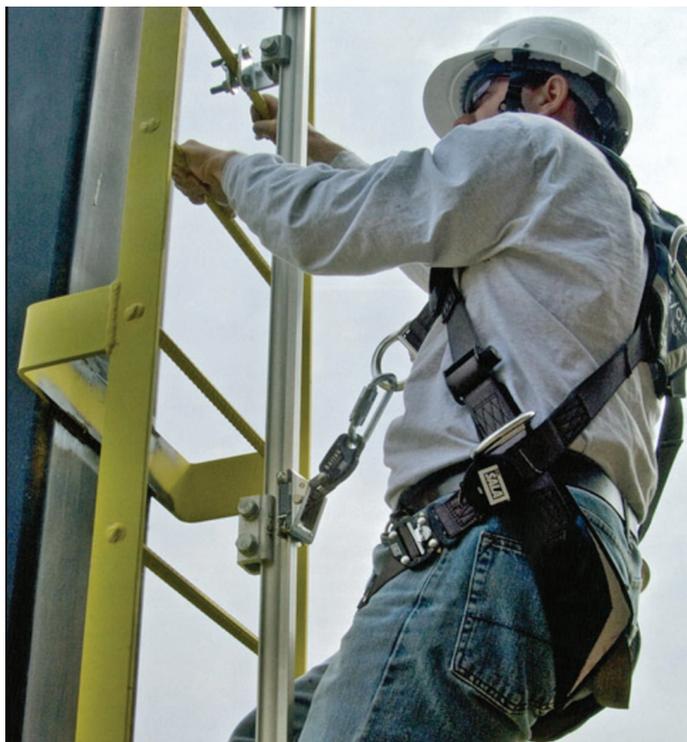
Single strap/clip in conjunction with continuous vertical safety line/rail

- The only way to reduce the risk of falling from a vertical ladder is to use either a double strap/clip arrangement such that one clip is always attached to a secure point or, if a single strap/clip, to use it in combination with a vertical continuous safety line/rail and fall arrestor, as in the photo left.
- If such equipment is not on board, Australian ladders should always be used to enter and exit a hold.
- Never climb or descend a vertical ladder without continuous fall protection. Your life depends on it.

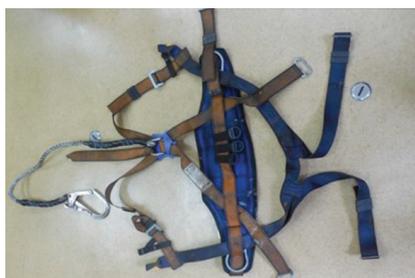
Safety harness used by victim

It could not be determined why the victim, a very experienced seafarer, chose to descend the vertical ladder instead of the Australian ladder. This went against recent practice and the agreed method to enter and exit the hold. The investigation found that although the victim was wearing a safety harness, it was of the single strap/clip variety, not a double strap/clip. There were no indications that the safety harness, lifeline, or clip had failed.

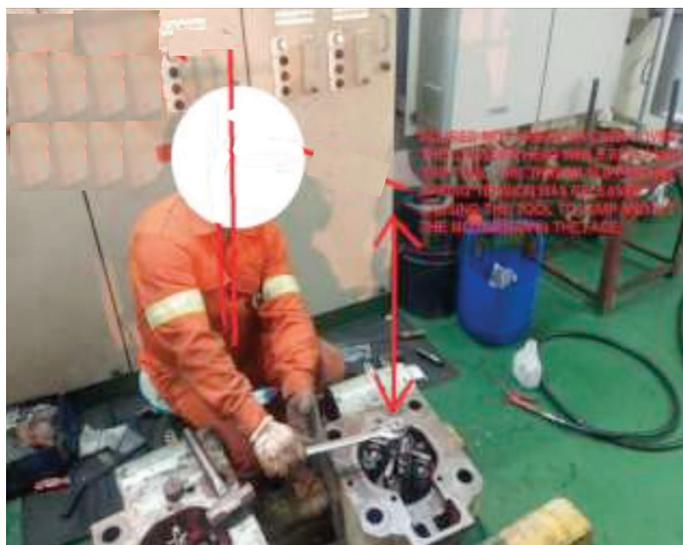
→ A member of the engine room staff was carrying out routine maintenance on an auxiliary engine while the vessel was at anchor. He was extracting the suction and exhaust valves of the auxiliary engine by decompressing the support springs, using the correct tool for the purpose, when the tool slipped and the springs jumped off, striking him on the chin, lower lip and left eye.

Correct position is with back straight – head away from the tool and cylinder head while loosening the nut to avoid such injuries

- When working with elements that have potential energy, proper PPE and correct body position are vital for safety.
