Loss Prevention Bulletin

The use of ECDIS Alarms

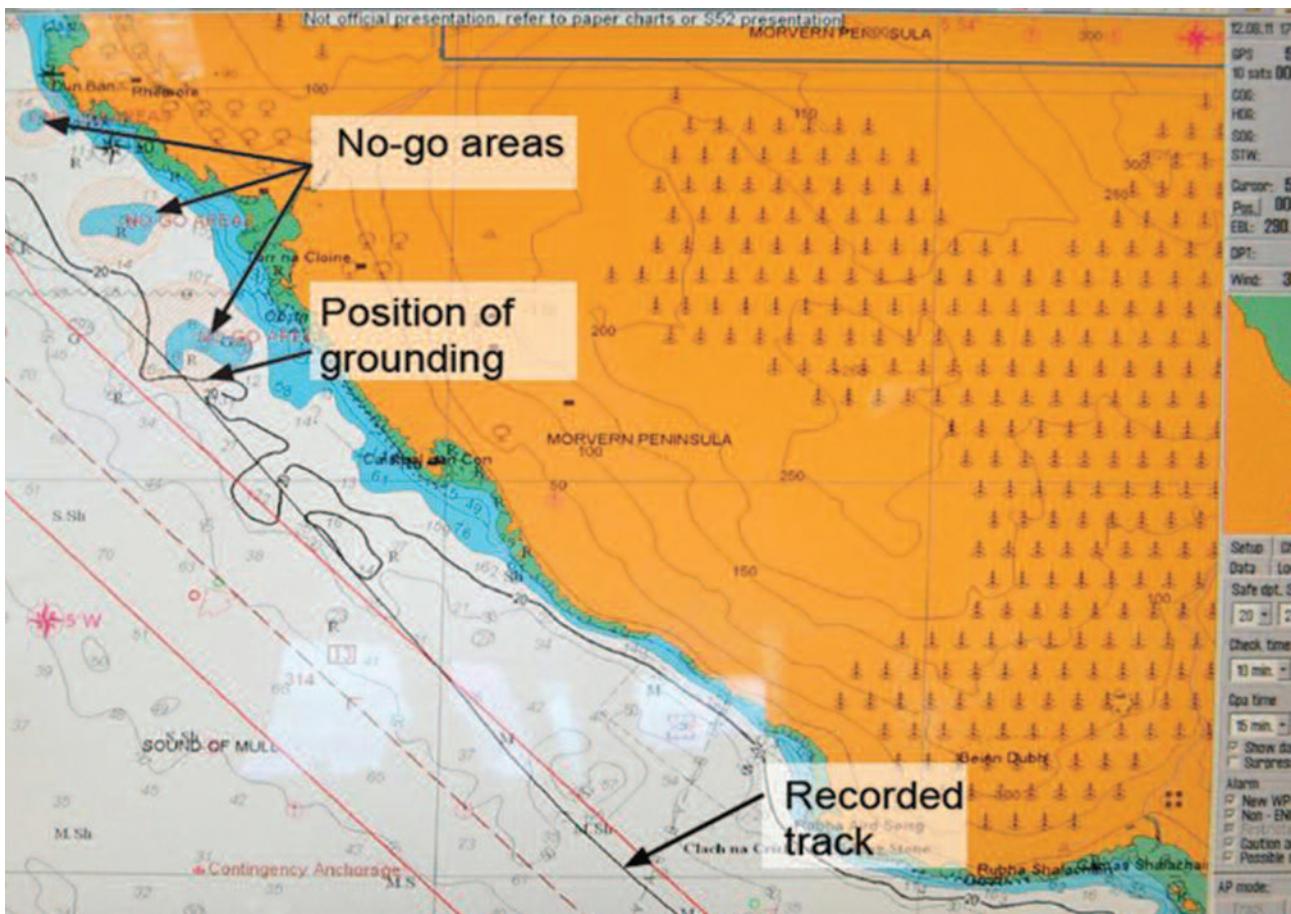
A 19,000 GT self-discharging bulk carrier was on a loaded passage through confined waters when the vessel grounded and sustained a 3 metre fracture in a ballast tank. The bridge watchkeeping officer had made a number of alterations of course to avoid a sailing vessel and another small craft. These collision avoidance manoeuvres forced the vessel away from

The vessel had a maximum draft of 10.6m and may also have been affected by squat. It was subsequently found that the safety contour had been set to 10m which, even allowing for the rise of tide above chart datum, was clearly inadequate.

The alarm was triggered before the safety contour was crossed, but the only warning was a visual alert on the ECDIS screen. This was not noticed by the watch-keeping officer as he was engaged in collision avoidance and was not monitoring the vessel's position on the ENC. Although an audible alarm should have sounded in addition to the visual alert, the audible alarm feed had been disconnected.

Planned and actual track of 19,000 GT bulk carrier

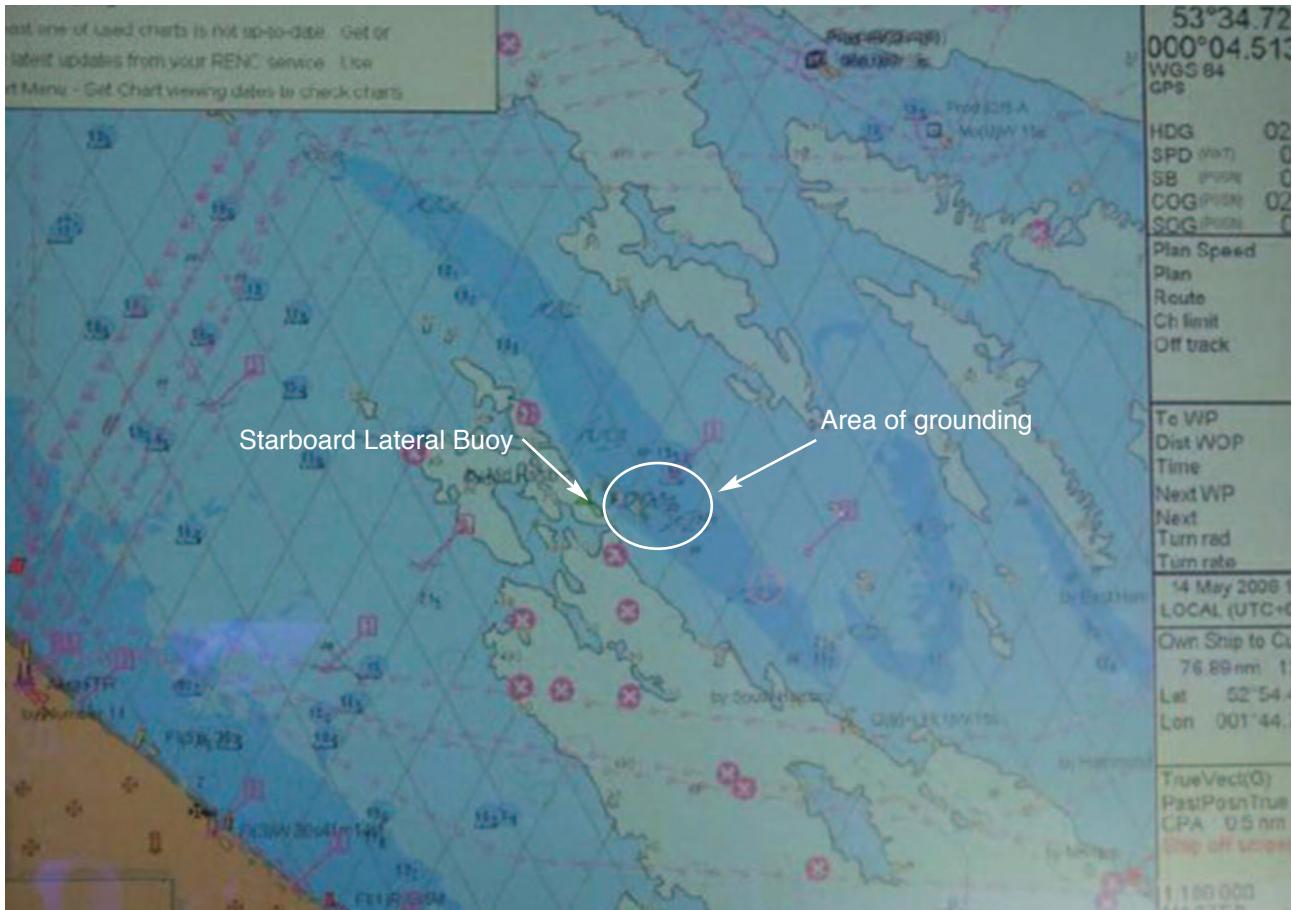
A 4,000 GT general cargo ship adjusted its ETA to arrive at the pilot station earlier than planned in order to meet a high tide. The vessel subsequently grounded on a sandbank.

The passage plan was amended when the ECDIS was displaying the ENC at a scale of 1:100,000. Visual inspection of the route on the ECDIS showed it to be clear at this scale. The fact that the vessel would pass a starboard hand lateral buoy on the port side whilst following the direction of buoyage was not investigated further. Had this been checked, it would have been evident that the amended passage plan took the vessel over a sandbank with charted depths considerably less than the vessel's draft. However, this was not obvious to the

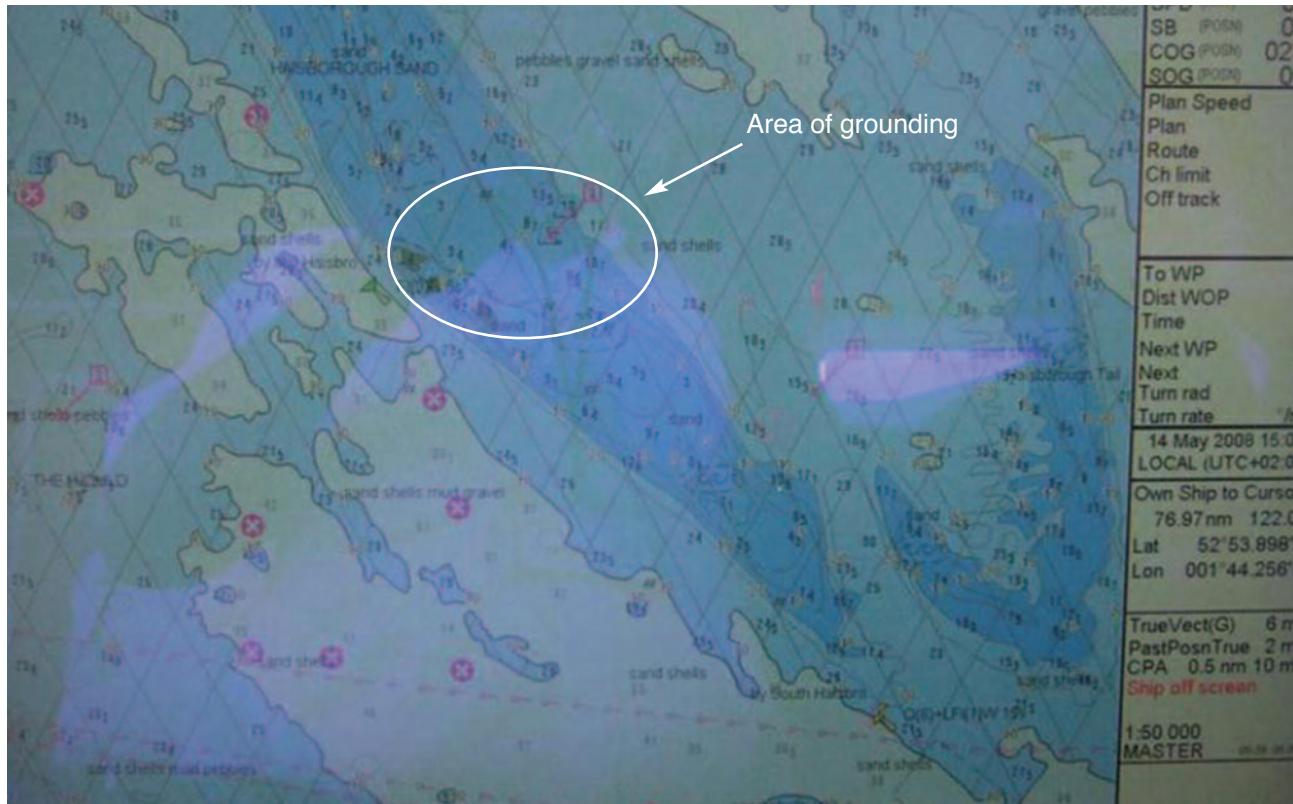
The safety contour function on the vessel's ECDIS was fitted with a watch vector function whereby a time and angle for the predicted movement of the vessel needed to be set in order to trigger the safety contour alarm. Although the safety contour had been set at 30m, the alarm did not function as the watch vector had not been activated by the bridge team.

Chart view on 4,000 GT general cargo ship at a scale of 1:50,000; note the much greater detail in the area of the grounding
