# Mariners' Alerting and Reporting Scheme

MARS Report No. 315 January 2019

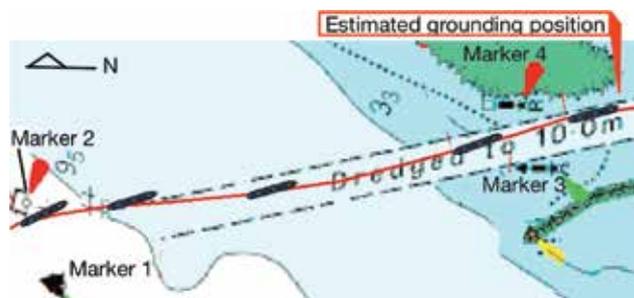
As the vessel passed between No. 3 and No. 4 lateral markers on a heading of 163° at nearly 5kt there was an exchange between the two pilots about an alteration of heading to starboard. During the exchange, the pilots gave different starboard helm orders, which prompted the helmsman to seek clarification from the Master. The Master told the helmsman to follow only his orders. Seconds later shuddering and heavy vibration was felt on board and the vessel's speed reduced for a few seconds to less than 3kt.

Although the bulk carrier was thereafter safely berthed, a dive inspection identified a series of splits, deep indentations and buckling of the shell plating on the port side that required drydock repairs.

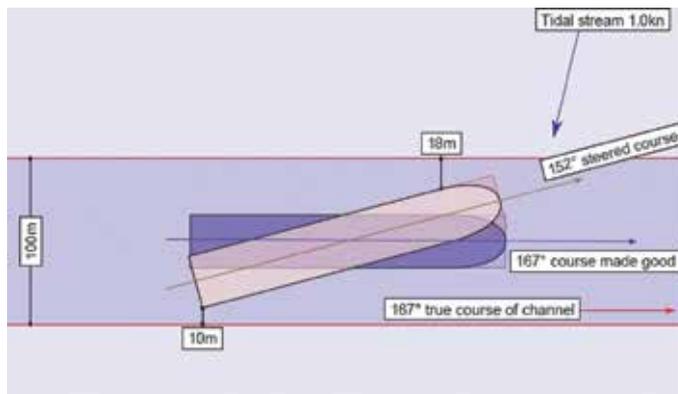
■ **Editor's note:** As the diagram above right (to scale) illustrates, given this vessel's dimensions there was very little margin for error in the narrow dredged channel. Had a proper risk assessment been performed before the entry it may have become evident that one or more assisting tugs would have made the entry much safer, even assuming slack water.

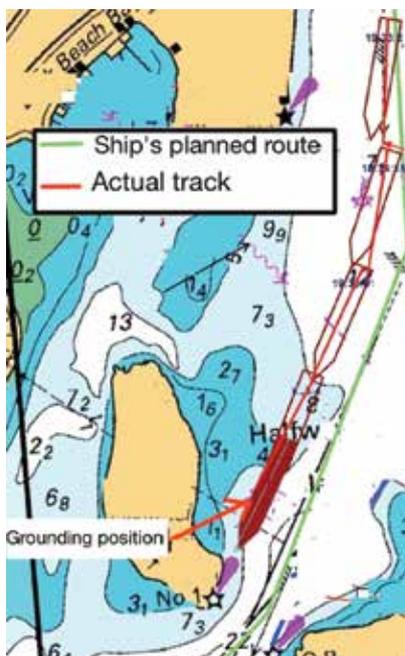
The leading marks showed that the vessel was to starboard of the intended track, which the pilot was aware of. The pilot made a succession of helm orders for 5°, 10° and then 15° of port helm and then ordered the helm to amidships in anticipation of the change in direction of the tidal set. Noticing that the vessel was still to starboard of the line of the leading beacons, he ordered 5° then 10° of port helm and then ordered the helm to amidships.

The members of the bridge team, including the pilot, then felt a bump. Initially, they thought it was the aft tug bumping the stern of the vessel. The pilot saw that the speed was reducing and he noted that the vessel's head was swinging to starboard despite the 10° of port helm being applied. Both the Master and the pilot realised the vessel had grounded, and ordered stop engines, half astern and full astern in quick succession.

- The grounding occurred because the bridge team, including the pilot, lost situational awareness. Although the pilot was aware that the vessel had deviated starboard of the intended track, the extent of that deviation was not known because the vessel's progress was not being monitored effectively and by all available means.
- The vessel's ECDIS was not correctly configured for navigation in a narrow channel. As a result, crew members were not adequately monitoring the progress of the vessel in support of the pilot, who was navigating mainly by visual references.

- In restricted waters, even 30 seconds delay or hastiness in helm orders could mean the difference between afloat and aground. Support the pilot by giving your input and voicing any concerns promptly.
- Maintain your situational awareness by keeping an eye on your (properly adjusted) ECDIS.
- The published port passage plan was not entered into the vessel's ECDIS, so this valuable information was of no practical benefit.

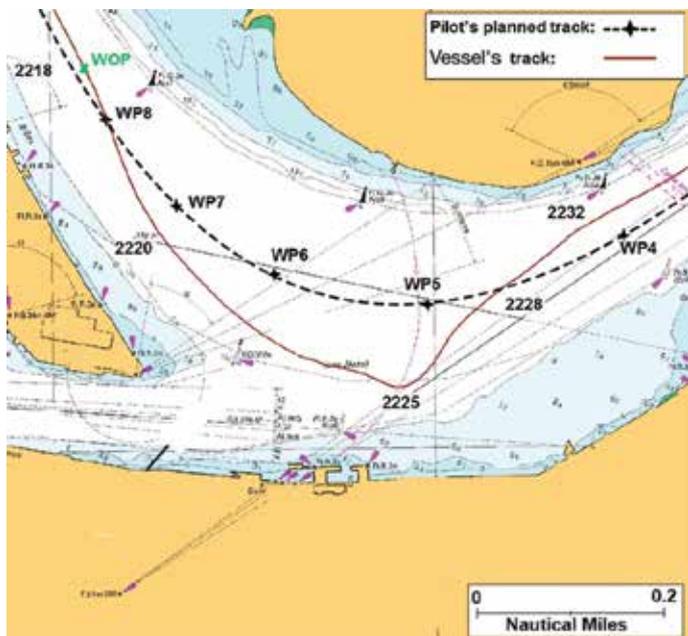
The ship's bow turned to port while the ship continued to track almost straight ahead. Hard port rudder was ordered before the ship slowly began to turn to port. The pilot continued to focus on the rate of turn indicator to see if the ship was turning as quickly as desired. A short time later, when he checked the ship's position visually, he realised the

ship was off the desired route; it was well south of his intended track and closing on an east cardinal buoy. The pilot contacted the tugs to assist the turn. Meanwhile, the Master followed the progress of the ship but did not challenge or intervene because he assessed the actions taken to be appropriate.

Insufficient rudder was applied as the vessel started the 90° course alteration to port, and it was applied too late to achieve the necessary rate of turn. As a consequence, the ship went off course and very nearly grounded.

- Similar lessons to MARS 201901.
- As a consequence of this near grounding the port authority decided to amend their procedures to require compulsory carriage of a PPU on all pilotage assignments. For further insights on the PPU, readers might care to refer to the article in this month's *Seaways*, The Portable Pilotage Unit: Panacea or Pandora's Box.

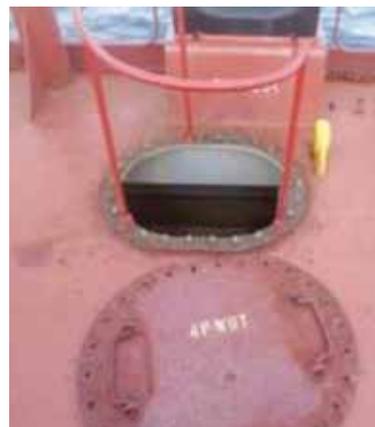
➔ A tanker was in port to undergo a class survey. Cargo and ballast tanks had been opened and cleared for entry and inspection. A class surveyor, a crew member and an ultrasonic measurement technician entered Ballast Tank No 4 Port. Inspection work was in progress when water started to enter the tank from the opened deck manhole.

The company investigation found that the enclosed space attending officer had been called to the cargo control room. While he was away from his assigned post, ballast water overflowing from the air vent of another tank had spilled along the deck and then drained down the open manhole of Ballast Tank No 4 Port.

- Never leave the entrance to an enclosed space unattended if there are people inside.
- Simultaneous operations such as ballasting and deballasting while also inspecting ballast tanks can introduce unnecessary risks to the operation.

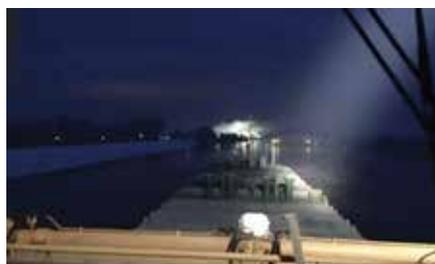
Approaching the bridge with searchlights

to illuminate forward. The pilot called the bridge operator and understood that the vessel could pass the bridge as the next scheduled train was delayed. At about six cables to the bridge the vessel's speed was reduced. In the darkness it was not possible to make out the bridge signal lights because of the glare from bright background floodlights nearby.

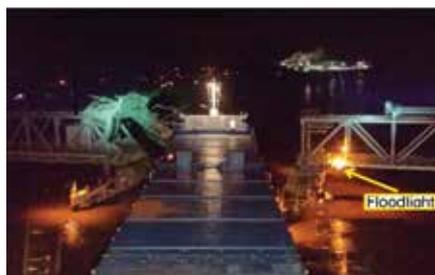
Collision with the bridge

When the vessel was some 1.5 ship lengths away from the bridge the bridge operator called to say the bridge was not raised and that the vessel must stop. Full astern pitch was immediately applied but to no avail. The vessel collided with the bridge about one minute later.

- Communication between the bridge operator and the pilot was informal. No clear information on the status of the bridge or of the vessel passage had been exchanged by either side.
- The duties of the pilot were too much for one person.
- The lighting and status of the bascule bridge (open or closed) was not to a reasonably safe standard.

- When in restricted waterways support the pilot by all possible means such as supplying a helmsman and using the radar to inform the pilot of distances and position.
- If the pilot is communicating with VTS, vessels or shore authorities in a language that is unknown to you, ask them to explain what was said.

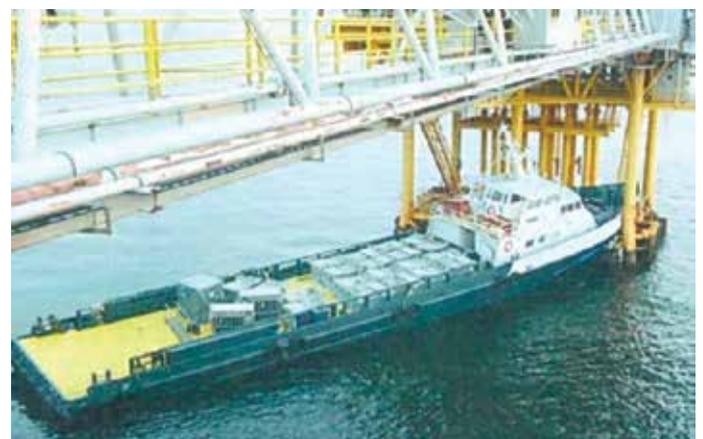
→ Auto-pilot systems can reduce the monotony of steering by freeing the helmsman to step away from the helm to perform other minor tasks and gain different navigational viewpoints. They also have disadvantages by making it easier for operators to engage in negligent navigational practices. Over-reliance on these systems can allow an operator to become too engrossed in performing other work on the bridge and, in extreme cases, can lead to personnel leaving the bridge for extended periods of time.

In some past incidents, the operator's lack of system knowledge has hindered their ability to change over rapidly from auto-pilot to manual steering even when there was time to take corrective action.

- Using auto-pilot does not relieve crew from always keeping a sharp lookout.
- Know how to switch quickly from auto-pilot to manual steering.
- If there is a change in conditions (visibility, traffic density, area of navigation) re-evaluate the use of auto-pilot.
