Mariners' Alerting and Reporting Scheme

MARS Report No 351 January 2022

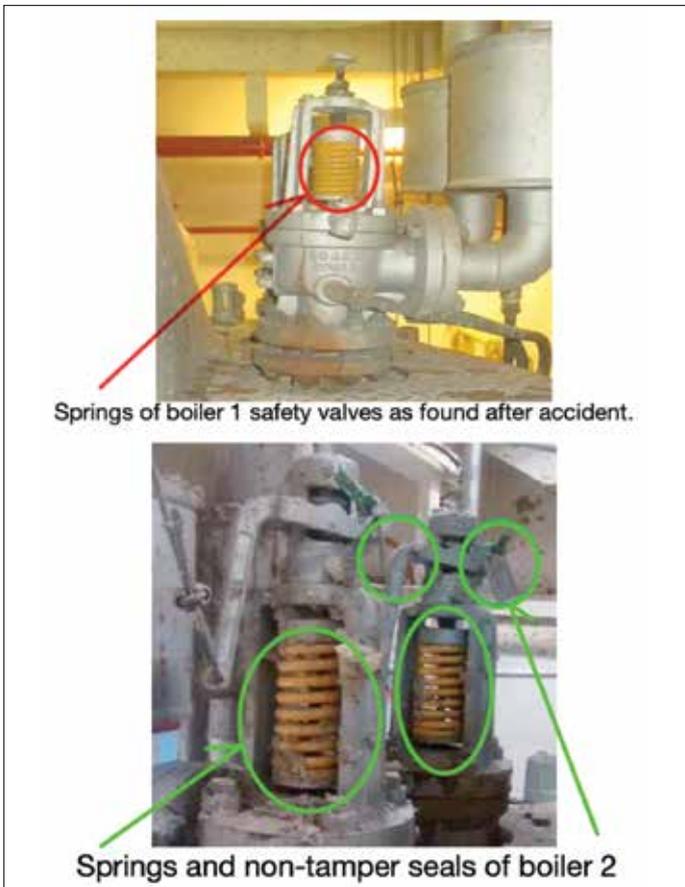
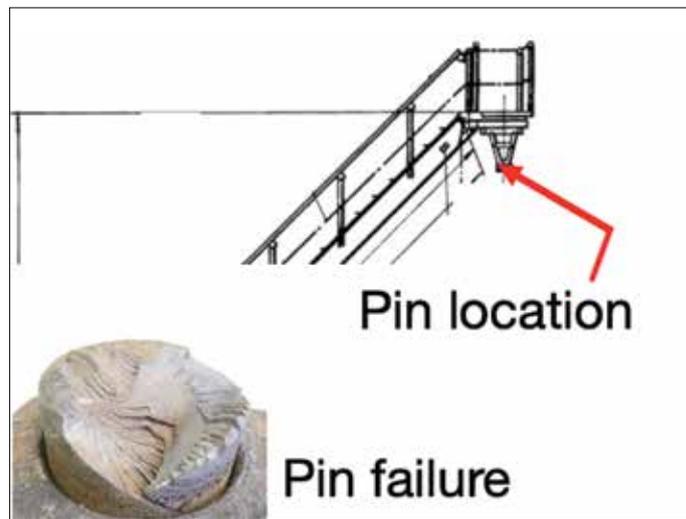
The vessel's crew was stowing the accommodation ladder when the turntable pin failed. The victim, who was on the accommodation ladder at the time, fell approximately nine metres and sustained serious injuries.

Currently, there are no established timelines or requirements to replace turntable pins. Without periodic examination (and replacement if needed), corrosion can ultimately lead to structural failure.

After the incident specific inspections were undertaken; local authorities noted that many vessels had accommodation ladder turntable pins that had been in service for more than 20 years without replacement. Notwithstanding the guidelines on the maintenance of accommodation ladders contained within 74 SOLAS (14) II-1/3-9, MSC.1/ Circ. 1331, and 74 SOLAS (14) III/20.7.2, none of these references include maintenance guidelines for turntable pins.

- While the turntable pin may seem like a minor component, failure can cause significant harm to anyone using the accommodation ladder at the time.
- Periodically inspect the condition of the turntable pins and replace when necessary.
- Revise accommodation ladder maintenance plans to include turntable pins.

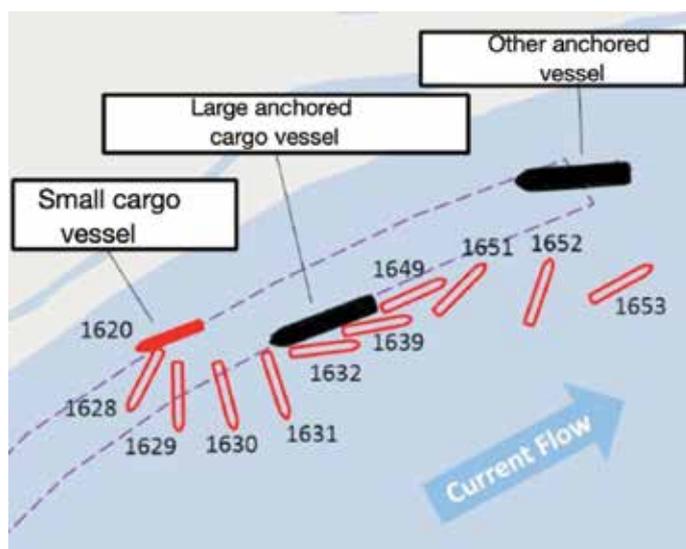
The transit downriver was without incident. With the assistance of two tugboats, the vessel was anchored at 16:00 using both anchors, placed at the ten and two o'clock positions respectively. By about 16:17 the anchor chains had become taut and the stern of the vessel was about 152 metres from the bow of a much larger general cargo vessel anchored astern. At about 16:26, as the pilot boat approached to disembark the pilot, the vessel's bow swung quickly into the river current. By the time the pilot regained the bridge the ship was almost perpendicular to the river. The pilot requested 'half ahead and starboard' but the engines were not able to overcome the force of the river current, and the anchors dragged. A few seconds later the pilot informed the Master that they were going to collide with the bulk carrier anchored astern. The pilot radioed the two tugboats that had been assisting during the anchoring, requesting that they return as quickly as possible. The ship's whistle was used to sound the danger signal and warn of the impending collision.

About 15 minutes after being 'safely' anchored, the vessel was being carried by the current at a speed of 5.5 knots. The vessel drifted until its propeller caught the starboard anchor chain of the larger vessel anchored astern. The entanglement pulled the drifting vessel's propeller shaft outward damaging reduction gears and cracking the gear box.

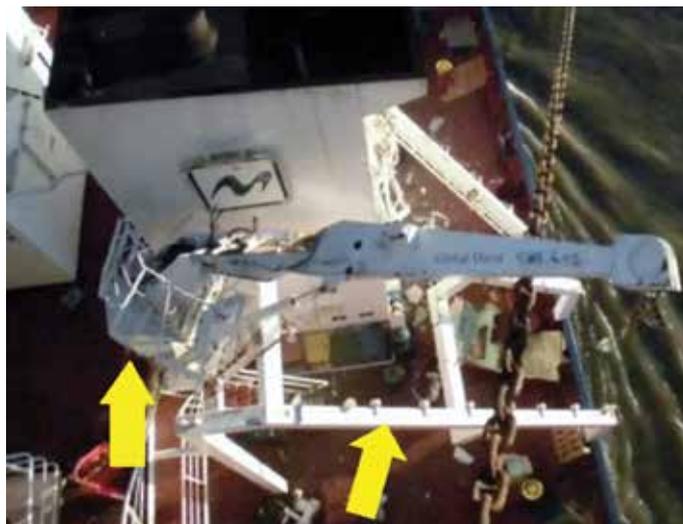
Stern crane and lifeboat torn off by large anchored vessel's anchor chain

Subsequently, the small cargo vessel drifted toward the port anchor chain and bow of the larger anchored vessel. The anchored vessel's port anchor chain caught and then wrapped around the drifting vessel's stern crane, holding the vessel in place as the current pivoted it around the bow of the bulk carrier. The crane and the stern mounted lifeboat of the drifting vessel were destroyed. The highest point on the drifting vessel's aft deckhouse was well below the main deck of the larger anchored vessel, and the bridge wing of the drifting vessel was torn off.
