Mariners' Alerting and Reporting Scheme

MARS Report No 320 June 2019

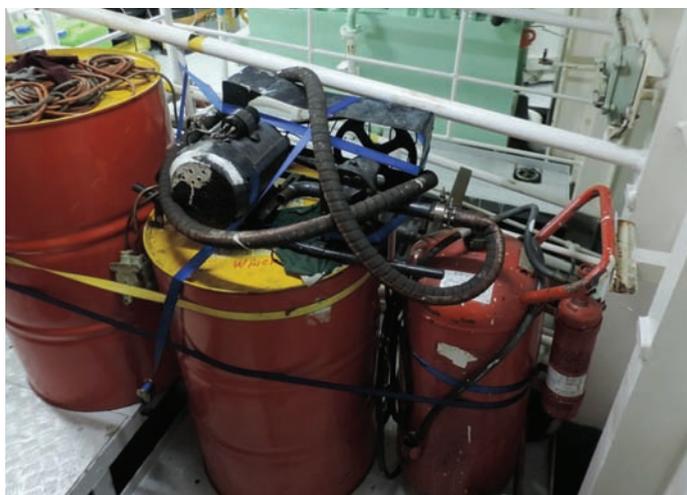
Fire extinguisher lashed and access hindered by other gear

- Are you joining a newly acquired vessel? Do the rounds and check the safety equipment.
- Keep fire-fighting equipment accessible and clear of all other gear.

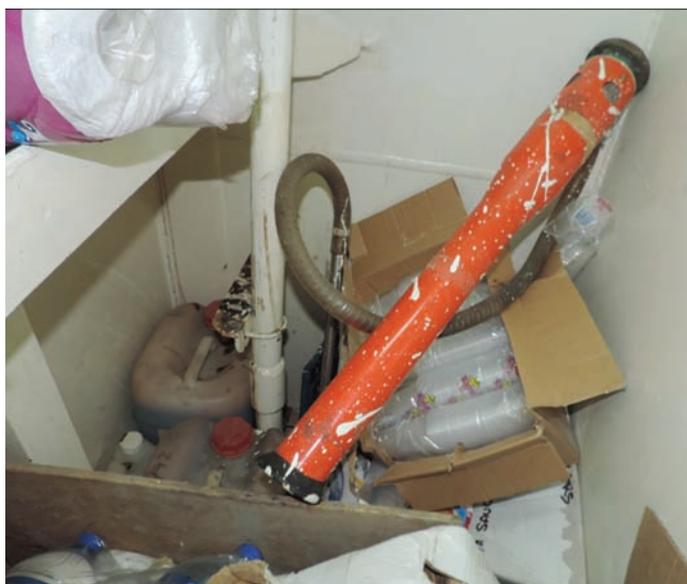
Foam nozzle stored carelessly and amongst unrelated items

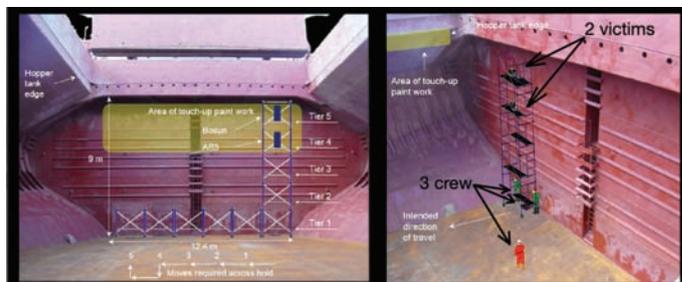
When the scaffold tower needed to be moved again, the two men stayed on the tower. The scaffold wheel brakes were released. As the three crew below moved the structure it suddenly toppled forward to the deck, taking the two men perched on tiers four and five with it.

- Some of the contributing factors listed in the official report were:
- Contrary to established procedures, two crew members remained on the unsecured scaffold tower in preparation for repositioning, rendering it top-heavy and unstable.

- The lack of formal supervision in the afternoon, plus a desire to expedite the task in difficult working conditions, probably prompted the crew members to remain unsecured on the scaffolding as it was repositioned.
- The report also identified several factors that increased risk, such as:
 - The scaffold tower had several defects that reduced its stability.
 - Guidelines for the provision, care and use of the scaffold tower were not supported by suitable onboard documentation.
 - Neither crew member on the scaffold tower made use of the required safety harness and associated safety lines, which would have prevented them falling when climbing or working on the tower.

- Where there is a strong safety culture, crew are likely to work safely, even when under their own supervision.
- Always wear fall-arrest protection when working aloft.
- Needing to get the work done is no excuse for skirting procedures.
