Mariners' Alerting and Reporting Scheme

MARS Report No 349 November 2021

MARS 202153

Allision with bridge support

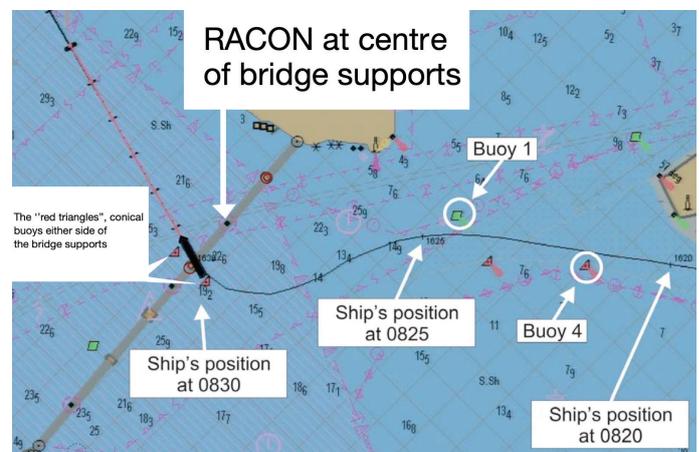
Shortly afterwards, the pilot ordered 10 degrees starboard rudder, then 20, and asked for full ahead. According to the Voyage Data Recorder (VDR) capture of the ship's radar display at this moment, the ship's heading was 241° (almost parallel with the bridge) and its course over ground was 255°. About this time, when the vessel was 0.3 nm from the bridge, a port VTS operator was concerned that the vessel was out of position to make an approach under the bridge. He called the pilot, addressing him by his pilot designator name, 'Romeo' instead of the vessel's name, as was the practice in this port. When the VTS call came the pilot asked the helmsman to ease to 10° starboard. Once the conversation with VTS was finished, some 25 seconds later, the pilot requested starboard 20° helm once again. Pointing to a place on the electronic chart, the pilot asked the bridge crew 'This is the centre of the bridge, right?' The Master responded yes, and soon afterward the pilot requested hard starboard.

Over the next two minutes, the pilot gave rudder orders of hard starboard, mid-ships, starboard 20°, and hard starboard. At 08:29, the crew posted at the bow reported the bridge column close to port. About 10 seconds later, the pilot ordered the rudder midships and then hard port rudder. An allision was now inevitable and the pilot wanted to reduce the swing of the stern towards the bridge support.

The forward port side of the vessel struck the corner of the fendering system at the base of the bridge support at 08:30. The bridge support was unaffected due to the fendering and cement pier skirt but the vessel suffered a large gash. Fuel tanks were punctured, causing pollution. The vessel was subsequently brought to anchorage to allow time to assess the situation.

- A shared plan where everyone on the bridge is working from the same basis means there is a chance of catching and correcting an error, if it happens.

● In this case, the Master had some reservations about the departure, as his comment to the pilot testifies ('the fog is so heavy'). But he did not question the pilot's impetus to leave. If you are in charge, take charge.

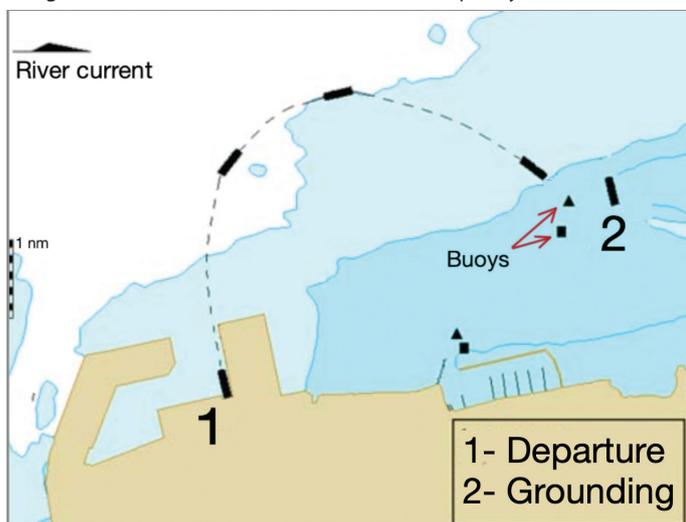
Once the vessel cleared the departure basin and passed the jetties, it quickly fell off to starboard into the river current setting approximately 075° at two knots (see below), but this was not visually apparent to the bridge team. However, the Master and mate both noticed that the gyrocompass repeater heading was rapidly turning to the east.

As the Master and mate monitored the radars, both set on the 1.5 nautical mile scale, they saw the echoes of the nearby landmass quickly shifting, creating a blurred image. This was to be expected since the radars were set on unstabilised, head-up presentation. Nonetheless, the bridge team were now flustered and unable to quickly determine the

- Blind pilotage not only requires proper training, but practice too. Practise your blind pilotage technique whenever possibly, especially in good weather.
- A north-up, stabilised radar setup is superior to an unstabilised setting when navigating in low visibility conditions.

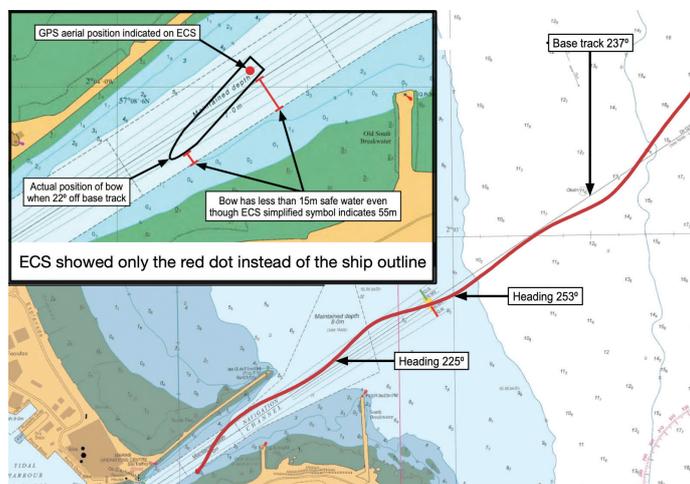
The vessel was now fully in the navigation channel, and the PEC holder reduced speed to dead slow, which gave 6.5kts over the ground. The PEC holder altered the vessel's heading to 245°, and the ferry again moved north of the centreline and to the very edge of navigable water to the north. The Master and PEC holder then saw the north breakwater and realised they were heading into danger.

The PEC holder applied about 10° of port rudder to bring the ship back towards the planned track. In response to prompting from the Master, the PEC holder applied more port helm until there was 30°. The vessel rapidly crossed the narrow channel, and after 15 seconds, the PEC holder realised the new danger and applied maximum starboard

rudder, but this alteration was too late. The ferry grounded at 6.5kts, raking along its port bow and port side before coming to a stop on the southern edge of the 70 metre wide channel.

Hull, propellor and rudder damage on the port side required repairs that kept the ferry out of service for four weeks. The official investigation found, among other things, that the grounding was due to the bridge team losing situational awareness in thick fog.

Another finding was that the use of one parallel index (PI), as in this case, was insufficient for safe navigation in near zero visibility. Multiple PIs to display safety limits, effectively drawing a corridor down which the ship can be safely driven, would be more appropriate for such conditions. Additionally, by having only a symbol representing the ship on the ECS instead of a scale outline of the vessel, important safety information such as the swept breadth within the channel was not available to the bridge team.

- Commercial pressure or even personal overconfidence can contribute to our making wrong decisions. When it comes to conning a ship in restricted waters and visibility, taking a conservative approach is probably the best option.
