### MARS 202543

Fatal fall into container bay

## Fatal fall into container bay

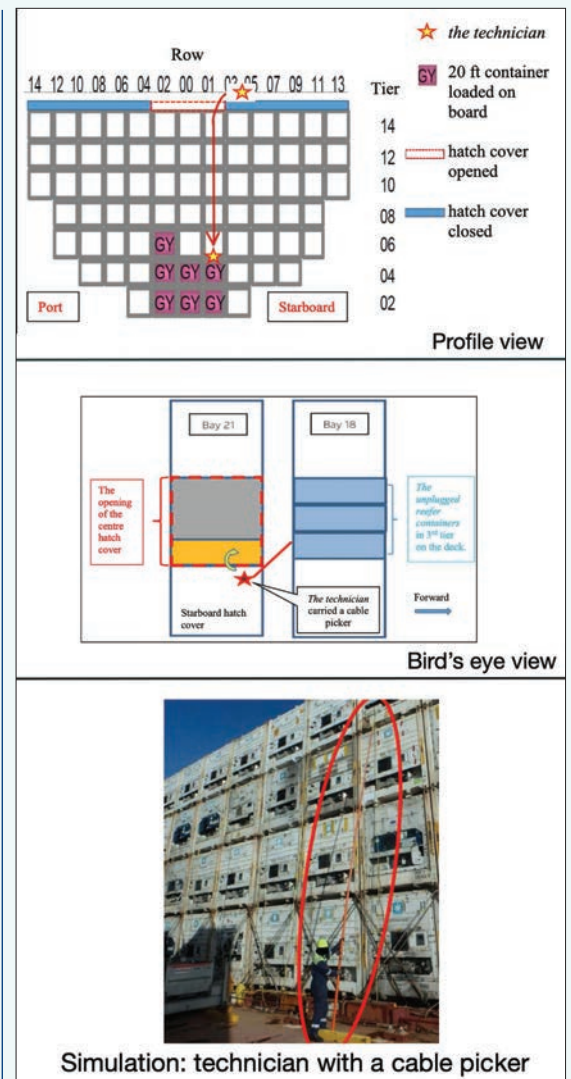
At night, a container vessel had discharged all containers and commenced loading outbound containers, including reefer containers. Some hatches were left open after discharge was completed.

Eight shore technicians from a service company boarded the vessel to connect the vessel's power supply to the reefer containers. One of the technicians, standing at bay 21, was attempting to access the reefer connection cables of a container located above him at tier 3 of bay 18 using a cable picker. No one witnessed what happened next, but it is assumed that the technician did not notice or was otherwise unaware that there was an open hatch nearby.

About 6.5 hours after the shore technicians had boarded, the technician was found motionless on top of a container in the hold, more than 10m below the deck. A rescue team arrived quickly but the victim was found deceased. His body was removed with the help of a shore crane.

The investigation found that the technician had been working alone near the open hatch cover. It appears the accident was a perfect storm of the common 'get the work done' attitude and practices common to the container trade, such as:

- No safety meeting before work;
- No safety instructions for wearing appropriate PPE during work;
- Lack of a risk assessment or control measures taken for working 'aloft';
- No action to close the hatch cover as soon as discharge cargo operation terminated;
- Less than adequate supervision of operations by crew.

- Working on deck is no guarantee that you can't fall a great distance. Be aware of your surroundings – never work close to an unprotected fall hazard area without the correct equipment such as a fall arrest safety line.

- Potential fall hazard areas should be protected or otherwise closed off as soon as possible.
- A golden rule to ensure safety is to hold a safety meeting with onboarding contractors before they begin work.

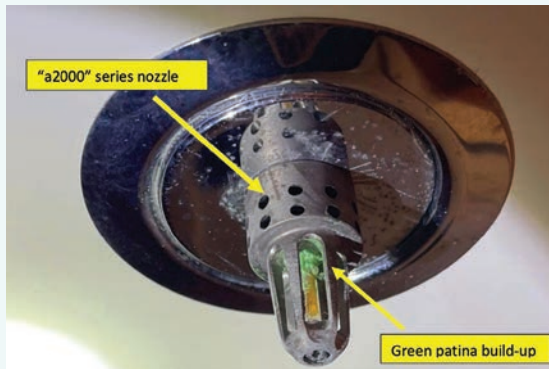
A passenger vessel was undergoing a US Coast Guard inspection, including a test of the high-pressure water mist nozzles (part of the HI-FOG fire suppression system). The high-pressure water mist nozzles are designed to hold the standard line pressure of 25 bar (363 PSI). When the glass bulb thermal actuator reaches a certain temperature, it breaks, activating the release mechanism which allows water to flow through the nozzle at the standing pressure. The system then senses the drop

in pressure and automatically activates the high-pressure pumps, increasing the pressure to 140 bar (2,031 PSI). This increased pressure is required for the system to achieve an effective release of water as a mist.

Due to past failures, the manufacturer (Marioff) released a Service Bulletin (001/2012) recommending that if a nozzle fails to release at the standing pressure of 25 bar after the glass bulb is broken, the high-pressure pumps must be manually energised to raise the pressure to 140 bar. This should activate the release mechanism, allowing water to flow through the nozzle. During the examination this recommended action was taken, but did not activate the release mechanism of the nozzles as expected.

Upon closer inspection, it was found that the high-pressure water mist nozzles had accumulations of green patina, a sign of corrosion, which rendered them unable to release water after the glass bulb broke, even with 140 bar pressure.

- Does your vessel have high-pressure water mist nozzles? Check for green patina!
- Sprinklers at the highest risk of corrosion include sprinklers more than 10 years old and those located in high moisture and corrosive atmospheres. Areas of high moisture could include outer decks, spas, pool areas, galleys, or even normal passenger and crew areas close to external doors.
- Contact the manufacturer if any signs of green patina build-up are observed on high-pressure water mist nozzles. Consider replacing the affected nozzles.
