## In this bulletin...

### **MARS 202612**

### **MARS 202613**

### **MARS 202614**

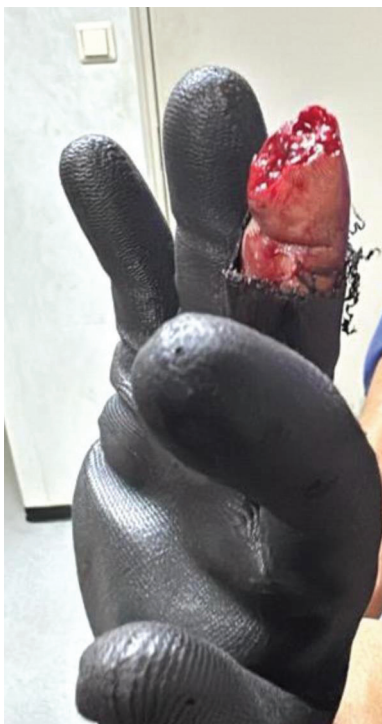
An engine crew member was assembling the sewage air blower motor back into position after maintenance. He had to lower the motor vertically to align with the shaft below. Since it was a small motor, he thought it safe to align it with his hands while wearing gloves.

Once the motor was aligned, he had to lower it into the slot. While doing this, his grip loosened, and the motor slid down under gravity. The victim's right forefinger was severely pinched between the motor body and base plate. He was able to remove his finger, but the fingertip was badly mangled.

- When deciding how to do a job, bear in mind all the hazards and the worst-case scenario. An informal way of doing this is called **take five**. That is, take five minutes to review the task in your mind's eye. Ask yourself 'What could go wrong here?'
- Proper tools or engineering controls are your first line of defence. Personal Protective Equipment (PPE) is the final barrier and may ultimately fail to protect.
- Even the most mundane of tasks can leave lasting scars if proper methods of work are not adopted.

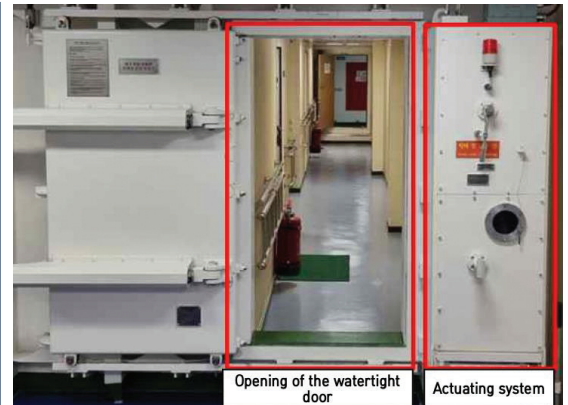
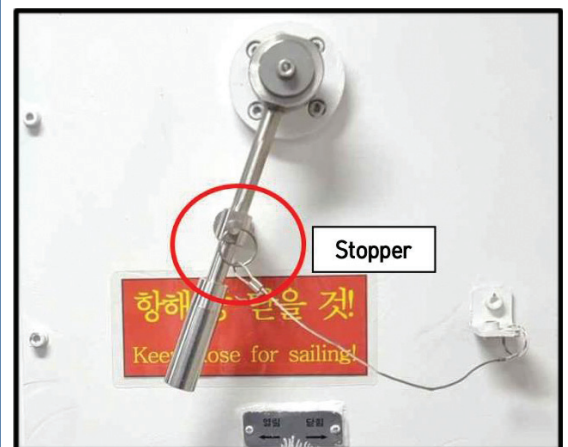
The crew member took out the stopper and opened the watertight door by turning and holding the lever to the right – the opening direction. Since the power switchboard for the watertight door was turned off, the door was operated by residual hydraulic pressure in the accumulator. Normally an alarm signal and visual strobe would sound/flash when opening or closing but since the power was off, there was no signal.

He probably intended to pass through the door, then close it while simultaneously putting the stopper into the control lever. While standing in the middle of the watertight door frame, he pushed the corridor-side control lever in the closing direction with his left hand. The residual hydraulic pressure then caused the door to return to the closing direction.

As the door was closing, he tried to put the stopper into the control lever, but somehow got trapped in the closing door. The watertight door pressed down on him powerfully from behind. The force of the closing door would have been weaker than the normal set pressure, but it was strong enough to trap him in the door.

The investigation found that the stopper on the actuating system had been installed in case the door needed to remain open for a long time during inspection or while work was being carried out. When the door is opened, its control lever is in neutral. As long as the lever is not turned to the closing direction, the door remains opened. The stopper is intended to prevent the door closing if the lever is activated due to negligence or malfunction.

The vessel's crew did not clearly understand the function of the stopper. They believed, incorrectly, that it was a safety pin which had to be inserted so that the control lever could not move. The victim probably also regarded it as a safety pin that should remain inserted. In other words, the victim's belief that he had to insert the stopper is likely to have contributed to this accident, along with his decision to pass through the door.

- It appears the crew were not very familiar with the use and operation of the watertight doors, and specifically the rationale for the 'stoppers'.
- It should be second nature to use Lock out tag out (LOTO) procedures for any machinery that has stored potential energy, to ensure safe operations. If you don't buy your LOTO ticket, you will never win!
- Watertight doors are an integral part of the safety of the ships that are fitted with them. Yet the doors themselves contain stored energy and potential for great harm. All crew on ships with watertight doors should be completely conversant with their operation.
