MARS – Lessons Learned

MARS Report No 388 February 2025

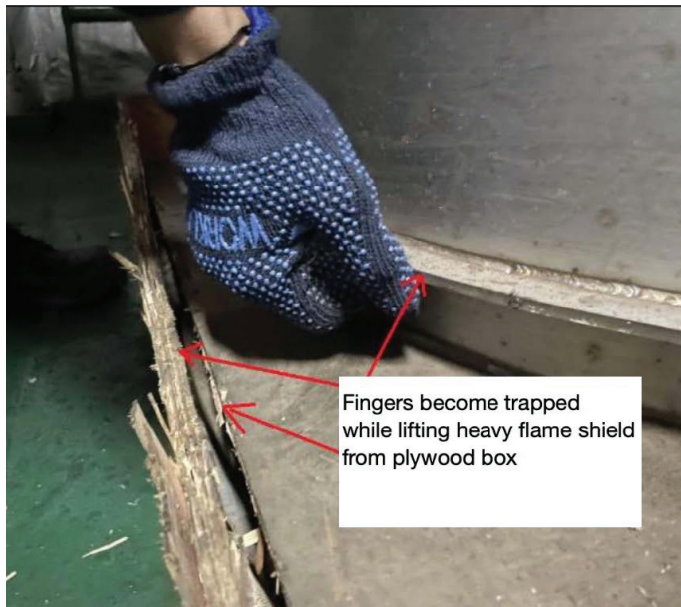
The plywood cover of the impeller box was only loosely installed. While shifting the flame shield, the loose plywood cover also moved, and one corner of the cover slid and fell inside the box. The flame shield was too heavy for the crew to support the weight, and the engineer's right index and middle finger were trapped between the flame shield and the wooden box. The victim received a deep cut on the index finger and a swollen middle finger.

Fingers become trapped while lifting heavy flame shield from plywood box

- Before carrying out any job, carry out an informal risk assessment which involves inspecting the job and the surrounding area. Ask yourself, what are the hazards?
- Whenever handling a heavy object, evaluate whether lifting appliances can be employed or alternate methods used to lift or handle the object. Use common sense before brute strength!
- Alternatively, if space constraints prevent the use of lifting appliances, it is crucial to ensure an adequate number of crew members are available for the task.
- Never put your hands below a heavy object or take a position which might lead to a crush injury.
- Use appropriate PPE. Debatably, leather gloves would have been more appropriate for this task and would have probably reduced the severity of the injuries. Yet, no injuries would have been sustained had the above lessons been applied prior to working.

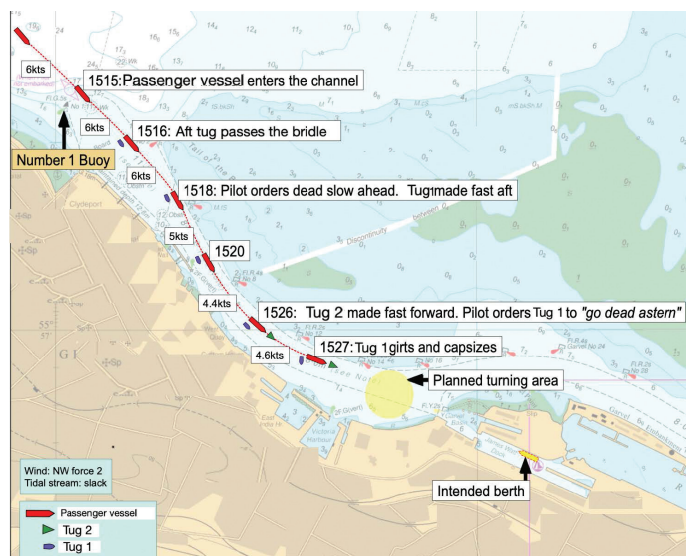
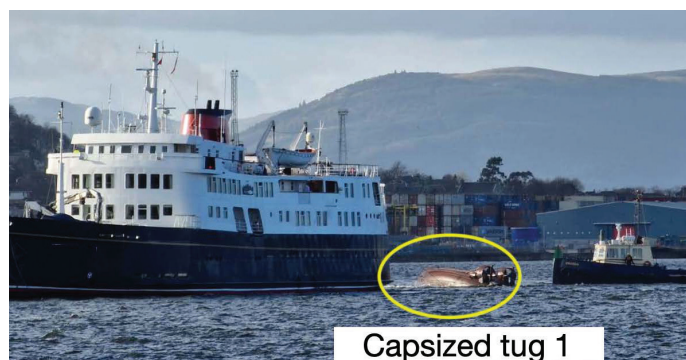
Capsized tug 1

On the aft tug's deck, the starboard bridle became taut. The tug's turn stalled with its heading now approximately 45 degrees to the right of the passenger vessel's track. The tug was quickly pulled sideways by the bridle and almost immediately heeled to port. It capsized within 10 seconds. Some of the aft mooring party on the passenger vessel threw lifebuoys overboard and looked for survivors, while one crew rushed to the galley for a knife to cut the tug's bridle.

The investigation found that, considering the speed (4.6kts), the tug had just over 10 seconds to reverse direction into its new position astern of the passenger vessel before its weight came onto the towlines. Instead, the tug's turn stalled and the bridle came under tension. The tug was using a gob rope, but this did not prevent the tug being towed sideways. The tug's emergency tow hook release was found to be operating correctly after the accident, but it is hypothesised that the crew did not have enough time to operate it before capsizing.

- The gob rope in this case was led through a bow shackle 2.8m behind the towing hook, about 0.5m above the deck and over 1m from the tug's transom. This gob rope arrangement was unlikely to be as effective as one rigged closer to the transom. It is therefore possible that this arrangement left the tug more vulnerable to being towed sideways and girted.

- The passenger vessel's speed at the time of the manoeuvre exceeded the 2-3kts recommended by both industry and the local port towing guidelines.
- Investigations into similar girting accidents found that it was essential that conventional tugs use a gob rope during towing operations to ensure the safety of the tug. To be fully effective, this rope must be correctly set and secured. A gob rope must be as low in the vessel as possible and as close as possible to the tug's transom.

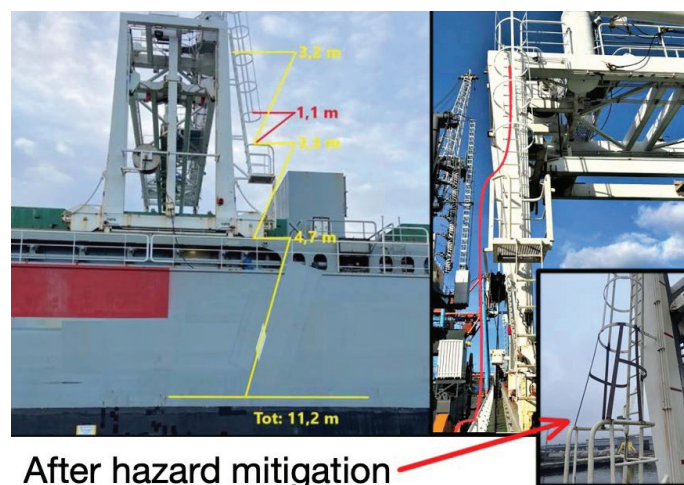
A crew member was climbing down from the gantry crane control area to the deck. While proceeding down the ladder, the crew member lost their footing on one of the upper rungs. They initially fell to a platform on the lower part of the gantry crane, but the momentum from the initial fall carried them over the platform railing and then down over the ship's side railing before finally landing on the quay.

The ladder in question was equipped with a protective cage and the platform under the ladder was equipped with a railing. Between the platform railing and the ladder's protective cage there was an unprotected space measuring just over 1m. The crew member fell through this space and down onto the quay. The total height of the fall was just over 11m.

- This accident again illustrates the benefit of doing the rounds of your vessel with 'new eyes'. Try and see where hazards exist but have always been in plain sight. We become too accustomed to hazards in plain sight; we see them as 'normal'.
- The victim had used a protective helmet with chin strap. The chin strap, an often-maligned PPE detail, was instrumental in keeping the helmet on their head during the multiple impacts of the fall and may have saved their life.

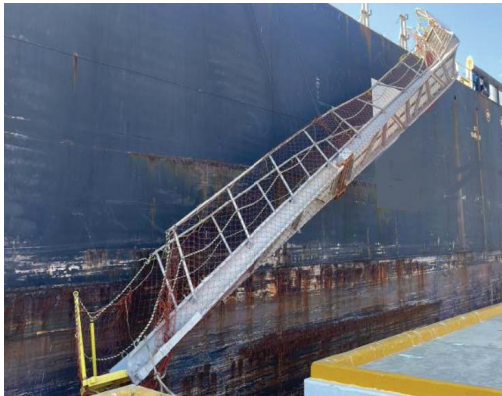
As the vessel was moving somewhat, both vertically (15 cm) and horizontally (30 cm), the ladder hit the dock and suffered damage before it could be raised above the level of the jetty.

- Consider your actions before executing them – bad consequences are a possibility so be situationally aware.
- Sometimes we rush to please others. Stay focused on safety.
