Mariners' Alerting and Reporting Scheme

MARS Report No 342 April 2021

MARS 202118

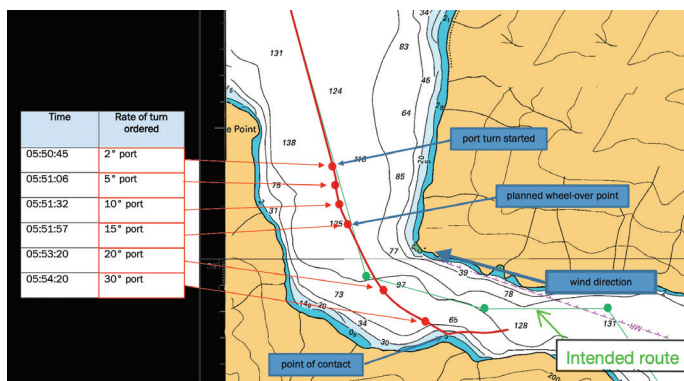
The vessel was brought to the middle of the channel while the Master and the remainder of the bridge team followed a vessel-grounding checklist. While this was happening the pilot continued to con the vessel to a safe anchorage. Inspections confirmed that the hull had not been breached although the dive survey revealed that the vessel's hull was indented along the starboard side for about 65 metres.

The investigation found, among others, that although the tracks were clearly displayed on all of the bridge equipment, at no time was a challenge voiced to the pilot until it was too late. Also, it is likely that the pilot became overly focused on the ROT thus losing situational awareness of where the ship was, where it was heading, and what other factors were influencing its progress.

- Darkness changes everything! Ask yourself, would this event have happened in daylight and good visibility?
- Correctly executed blind pilotage means using all instruments at your disposal as well as all senses. Why wasn't a parallel index used here as a backup check on the adherence to the planned track?
- Rate of turn is an excellent manoeuvring tool but under certain circumstances it is not a substitute for helm orders.

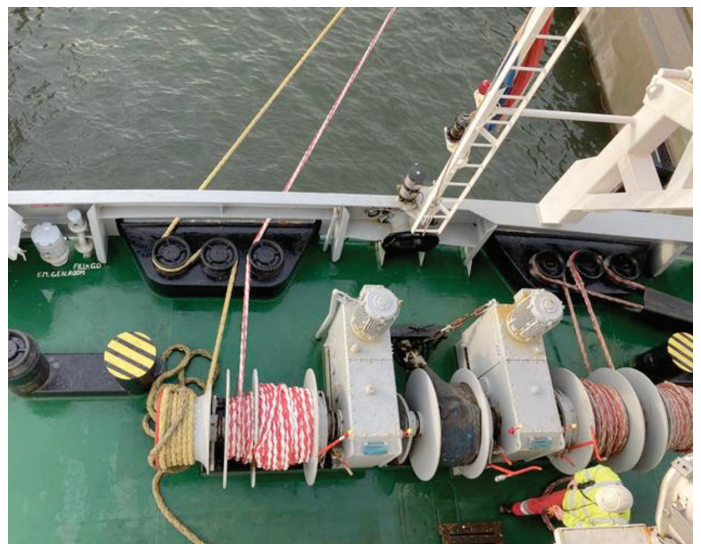
➔ A vessel was at berth and a MARS reporter who was not a member of the crew noticed some possible mooring arrangement problems. Below is a photo taken at the time.

- Improper leads of the mooring ropes around rollers including full turns and chafing situations.
- Ropes left on warping drum ends instead of being transferred onto mooring bitts.
- Too many turns on the working part of the split drum winch.
- No SWL marking on mooring bitts.
- Different types of ropes (so different breaking limit) working in same direction.

- Once again, new eyes can see hazards that may not be apparent to crew who are desensitised to the hazard.
- Unfortunately, poor design is also often at the basis of improper mooring patterns; something which is often overlooked during building.

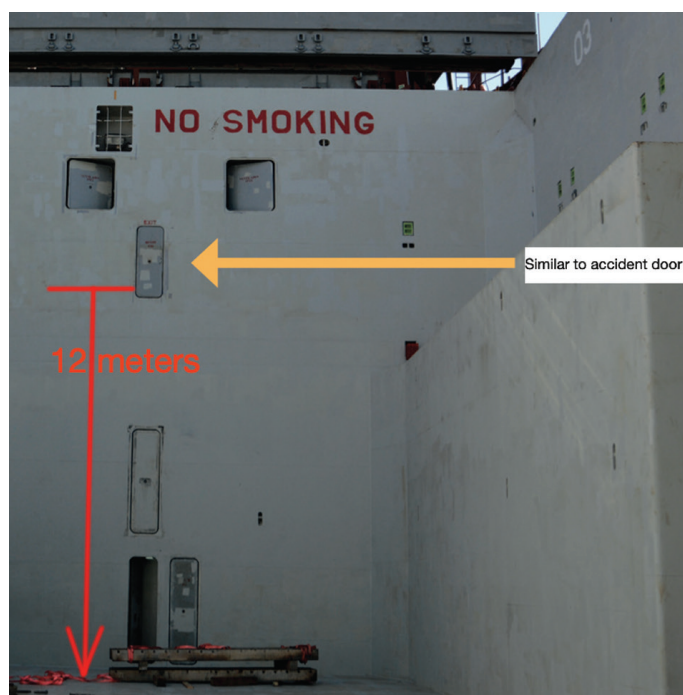
The investigation found, among others, that the victim had entered through one of the door openings in place for use with the tween-decks – even though he knew that hold 1 was now without a tween-deck. Because there was no tween-deck, he fell about 12 metres into the hold. At the moment of the accident, the lighting in the hold was not switched on and, because the hatches were closed, hold 1 was in complete darkness. The lighting in the stairwell was also not switched on and the victim was using a small torch light.

- On ships with multiple hold configurations, great care and failsafe precautions must be taken with doors leading to the hold. If these are not fully closed and locked prior to the removal of the pontoon decks, then grave accidents can occur, even to crew who are aware of the danger.
- We often become preoccupied with the task at hand. In this case the victim walked through (or fell through) a door that he knew was unsafe but had probably not stopped to think, too engrossed in his present task of search for stacking cones.
- Working in dark areas presents extra risks; always have local lighting illuminated for your work area if possible.

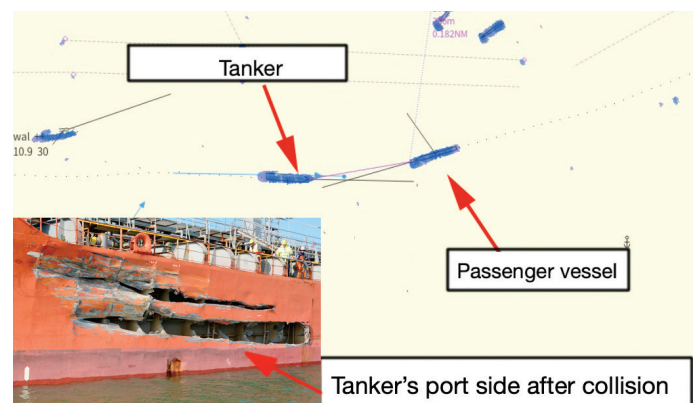
About 30 seconds before the collision (time of diagram), the pilot on the tanker issued a warning via the VHF and shortly afterwards ordered the helmsman to turn hard to starboard so that the tanker would not hit the river cruise ship amidships, which might cause catastrophic damage. In the meantime, VTS called the passenger vessel twice to turn to starboard, but without effect. Shortly afterwards, the passenger ship and tanker collided.

The investigation revealed that the crew of the passenger vessel had seen the tanker, but that based on their understanding of the communication, they believed that vessel would make a turn to port ('red side turn') resulting in a green to green passage. They had not understood that this plan had been refused earlier by VTS. The investigation also found that the English communication skills of the passenger vessel's bridge team were quite rudimentary. This may have contributed to their miscomprehension of the situation.

- Good communication is critical for safety.
- Meeting arrangements should ideally be made in good time and directly between the two vessels concerned, not through a third party.
- When in doubt, slow down.

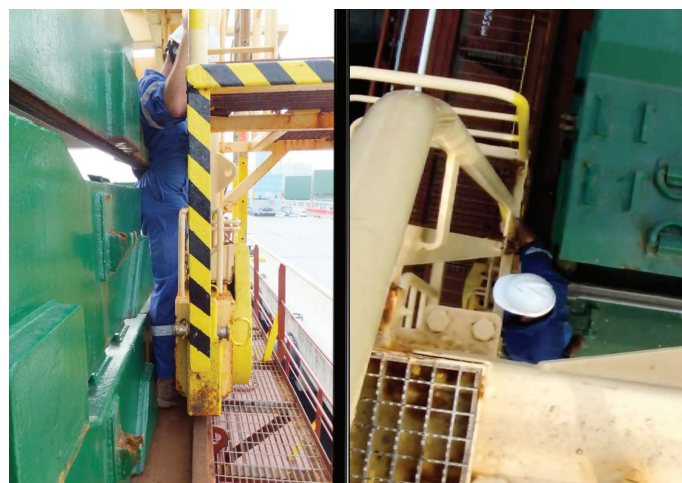
Simulation

- The victim was crushed because he attempted to walk between the vessel's gantry crane and a stack of cargo hold hatch covers. The C/O did not know that the victim was under the crane or what his intentions were because he was focused on raising the crane's lifting bar.
- The toxicology report showed that the victim had more than twice the legal limit of alcohol in his bloodstream. Almost certainly the consumption of alcohol was a significant contributory factor in this accident.

- Severe accidents involving gantry cranes are unfortunately not uncommon. The lessons learned from the past can be reviewed in MARS 201525, 201460 and 98058 for example.
- It goes without saying that alcohol consumption above the limits set for all mariners via STCW is to be condemned. Many companies have now adopted 'dry-ship' practice in order to help in the practical management of this norm.
- A strong safety culture is not a guarantee of zero accidents, but it is a bulwark against many potential bad outcomes.
- In this instance it was found that emergency stops for the gantry crane were not in sufficient number and those that were installed were badly positioned.

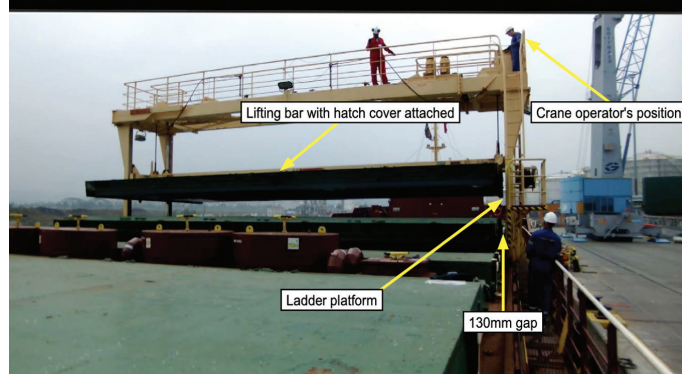
Overview simulation

- The safety culture on board the vessel was weak. Personnel were working close to moving equipment and unprotected edges, and were not wearing adequate levels of PPE. Also, alcohol consumption on a ship cannot usually go undetected. If this behaviour is tolerated then the conditions are set for a major undermining force in the safety culture on board.
