## In this bulletin...

### MARS 202619

### MARS 202620

### MARS 202621

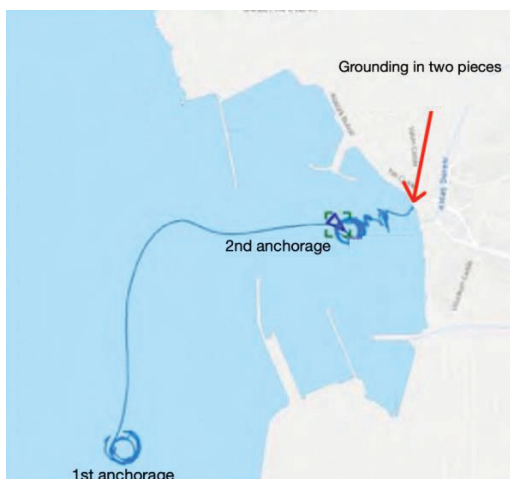
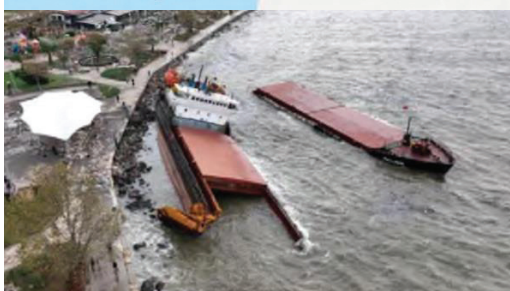
The Master called for tug assistance but due to the dangerous weather the tugs could not leave their berths. It was now too late for a plan B. With the shifting winds and waves, the vessel was exposed to gales and very large waves. Suddenly, with the hull stressed beyond its limits, the vessel broke in two and drifted ashore. Thankfully, all 13 crew were rescued.

- Even within the confines of port, weather-related wind and waves can affect your anchorage or berth.
- Keep one step ahead of events by having your Plan B ready. In this case, and in retrospect, the only option was to have berthed before the storm.

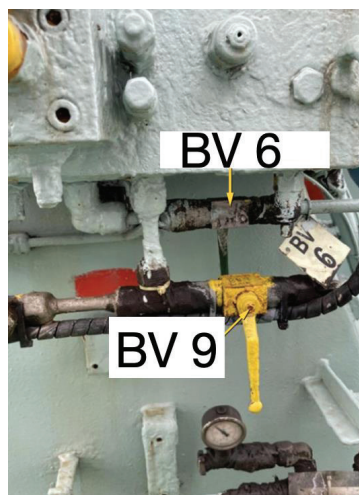
The FRC was recovered and the launch system inspected. It was found that a valve for draining pressure from the hydraulic system was mistakenly left in the open position. The preliminary investigation found, among other things, that ball valve 9 (BV9) had been mistaken for BV6. The operation of BV9 was not included in the procedure for launching the FRC using stored power. Once BV9 was put in the open position, there was no hydraulic oil pressure available in the system to arrest the fall of the FRC once the launch cable was pulled.

- Ideally, a procedure should fit on one page and be as simple as possible.
- In this case, the two valves were close together and the identification label for BV6 was sideways, so that it was not clear which valve it referred to (see photo - labels added to image). 9 and 6 can be confused when the orientation of the sign is not made clear.
- The BV9 valve was in the foreground and painted yellow, thus attracting more attention than the BV6 valve, which was in the background and more restrained in colour.

The stored power launch system was subsequently tested using the documented procedure with the correct valve sequence and proven to work without incident.

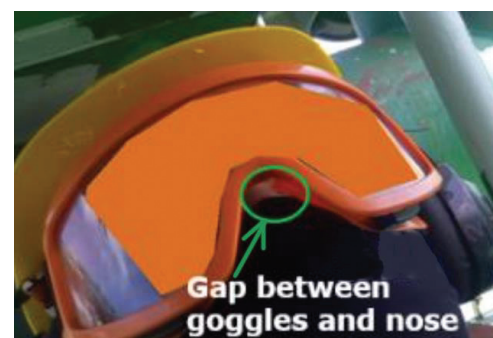
A crewmember was assigned to perform chipping on deck near the cargo manifolds crossover area. While chipping, a particle of rust passed through a gap near the nose in his goggles and into the eye. He did not go directly to flush the eye, hoping that the particle would come out by itself.

- Any incident involving an eye should be immediately reported and attended to.
- As a general good practice, always check your PPE before each use.
- When wearing safety goggles for chipping, there should be absolutely no gap between the skin and the glasses.
