# Mariners' Alerting and Reporting Scheme

MARS Report No 326 December 2019

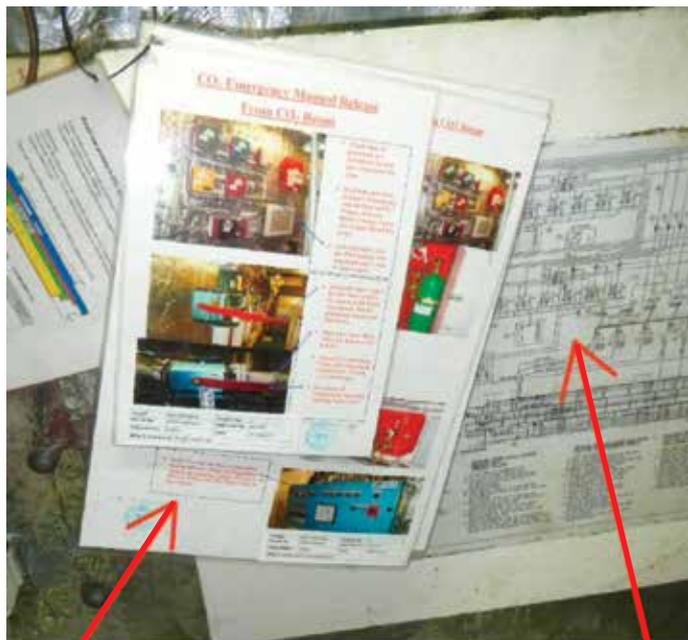
It was decided to use the CO<sub>2</sub> fire suppression system to combat the fire. Once it was confirmed that all crew were accounted for, the chief engineer initiated the extinguishing system. However, because there were two different versions of the activation procedure posted – one from the manufacturer, one from the ship – he found the instructions unclear. After about five minutes, he was finally able to activate the system, some 26 minutes since the fire alarm had first sounded.

Ship's operating instructions

Manufacturer's operating instructions

- Are there confusing, contradictory or competing procedures for CO<sub>2</sub> activation (or other actions) on your ship? Correct the situation before an incident occurs.
- Calling for help (PAN-PAN or distress message) is always a good idea when a fire breaks out. If it is brought under control you can always cancel the message.
- Always ensure all crew are accounted for before CO<sub>2</sub> is activated.
- Always check before and after CO<sub>2</sub> activation that all ventilation to the space is well and truly closed.

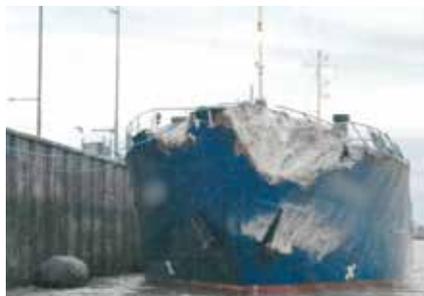
The Master arrived on the bridge at the moment of the collision with the pier. The starboard side of the vessel was severely dented and a small crack had formed level with the waterline. The Master sounded the general alarm and issued instructions for the two ratings to check inside the ship for damage. Realising that it was not possible to control the rudder from the bridge, he went to the steering gear compartment where he switched to the backup rudder system, carried out a test, and found that the rudder now responded. He then started the main engine and began to manoeuvre the ship astern and away from the pier.

After the accident, a service company discovered that the contacts of the steering switch were loose and corroded. Accordingly, in addition to the primary means of steering, the backup means of steering also failed.

- When the steering fails in restricted waters, time is of the essence and the stress on watchkeepers can be intense. Practice drills involving scenarios of this kind should be undertaken to help crew prepare for such eventualities.
- With only four crew on this vessel it is hard to imagine how a full and effective response to the steering failure could have been undertaken in time.

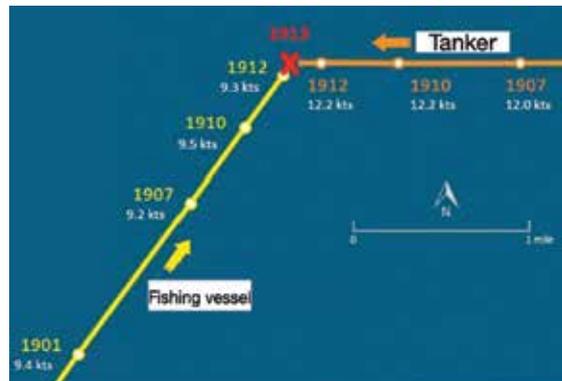
Meanwhile on the fishing boat, the lone watchkeeper had been cleaning when he heard a metallic sound, which turned out to be the first contact of the fishing vessel's outriggers with the side of the tanker. He tried to turn the vessel but it was too late and it made heavy contact with the tanker.

Fishing vessel

Tanker

- Many collisions can be attributed to ineffective lookout and low situational awareness. This accident is yet another example.
- Never assume the give-way vessel will pass ahead or astern; plot the targets and follow the situation until all clear.
- Undertaking other duties that distract from your navigation responsibilities, as on the fishing vessel in this instance, is a recipe for an accident.

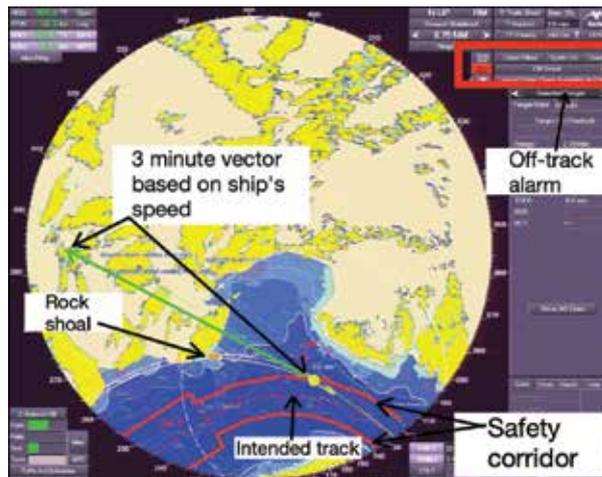
Under the pilot's con, the first alteration of course to port was initiated using three degrees of port helm. At this time the vessel had a speed over ground (SOG) of nearly 18 knots. The initial helm order was followed by successive increases to five and then 10 degrees of rudder. About one minute after the initial three degree port helm order an off-track alarm flashed on the ECDIS, but this information was not brought to the attention of the Master or the pilot. The alarm appeared only as a visual indicator on the radar screen because its audio had been muted prior to the ship entering the channel (see VDR screen capture).

Yellow dot ● shows position of vessel when off-track alarm flashes

- Plan safely and then execute safely. In this case the intended route, as entered in the ECDIS, was a good plan, but it was not adhered to.
- Muting alarms on an ECDIS is not considered industry good practice.
- If conditions allow, consider reducing speed for manoeuvres in restricted waterways. This will give more time for the bridge team to react to deviations in the plan.
