Mariners' Alerting and Reporting Scheme

MARS Report No 358 August 2022

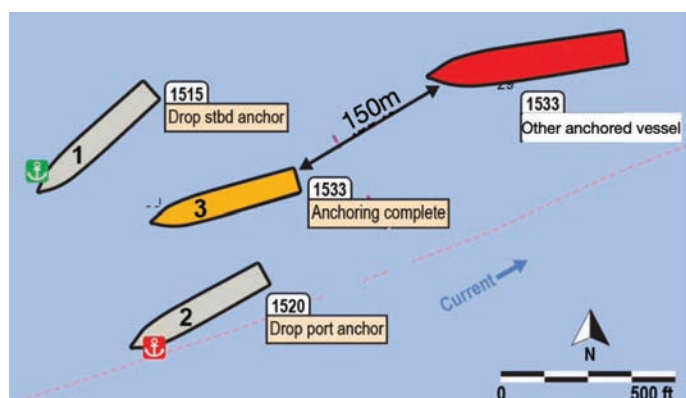
The starboard anchor was let go (position 1 in the diagram). The vessel then manoeuvred to port and, five minutes later, the port anchor was also let go (position 2). The starboard anchor was heaved to four shackles on deck and the port to three shackles in the water. About 15 minutes after the port anchor was let go the pilot informed the Master that the anchoring was finished. The pilot was satisfied with the situation (position 3), but recommended keeping the engine on short standby due to the inclement weather that was due to arrive and the strong river current. Another issue was that the vessel's stern was only 150 metres from the bow of another ship anchored astern (shown in red in the diagram).

The pilot left the vessel a few minutes later. Unknown to him, the vessel was not in a stable condition and continued to yaw between the two anchors.

- The first minutes after anchoring are important. Special attention should be given to ensuring the vessel's anchors are indeed holding and the vessel is stable.

- Given the distance of just 150 metres from the stern of the vessel to the bow of the other anchored vessel, the anchor watch alarm radius setting of 180 metres was too large to provide a timely alarm of the ship dragging.

- When at anchor, all means to detect vessel movement should be employed. In particular, the radar should be used to crosscheck ranges to shore or other anchored vessels.

- In this case, there were four shackles on deck on the starboard anchor and three in the water on the port anchor. Best practice with opposing forces ahead (such as in a river current) would be to have equal amounts deployed on each chain to avoid unequal distribution of stress. Unequal distribution of stress could result in one anchor taking the load, then dragging and putting the load on the other anchor, which in turn takes the load, and then drags. This in effect nullifies the advantages of deploying two anchors. Readers may remember another recent MARS report where dragging anchor in a crowded anchorage caused problems; M202216.

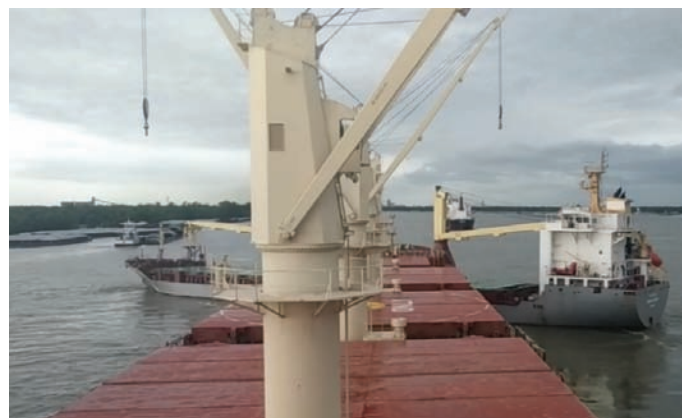
At 1639, the OOW became aware that they were now too close to the other anchored vessel. He contacted the engine room and engine control was received on the bridge nine minutes later. The Master began using full ahead engine, along with the bow thruster and rudder, to reduce the swing and bring the ship ahead. By this point, the ship was unable to turn to starboard away from the other anchored ship. At 1655, with the first vessel now broadside to the current and pushing on the bow of the other anchored vessel, both vessels were now dragging anchor.

Tugs were requested to help hold and stabilise the vessel. The first tug arrived on scene about 30 minutes later. A further 30 minutes passed before pilots arrived on both vessels, but more tugs were needed to extricate the vessels from their position. Although these arrived some time later, the vessel nonetheless hit a shore dock at a speed of 6 knots before its bow grounded on the river bank. Damage to the two vessels and the dock were estimated at \$16.9 million.

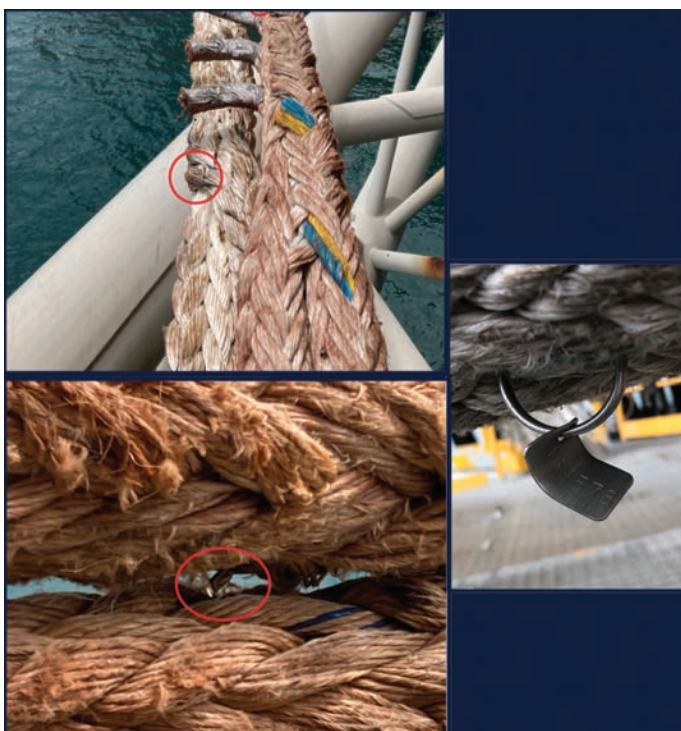
➔ During berthing operations at a loading terminal, the line-handling crew were surprised to find metal rings and tags entwined within the yarns and strands of a vessel’s lines. These objects present a potential catch point and/or finger entrapment hazard for anyone handling the lines. There is also a risk that these objects could detach and become projectiles when lines are under load or when lines are being run. This was the fourth vessel in six months to have lines with such hazards. The terminal authorities grew concerned and made a MARS report.

It is likely that the rings and tags are items associated with materials used to pack the lines themselves. It is also possible that these objects could have become embedded within the lines during usage.

- When bringing a new line into service, ensure all packing and extraneous materials are removed from the line before use.
- It is good practice to observe and inspect berthing lines at every use; as they go out and when they come on board. The inspection should cover the general state of the line, but be aware of any objects that may embed themselves into the fibre of the rope during usage.

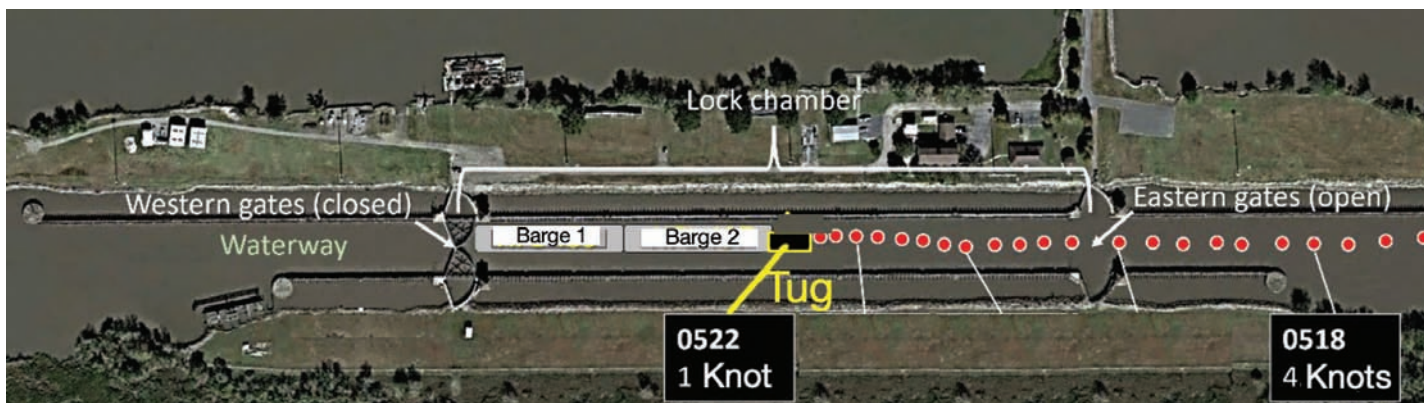
With the tug and barges now at a speed of about two knots, the Master received a distance report from the deckhand and, realising they were close to the front of the lock, put the engines to full astern. The tow continued to slow but was still making about one knot when the starboard bow of the forward barge (1 in picture) struck the closed western lock gate.

The official investigation found that the Master’s performance and decision making were probably negatively affected by sleep inertia. Sleep inertia can be a factor for 30 minutes or more after waking, especially in demanding situations that require high levels of attention and cognitive demand. Further, waking during a circadian low, such as in this case at 5am, and partial sleep deprivation, can amplify the effects of sleep inertia.

- The company operations manual required that a change of watch was not to occur during ‘a critical move’. Examples included operations involving ‘bridges, locks, and docking operations’. The requirement is one of common sense and, in this case, does seem fully justified.

- Fatigue has many negative effects on performance and is notoriously hard to objectively assess by its victims. Sleep inertia is a silent companion to fatigue and mariners would be well served to be aware of its existence.

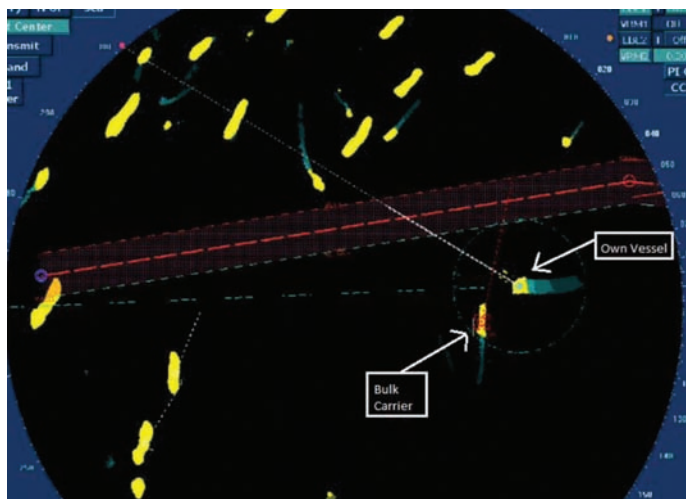
➔ In darkness, a vessel was proceeding to a busy anchorage under the con of a pilot who had just boarded. The pilot and the Master engaged in small talk as they proceeded and there was also an OOW and a lookout on the bridge. Another vessel underway in the vicinity had recently altered course to port and, unknown to the bridge team or pilot, was now in a potential close quarters situation. Almost 10 minutes passed before the potential close quarters situation was observed by local VTS and the bridge team alerted to the danger by VHF radio.

Only now, with the other vessel just 0.3 nm away, was it plotted. There was initially some confusion as to the speed of the other vessel as the value was changing; but this was to be expected in the first minute after plotting as the ARPA target acquisition algorithm needs to refine the calculations. Emergency course alterations were made and the bridge team tried to communicate with the other vessel by VHF radio. As the distance decreased between the two vessels, the bridge team, now under some stress, sounded a long blast on the fog horn. Finally, the other vessel passed astern only 35 metres away.

- A common mistake when a pilot boards is for the bridge team to relax; the unstated assumption is that the pilot has everything under control. Not so! The bridge team must continue to do their jobs in full support of the pilot and visa versa.
- As part of a bridge team, never assume that someone else will see it. It is possible for any member of the bridge team to make an error or miss a cue. YOU may be the only one that identifies a potentially hazardous situation, and for this reason, every bridge team member should be alert.
- The danger signal is at least five short blasts.
