Mariners' Alerting and Reporting Scheme

MARS Report No 338 December 2020

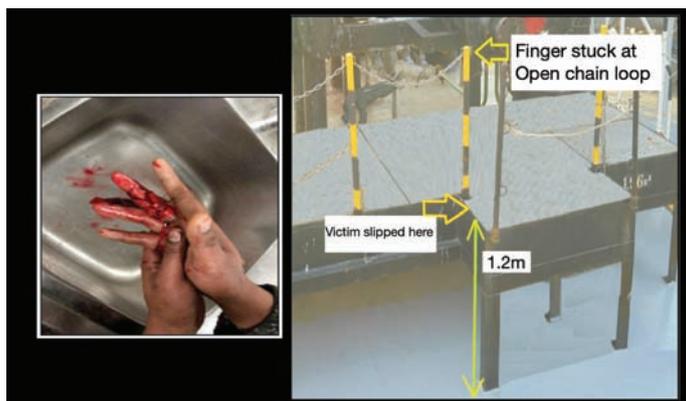
While adjusting the suspended cargo hose, the belt sling shifted and the crewmember tried to hold the belt in place. He was standing near the edge of the cargo manifold drip tray, and his actions caused him to lose balance. The safety chain was not in place, so to avoid falling he tried to hold on to the closest stanchion and then leaped down to the main deck about 1.2 metres below. In doing so, his right-hand middle finger got stuck in the open half link that served as a support for the safety chain. He suffered a deep cut and was given first aid and sent for shore medical assistance. The victim was repatriated for further treatment as per shore medical advice.

- Had the victim been wearing safety gloves at the time the injury could have been avoided or much reduced.
- Sometimes, safety equipment itself can be a hazard. In this case, open half-links were used to support the safety chain on the stanchions, but these can be a snag hazard. Closed loops with shackle connections would be a safer, non-snagging option.
- Do a safety audit around your ship today. Are there any hazards 'built-in' to your safety gear?

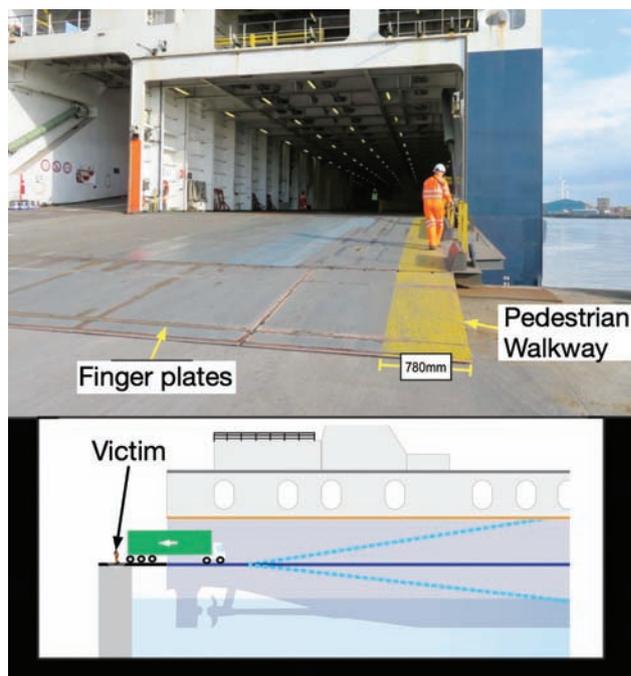
As the officer talked on his phone, he remained standing on the stern ramp's starboard side, gradually moving down the ramp towards the quay with his back to the vessel. Meanwhile, the semi-trailer being pushed down the ramp was approaching. Another tractor driver, in his cab on the quay, saw the danger and sounded his horn to give warning. Approximately three seconds later, the rear of the semi-trailer struck the victim, fatally injuring him.

The official investigation found that the tractor driver's view ahead was blocked by the semi-trailer; the victim would not have been visible to him. Furthermore, he was not expecting pedestrians to be standing on the ramp directly ahead of his vehicle. The victim had probably not heard the semi-trailer approaching as the sound of the tractor's reversing alarm and its engine would have been masked by the ambient noise of the vessel. Also, the reversing alarm would have been absorbed or reflected to some degree by the semi-trailer between the tractor and the victim, to say nothing of the victim holding a phone to his ear and being absorbed in a conversation.

- Updating loading procedure for the lower vehicle decks to ensure that discharge from the lower hold is by forward driving only.
- Updating company guidelines to prohibit pedestrians, including crew members, from being on the stern ramp at the same time as moving vehicles unless actively engaged in the loading/unloading of abnormal loads or vehicles with low ground clearance.

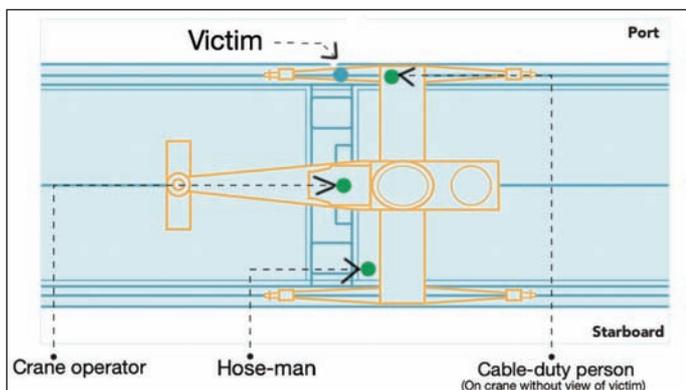
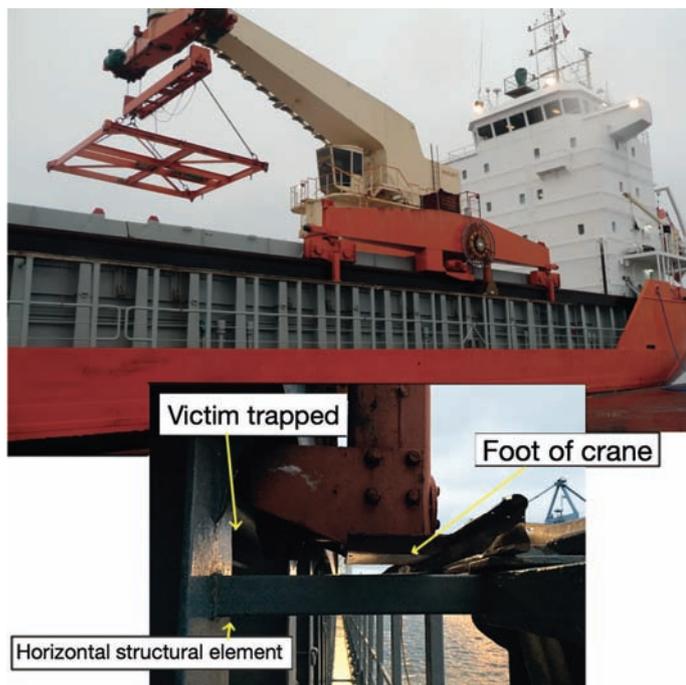
The port side was cleaned without incident and work started on the starboard side, proceeding from aft to forward. The crane operator was looking astern and the hose-man on the crane was spraying the coaming on the starboard side. The hose guide had last been seen extending the hose on the starboard side. He was contacted via his VHF, but he did not respond. Shortly afterwards, the hose guide was found lying on the deck on the port side, having been struck by the crane. Assistance was given but the victim succumbed to his injuries.

The official investigation found that it was probable that the victim had been seeking to close the cap on the hatch coaming drainage pipe, and had been struck by the moving crane in the process. The investigation was unable to establish why the victim had climbed up at exactly the moment the crane passed by.

- An audible gantry crane alarm, such as the one in this accident, is not a guarantee that all will go according to plan.
- Gantry crane operators are essentially driving blind as they often cannot see if the track is clear of personnel.
- This is not the first gantry crane accident and unfortunately probably not the last. Some additional safeguards appear necessary during gantry crane operations for the situation to become safer. Some past MARS reports can be found at 201525, 201460 and 98058.

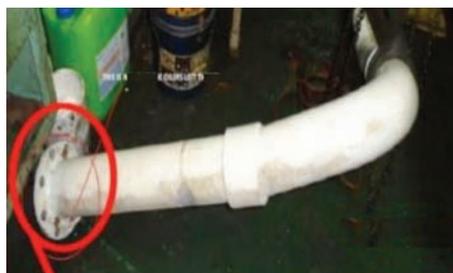
The attending crew attempted to shift the pipe to pass between the other pipes. One crew was standing in an awkward and improvised position, holding the pipe to maintain his balance. When the pipe swung clear, the flange crushed his left thumb. The victim was taken to the ship's hospital for first aid but quickly transferred to a shore hospital. After several days he was repatriated.

- Additional hazards for heavy lifting procedures in confined spaces were not accounted for as the victim was maintaining his balance in an improvised manner.
- No extra ropes were used to control and support the pipe, leading to the uncontrolled movement of the heavy pipe.

Flange / Pipe hit thumb

- Manipulating heavy objects in awkward positions requires good planning and execution to avoid bad consequences.
- 'Hands on Handle Only' (that is: only objects that have handles are to be lifted/moved by hand): other loads can be guided using tag lines and/or push pull sticks.
- This was a simple task that nonetheless resulted in a repatriation. No task is too simple to take for granted!

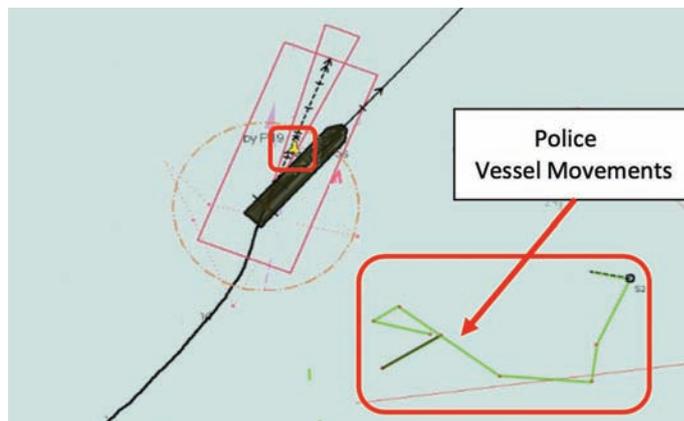
Speed was further reduced and soon the STS Mooring Master arrived along with two tugs. The tanker, now almost stopped, was affected by the NW current. Shortly after the STS Mooring Master had boarded, the tanker's port side lightly made contact with an anchorage buoy. The buoy slid aft along the hull and its chain became entangled with the vessel's propeller and rudder. The mooring and STS operation was aborted and the tanker anchored with tug assistance. The chain was cleared with the help of divers. Some minor damage to the propeller was recorded.

- Even in perfect weather conditions and full daylight, a bridge team can lose situational awareness. It is possible that the boarding of the STS Mooring Master combined with the erratic movements of the police boat and other congestion preoccupied the bridge team and caused the tanker's movement towards the buoy to go unnoticed until it was too late.
- One bridge team member should be tasked with overall situational awareness at all times, but especially when in congested waters and under close manoeuvring.

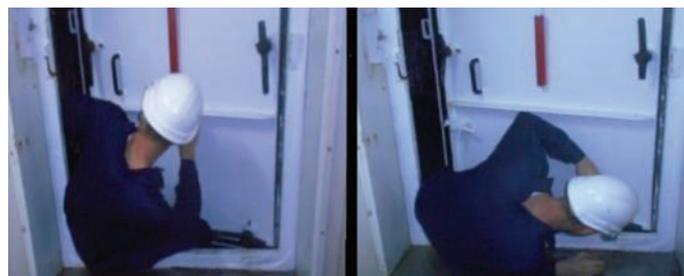
Simulation

➔ A vessel was en route in heavy weather and high winds. A crewmember attempted to exit the accommodation from the port side accommodation door on the upper deck, but had chosen the weather side of the ship. As he opened the door and stepped outside, the strong winds pushed the door back against him.

The door hit the victim in the face and he lost his balance and fell down. Two other crew observed the incident and immediately proceeded to help the victim, who was transferred to the hospital, where first aid was provided. He had sustained a gash of approximately 4cm across his face.

- Weather conditions affect almost every activity on board. Be aware!
- Always try and use the doors that are in the lee, protected from the wind.
