Mariners' Alerting and Reporting Scheme

MARS Report No. 319 May 2019

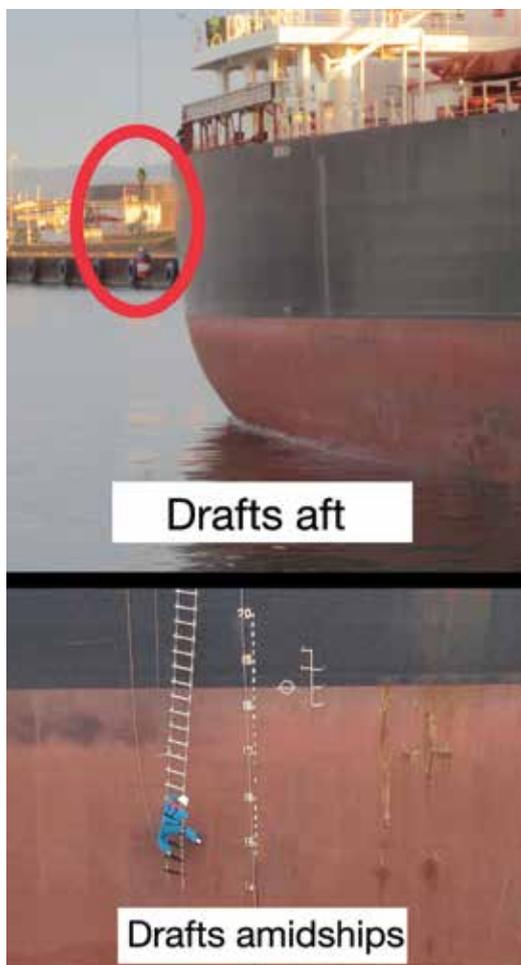
→ The following photographs were sent to MARS by one of our readers. For the aft draughts, the crew member can be seen being lowered over the side in a barrel via the ship's stores crane. To take the draughts amidships, he has climbed down the pilot ladder and, now near the end of the ladder, is struggling to view the draughts below.

Taking the outboard draughts on large vessels may seem a daunting task, and can be dangerous. But need it be? Although the crew member in these photographs appears to have a lifejacket on, what is wrong with this situation? Is there a safer way to take your draughts?

- Every task should be analysed for associated hazards. The work method adopted should be the one that decreases the associated risks to persons to the 'as low as reasonably practicable' (ALARP) level.
- What is the safest way to take your outboard draughts? Think about it, and continue reading below!

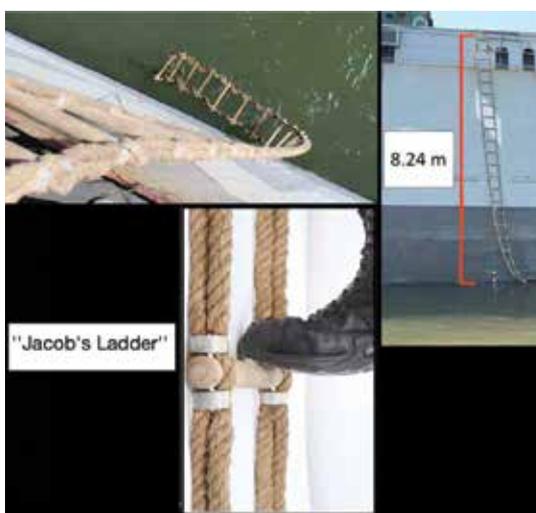
After about 14 hours of loading, and now in darkness, the duty deck officer was tasked with taking the draughts. He disembarked on the dock and took the three inboard draughts, reporting these via VHF radio to the vessel's cargo officer. He then proceeded to take the outboard midship draughts, descending the same Jacob's ladder, which was still rigged amidships on the port side from the morning's draught survey.

- The Jacob's ladder was rigged to the guardrail in such a way that there was no safe means of access; to reach the ladder from the deck it was necessary to straddle and step over the guardrail
- The Jacob's ladder was unsuitable for the task of reading the midship seaward draught marks. The ladder was unsuitable for a number of reasons, not least the very small tread area available for a foothold.

- The ILO's Code of Practice 'Accident prevention on board ship at sea and in port' states that persons working overboard should observe the following safety precautions:
 - Fall protection system and PFD to be worn
 - Another crew member should supervise and assist as needed
 - Lifebuoy with a safety line readily available
 - Risk assessment conducted and work permit issued
 - Although it is common practice to read the outboard draught marks from a rope ladder, a launch or small boat is more stable and brings the observer to a safer position closer to the water line
 - Even when taking the inboard (dockside) draughts, always wear a PFD, as dock edges can be slippery.
- **Editor's note:** For another unfortunate draught reading accident, see MARS 201822.

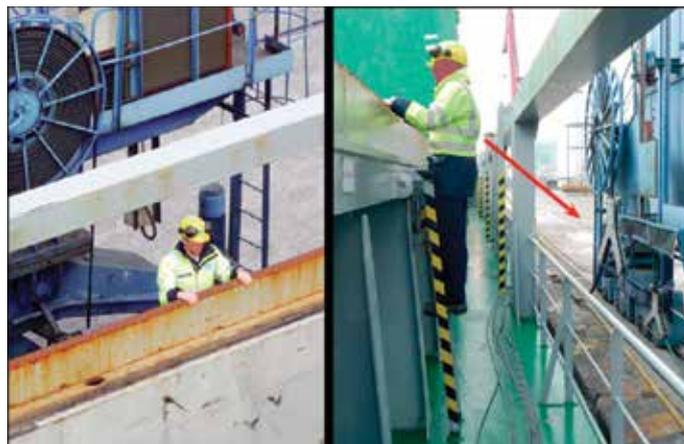
As the pontoon was positioned above the hatch coaming, the supervising officer instructed the crane operator to swing the pontoon to the left and then slowly lower it. A short time later the seaman near the gangway noticed someone had fallen overboard amidships, between the quay and the vessel. The seaman raised the alarm on his VHF, grabbed a lifebuoy and ran to the position where he presumed the victim – the supervising officer – had fallen into the water.

- Recurring operations, even the most mundane, should be carefully analysed for potential hazards and the associated risks brought to ALARP levels.
- There should always be a direct and unobstructed view between the crane operator and the person controlling the lift.
- Some risks for falling overboard can be 'hidden in plain sight', as in this case. Do a walk around on your vessel and see if you can find any.

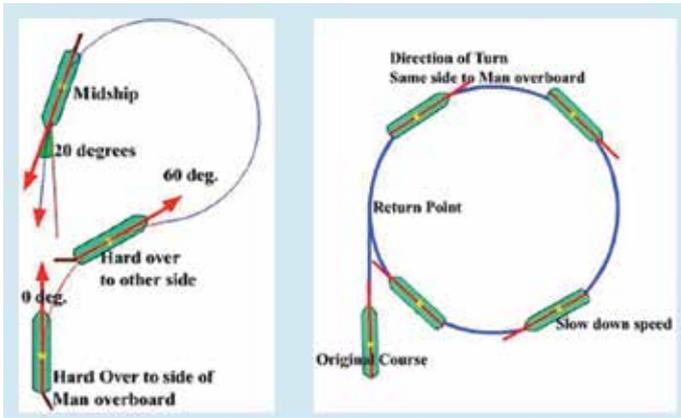
Williamson Turn

Anderson Turn

■ **Editor's note:** The Williamson turn is especially useful in reduced visibility as it brings the vessel back on a reciprocal course and into its own wake. However, with good visibility the Anderson turn should be employed as it is a quicker turn.

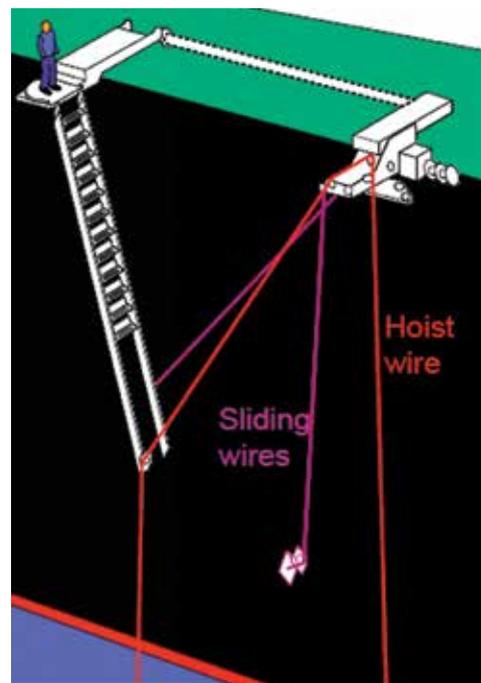
Suddenly, a loud bang was heard followed by a whirring sound as the ladder fell rapidly towards the sea. The lower ladder broke away and fell into the water, taking the attending crew member with it. The upper section of the ladder was left hanging vertically down from its upper platform hinges with the hoist wire dangling from the davit.

Collapsed accommodation ladder

- Accommodation ladder failures, although rare, are certainly not unheard of and numerous lives have been lost as a result. Risks involved in rigging and securing accommodation ladders should be duly accounted for.
- As in several of the MARS reports in this issue, the attending crew did not take basic precautions such as using fall protection and donning a PFD. The lack of these precautions cannot be solely attributed to the crew. The company and vessel leadership must also bear responsibility.
- The failure in this case to release the lifebuoys and smoke floats once the victim was in the water was particularly significant. It denied the ships involved in the search a visible reference, and also potentially denied the victim the buoyancy he required to remain afloat.
