## In this bulletin...

### MARS202538

## MARS 202538

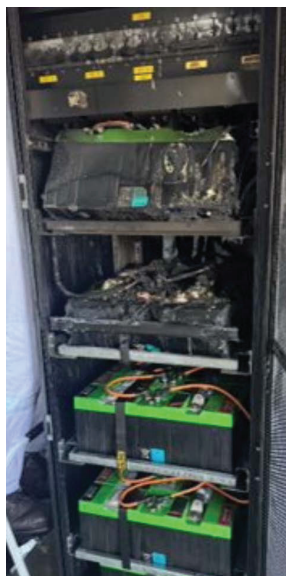
An integrated Li-ion battery bank recently caught fire on board a passenger vessel. It was found that loosely crimped lugs overheated and initiated the fire. No one was injured and the vessel sustained minimal damage, but this casualty highlights the safety hazards posed by Li-ion batteries.

The resulting investigation found, among other things, that all Li-ion installations used for propulsion, control and electrical power must undergo an engineering plan review and be fitted with supporting safety systems. Additionally, these systems should be tested and inspected at installation and periodically afterward, and be properly maintained by competent mariners, regardless of the battery bank size or end consumer.

- Batteries should be visually inspected for signs of deterioration, such as bulging cells or corroded electrical connections. Documentation on the

completion of required maintenance should be maintained.

- Crew members responsible for battery operation and maintenance should be trained in the manufacturer's guidelines and operational procedures and familiar with the functioning of the battery management system.
- Crew should know how to respond to abnormal battery conditions or fires. Safety drills for Li-ion battery fires should be performed, and Li-ion battery system arrangements and risks should be considered when conducting other drills.

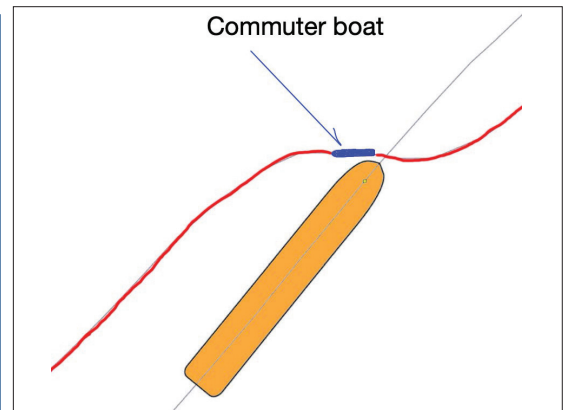
In fog, a passenger vessel was outbound in restricted waterway at 15 knots. The bridge team noticed an inbound commuter boat on the radar that appeared to be trending to its own port side. They decided to head slightly to port as well to give more room, presuming a starboard-to-starboard meeting, although no communication with the commuter boat had taken place.

Meanwhile, on the inbound commuter boat with 10 passengers on board, the Master was having problems with the starboard engine. An alarm was incessantly sounding. In attempting to silence the alarm the Master 'emergency stopped' the engine by mistake. He was then in telephone contact with the company's technical support while he and the deckhand tried to restart the engine. While still making 13 knots on the port engine, the Master was also manually steering the vessel. During this time, they had imperceptibly made way to their port side, that is, to the opposite side of the fairway. Soon after the starboard engine had been re-started, the two crew members on the bridge realized the outbound passenger vessel was almost directly in front of them.

The Master of the commuter boat applied engine power and turned sharply to starboard. The bridge team on the outbound passenger vessel saw the commuter boat coming out of the fog towards them and turning sharply to starboard, so they also initiated a turn to starboard. The vessels passed clear of each other by 10m.

- Steering manually in fog needs your 100% attention.
- Making 13 knots can reasonably be considered too fast given a restricted waterway in thick fog while meeting other vessels and attending to other tasks.
- Always adjust your speed to the weather conditions and the operational circumstances.
- Assuming an unconventional meeting such as starboard to starboard in a restricted waterway and low visibility without validating with the opposing vessel is a risky proposition.

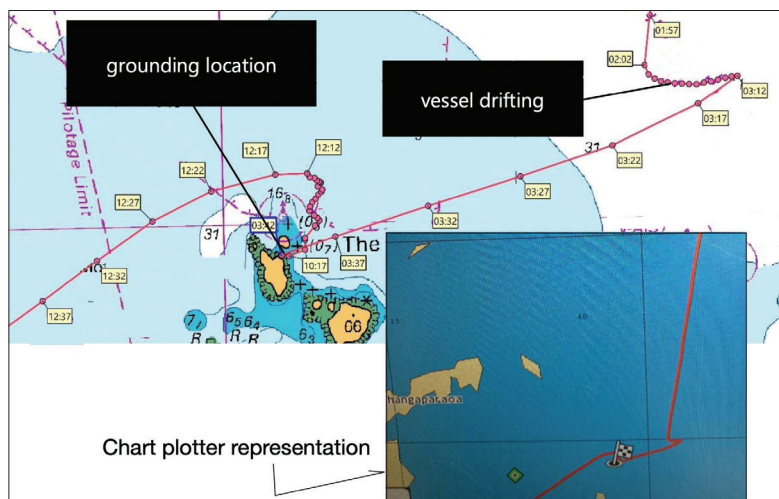
When the Master and the chief officer took over the watch the next morning it was still dark. Using the chart plotter, which was not an ECDIS, the Master set the course straight to the pilot boarding area. About 40 minutes later, the vessel ran aground on charted rocks at the periphery of an island at a speed of about eight knots. The vessel did not have the proper large-scale charts for the area, and the chart plotter did not show the rocks.

A small hole was observed in the bow as well as a damaged propeller. Luckily, the vessel could be refloated at high water and towed into port.

The investigation determined that the Master had based his decision on an incorrect understanding that they had safe water. Had an appraisal been conducted and a formal voyage plan prepared based on the applicable charts and nautical publications, it is virtually certain the navigational hazards would have been identified and a course set that kept the vessel clear of those hazards.

- It may seem like a 'beginner's mistake' not to have a proper passage plan and appropriate scale charts (or ECDIS), but the professional mariners involved in this accident were not amateurs.
- Relying exclusively on a chart plotter for positioning is obviously a mistake but other groundings have occurred while using fully compliant ECDIS. In particular, the safety depths (and/or contours) have been incorrectly entered, among others, thus showing safe water where none was for the vessel in question. See MARS 201505, 200930, 201660, 201875.

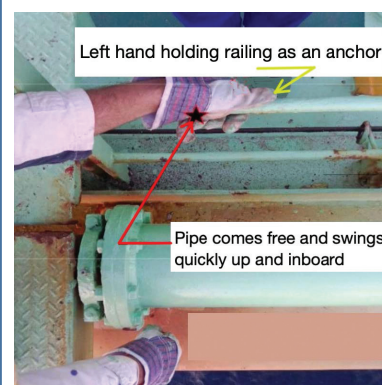
Deck crew were removing the starboard gangway's torsion tube for repairs. After removing the nuts and bolts, the tube remained stuck in place, probably due to paint and corrosion. To free it up, a crew member hammered the tube with his right hand while holding the shipside railing with his left hand as an anchor. Two other crew members were assisting, pulling at the other end of the torsion tube.

When the tube came free it swung up and inboard with force, hitting the left ring finger of the crew member holding the ship side railing. The finger was caught and crushed between the flange of the tube and the railing, resulting in a complex fracture.

Bird's eye view of the accident

- Some jobs appear mundane and routine, but every task can have hidden risks. If things don't go as planned, stop and re-evaluate. What is the best way to solve the problem?
