MARS 202528

One grounding not enough to warrant attention

MARS 202529

Wake up with a bump

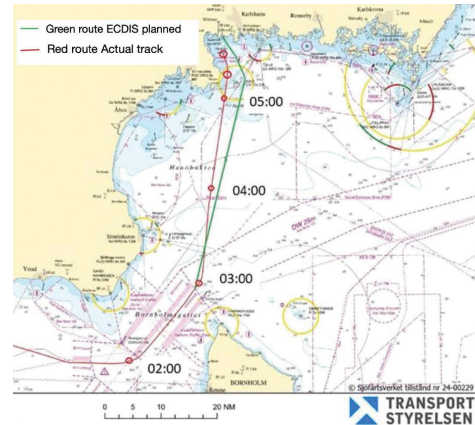
At 05:13 the vessel passed on the wrong side of an eastern cardinal mark that marks a shoal. The first grounding took place at this time. As the vessel passed over the shallow area, its speed decreased from 17 knots to 9 knots and there were strong vibrations, which continued for around 20 seconds. The chief officer, now on the bridge, observed that the X-band radar was missing a GPS signal and the OOW responded that this issue had persisted since the watch change. Once the vessel had passed the shoal and entered deeper water, speed increased again to 17 knots. The crew made no adjustments to the engine controls during the grounding because they did not realise they were off track and had touched bottom.

When the vessel entered shallower water, the vessel speed decreased and a second grounding occurred at 05:24, with strong vibrations again occurring. The vibrations ceased when the vessel came to a stop, but the bridge team were still unaware that the vessel had grounded. The engine controls were reduced to slow and the engine room crew assured the bridge team that the engines were functioning normally. The Master decided to continue the voyage into port, so he increased the engine control, but the speed remained at zero. He interpreted this as the vessel having lost propulsion, but the chief engineer assured him that the engine was functioning as expected.

The Master called the coastal Joint Rescue Coordination Centre (JRCC) to inform them of the situation. The JRCC operator checked the vessel's AIS track and realised there was an error. He informed the Master of the vessel's true position. After a second call, the Master checked and found they were truly aground and not in deep water.

vessel. The salvage operation lasted 11 days and included a third grounding before it was successful. Heavy fuel oil had escaped from the vessel and the environmental response was a protracted, complicated affair involving several organisations.

- OOW handover must be complete and detailed. In this case an important navigation alarm was not properly investigated nor communicated to the handover watchkeeper.

- Never rely on a single navigation appliance! The bridge team, even the Master, were fixated on the ECDIS display. A simple position check, ideally using two distances on a radar, would have shown their true position.

- If you see a 'dead reckoning' notification appear on your radar or ECDIS, immediately do a position check.
- Navigate your ship! In this case the vessel grounded twice; the first time 11 minutes before the second. Vibrations were felt and a large reduction in speed experienced, yet these unusual signs were not enough to convince the Master or OOW to verify their position by alternative means. Had they done so the second grounding (and the third, and the pollution) could have probably been avoided.

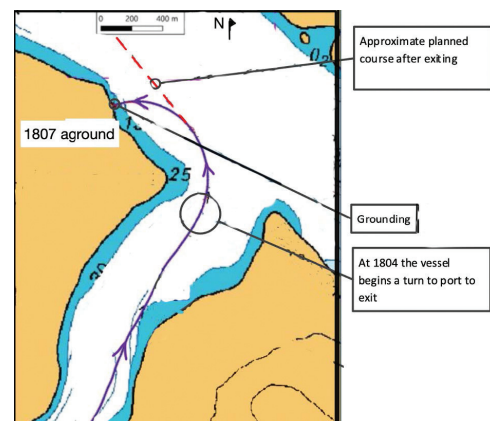
At approximately 1804 the Master began a turn to port. Three minutes later the vessel ran aground while at a speed of about 10 knots. Sitting in the conning chair, the Master woke from a micro-sleep when the vessel came to a sudden stop. The situation was quickly assessed and emergency response was begun; passengers were mustered using the public address system and the onshore manager was called to alert them to the accident.

had roles mustering passengers and assessing them for injuries. The vessel damage included a small hole below the waterline, but the rate of water ingress was not a material threat to the safety of the vessel. The use of a small bilge pump was enough to clear incoming water.

The investigation found, among other things, that the Master was very likely suffering from workload-induced fatigue that had not been recognised or mitigated by the operator's safety management system (SMS). The fatigue may have been compounded by a potential drowsiness side effect from a prescribed medication the Master was taking, but it was not possible to make a positive determination on this hypothesis.

- Micro-sleep exists, even while undertaking an active manoeuvre. If you can fall asleep at the wheel of a car, you can fall asleep at the con of a vessel.
- Sitting while navigating is one step towards further relaxation. Standing and moving (between navigation instruments?) means you are unlikely to experience a micro-sleep and may help your situational awareness.
- 'Sleep hygiene' is a critical element of safety in the transportation industry, yet one that is mostly self-managed. Take it seriously.
- Be aware of the potential side effects of certain prescription medications and how they can affect your performance.
