# Mariners' Alerting and Reporting Scheme

MARS Report No 334 August 2020

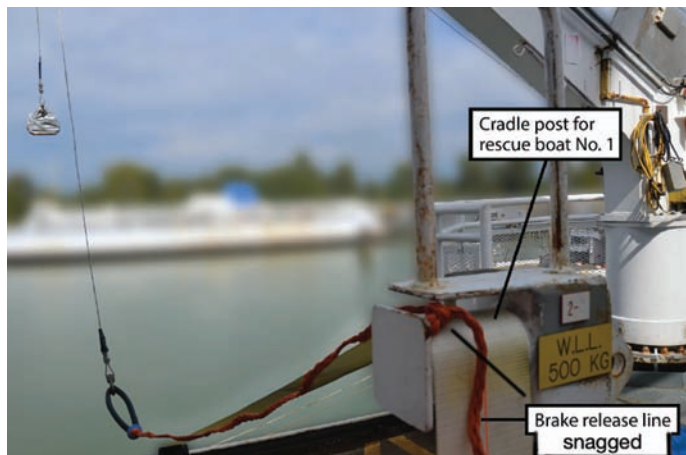
The two deckhands boarded the rescue boat, placing the brake release line bag on the deck of the ferry. They then signalled the davit operator to raise the boat from its cradle. When the boat had sufficient clearance from the cradle, the coxswain pulled the self-slewing line hanging above the rescue boat to slew the davit arm outboard. Approximately 15 cm of brake release line uncoiled from the storage bag on deck as the arm slewed. Then, the brake release line snagged on a vertical section of the cradle post creating tension on the brake release line.

As the davit arm slewed further outboard, tension on the brake release line increased sufficiently to release the brake. The rescue boat dropped, its hull hitting the raised edge of the outboard deck. It then tilted outboard to such a degree that the two men in the boat fell overboard. One fell approximately 14 metres into the water below, while the other managed to grab hold of the rescue boat's painter line four metres above the water, but eventually let go and dropped approximately two metres into the water. The rescue boat reached the water level soon after.

- The new rescue boats that had been installed on the ferry were of a greater height than the original rescue boats. Some of the rescue boat crews had developed an informal practice of removing the rescue boat's brake release line bag from its on board storage container and leaving it on the deck when the rescue boat was not self-launched.
- When the crew removed the brake release line storage bag from the rescue boat, there was no one available to take the bag from the crew, so it was left unattended on the deck.
- Although the coxswain assumed the responsibility of officer in charge of the rescue boat, his ability to supervise the launching operation was limited while he was actively engaged in his duties as coxswain.

- Any time you improvise or deviate from established procedures, risks can increase.
- Keep a keen eye for the signs of developing informal practices which insinuate themselves into established routines.

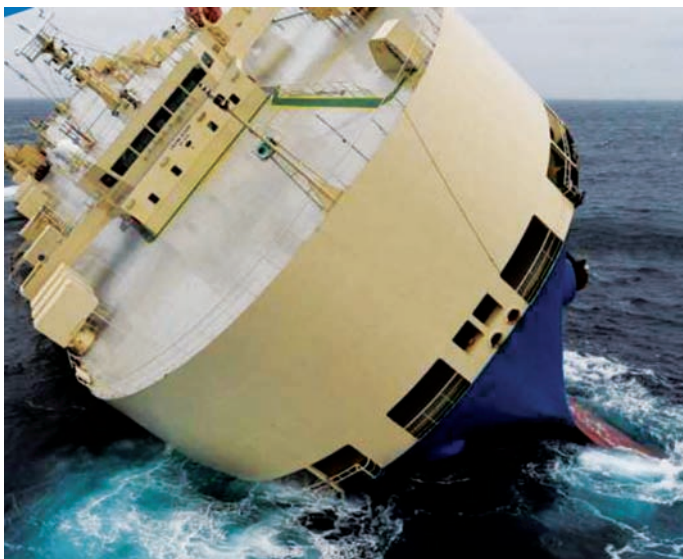
A loud noise was heard from the cargo decks. The helm was put hard to starboard but the vessel did not respond. The angle of list now made moving on the bridge almost impossible. A MAYDAY message was sent and the Master activated the GMDSS distress signals and then the abandon ship alarm. All crew were ordered to move to the port upper side deck.

The official investigation found, among other things, that cargo weights were about 29% greater than those declared by stevedores, contributing to a reduction in real GM. Also, more ballast was used than had been estimated, so GM was again less than calculated. Calculations were not efficiently supervised or followed up and no arrival calculations were considered. The CO and Master appeared to pay little attention to the importance of stability calculations since they were confident of the stability of the ship based on similar conditions in the past. However, conditions on this trip were not in fact similar to those in the past because this time bunkers had been kept to a minimum in anticipation of dry dock.

- Sailing without a finalised and accurately calculated GM is **not** a good idea.
- Without proper training it is likely that unsafe practices will become the norm.
- When unsafe practices become the norm, it is only a matter of time before an accident occurs.
- If you are required to carry an unusual cargo or a cargo that is not necessarily adapted to your vessel, best seek advice from Class or cargo experts before loading.

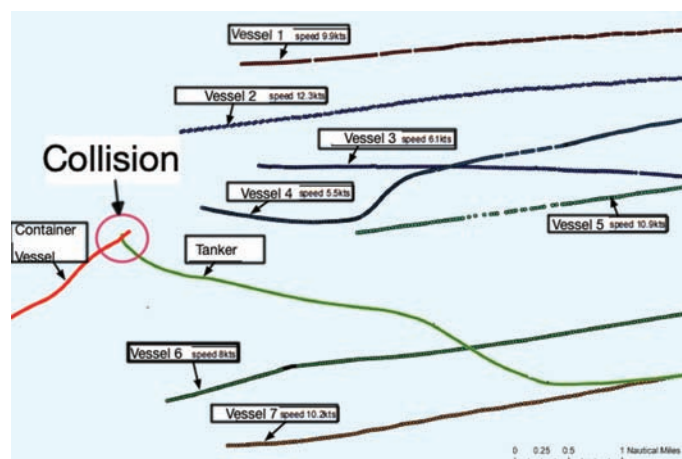
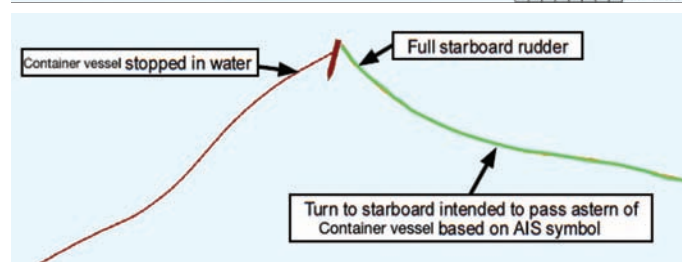
Just moments prior to collision, both the Master and the OOW of the tanker saw the superstructure deck lights of the container ship emerging from the foggy darkness ahead; the lights were spotted very close on the port bow. The tanker's port bow struck the container vessel's port quarter. None of the container vessel's bridge team saw the tanker, including the deck cadet, who was on the port bridge wing.

- Whether you are at anchor or drifting, don't assume other vessels will stay clear of you.
- Always keep your AIS navigational status up to date to reflect your vessel's actual condition.
- It would appear that many of the vessels in the vicinity of the collision, including the tanker, were proceeding at speeds that were arguably not really safe given near zero visibility and the density of the traffic.
- Paradoxically, even the container ship, which was drifting, could be considered as not proceeding at a safe speed because this gives very limited options for manoeuvring at a moment's notice.
- While AIS data can certainly enhance situational awareness, radar target and ARPA data should always be used in preference to AIS to determine if risk of collision exists.
- As OOW, if you perceive danger or have concerns, always call the Master regardless of the hour.

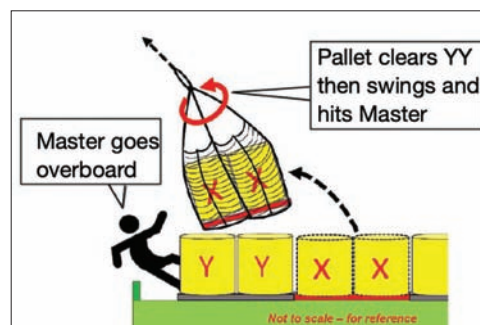
The re-supply boat came alongside the tanker and, without any lines attached, the tanker's crane's hook was lowered and the first pallet (XX in the diagram) was hooked on and the lift started. As the lift started, the re-supply boat began to veer away from the side of the tanker. The pallet, now partially lifted, was caught by another pallet (YY) on the deck of the re-supply boat. A crew member ran to the re-supply boat's wheelhouse to inform the Master to put more helm towards the tanker. The Master said he had done that, and suggested that the sheer was due to the lift coming clear of the boat's deck.

The Master then left the wheelhouse to try and help the deck crew clear the lift. The re-supply boat was still moving away from the tanker and the Master realised they needed to abort the lift. Before the lift could be lowered to the deck, it came free from the YY pallet, swinging toward the tanker and knocking the Master overboard.

The investigation found, among other things, that neither the deck crew nor the Master were wearing personal flotation devices, even though the gunwale was only 0.5 metres high meaning there was a considerable risk of falling overboard.

- The decision to transfer stores while making way at four knots was questionable. It certainly comprised more risks than stopping and allowing the re-supply boat to secure lines fore and aft to the tanker before the lifts began.
- Leaving the wheelhouse unattended to help on deck was another questionable decision. The vessel was underway at four knots and in close proximity to the tanker.
- Working on the deck of the re-supply boat, which had very low gunwales, without personal flotation devices was a clear oversight in risk appreciation – another example of 'risk in plain sight'.
