# MARS – Lessons Learned

MARS Report No 365 March 2023

## Procedural shortcut undercuts quality

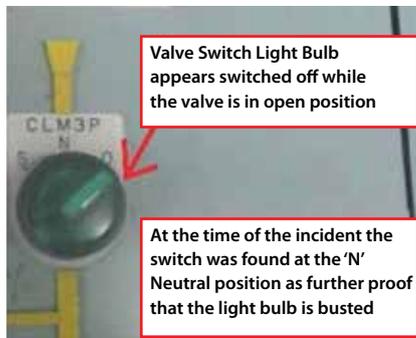
Photo 1

Unknown to those on board, the valve to the tank containing the second parcel had been left open after cargo loading and draining of the cargo arm. This remained unidentified for reasons that are explained below. Once the first parcel had been unloaded it was discovered that product from the second parcel had been discharged simultaneously with the first, contaminating both parcels.

- The light indicating that the tank valve is open was defective. When the vessel arrived at the discharge port, the fact that the light was off was taken as an indication that the valve was closed. (Photo 1, left)

- Procedures can be (and sometimes are) sidestepped by crew with a mind to ease the workload and accelerate a process. Attention to detail by vessel leaders should nip this practice in the bud before it becomes routine.
- Sometimes, well meaning 'barriers to hazards' put in place by crew, such as the plastic cover protection on the valves of tanks not being worked, can have unexpected negative consequences.

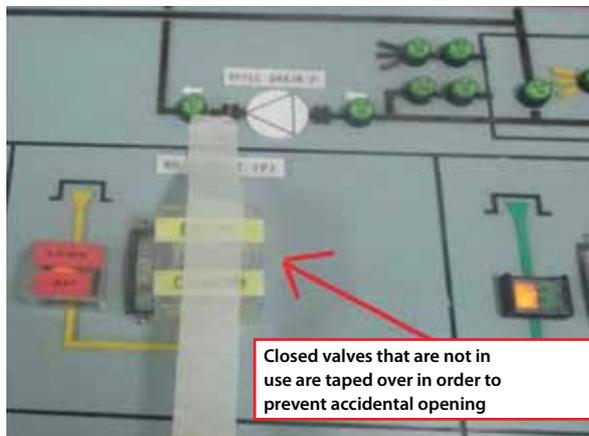
Photo 2

- It was standard practice that when more than one parcel is loaded, the valves that are not being worked are protected by a plastic cover which is secured in position with tape. This precaution causes its own unsafe condition; making harder to visually check the actual status of the valve. (Photo 2)

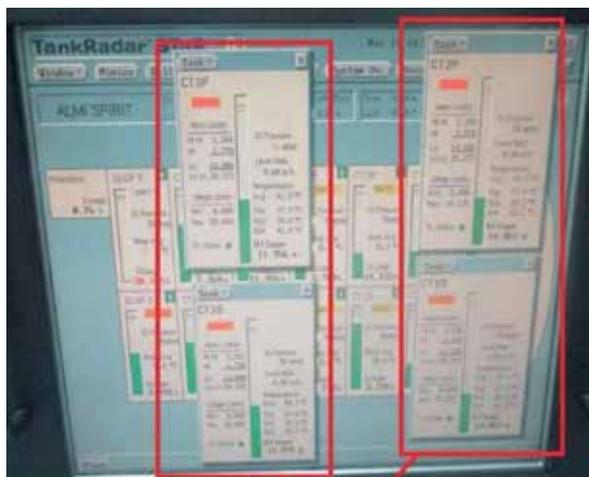
Photo 3

- Other 'barriers' in place to allow timely identification of any deviation from the plan were also sidestepped or otherwise annulled:
- The digital cargo level gauging system screen was rearranged so that the display for the first parcel was shown on top of the other tank readings. It was therefore difficult to see the change in quantity of the second parcel that was being simultaneously discharged. (Photo 3)

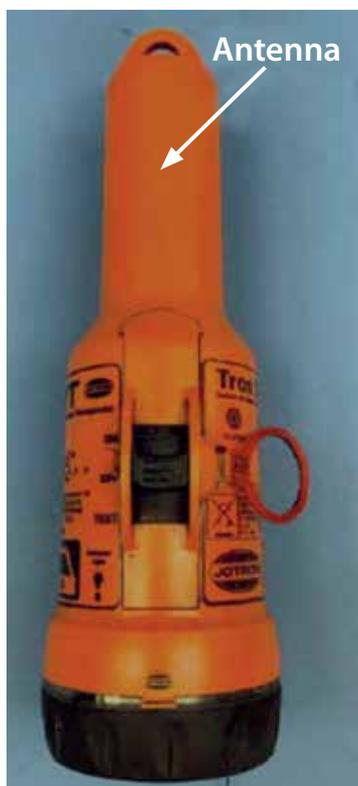
The narrow end of a SART is the antenna. This should be vertical and as high as possible. But the narrow end is also the only suitable location for a person in distress to firmly hold a SART. If a person in the water holds a SART by its antenna, the SART's ability to transmit and receive signals from an X-band radar will be reduced.

- If you are on a vessel that has been assigned search and rescue duties and are searching for possible survivors, do not use the AUTO mode for radar rain, sea and gain settings. Use the manual modes and adjust the rain and sea clutter settings to the lowest possible setting that will still give a somewhat clear screen. The gain should be put to the highest possible adjustment without causing undue radar returns that pollute the screen.
- If you are a survivor floating in the sea and have an activated SART in hand, hold it as high as possible above your head but do not use the narrow end as a handle. This is the antenna.
- If you are a survivor in a lifeboat or liferaft, mount the SART as high as possible with the narrow end up.

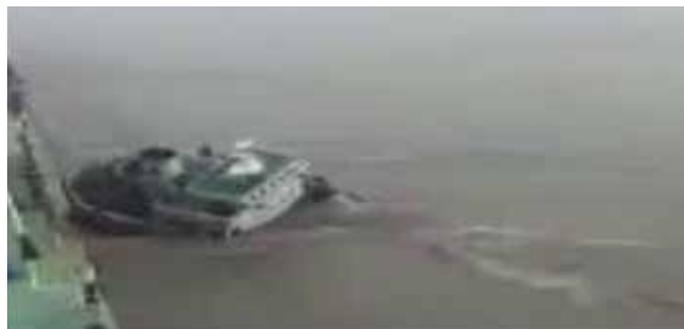
It became apparent that course made good was bringing the bulk carrier into a collision situation with an anchored vessel. In a desperate attempt to avoid contact with the anchored vessel the engine was increased to half ahead and then full ahead and hard port helm ordered. The bulk carrier nonetheless made contact on its starboard side with the other anchored vessel. The lightering barge that was moored on that side sustained major damage and foundered within five minutes. Some of its crew jumped into the water and were recovered. Unfortunately two crew were trapped within the sinking barge and were later declared deceased.

Lightering barge foundering after contact

- Good seamanship would normally see the lightering operations halted and the barges released prior to weighing anchor and re-positioning the vessel. This would have increased manoeuvrability, possibly allowing the move to be accomplished without incident. No fatalities would have been sustained even had the collision nonetheless occurred.
- Low under keel clearance will cause increased drag forces on a vessel and can initiate dragging anchor when all other factors seem benign.

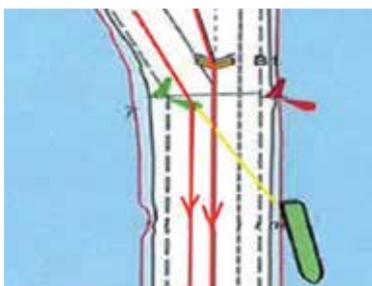
Very soon after ordering full ahead the pilot made another personal call on his mobile phone lasting approximately four minutes and sent a text message image to another pilot on non-urgent business matters. As the vessel approached a course alteration point the pilot ordered a heading of 161°. The helmsman confirmed this order. About two minutes later, the pilot viewed another screen on his PPU with the intention of taking a screenshot from another voyage. This action had the effect of distracting the pilot; he was now preoccupied with saving the screenshot and sending a non-urgent business email to another pilot. Meanwhile, the vessel crossed the inbound lane, overshooting the next course alteration to starboard.

— Intended route(s)  
— Actual route

- Whether you are a pilot, OOW or Master – if you are in the wheelhouse and assisting or conning a vessel keep your mobile phone in 'airplane mode'.
- The concept of 'challenge' in Bridge Resource Management (BRM) is an important one. In this case the OOW knew they were running into danger but his first 'challenge' to the pilot was understated and oblique. He only restated the facts of their present course and speed,

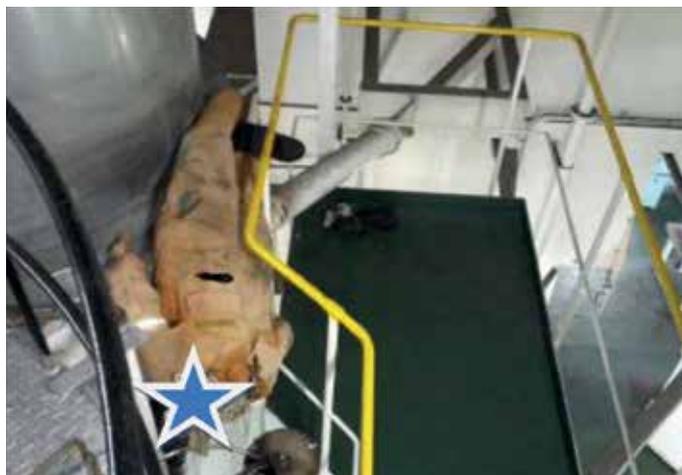
➔ A vessel was at anchor near a port. As part of regular maintenance checks, a member of the engine room crew went into the funnel space to verify whether the funnel flaps were working. In order to do this he installed a ladder in the relatively confined space and climbed up, unassisted. He slipped from the ladder and fell to the deck. He suffered multiple minor injuries for which he had to be evacuated to a shore hospital.

Reenactment of victim's final position

- Routine, everyday tasks can be deceptive; we tend to discount the potential harm of hazards we have successfully avoided in the past.
- A rule of thumb when using a ladder: have a second person hold the base while you climb. It is generally accepted that if the height of your climb is greater than 2/2.5 metres, use a safety harness.
