CHIRP

Confidential Human Factors Incident Reporting Programme

Danger! Working at height!

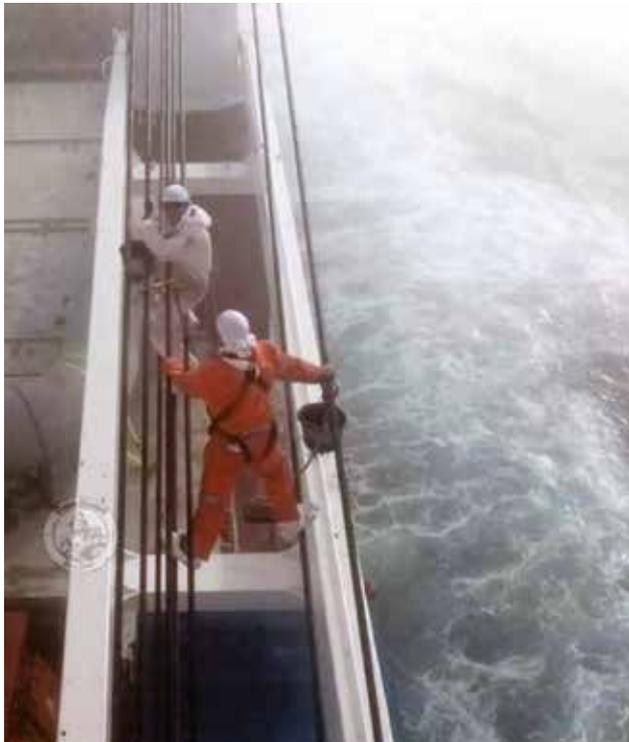
M1987

Our reporter sent us this picture of two seafarers working on a crane at height while the vessel was underway at sea in poor weather conditions. They appear to be re-greasing the sloping wires of a crane. Their lifelines are attached to the same wires. Nothing would stop them from falling to the bottom if they slipped and fell.

They are not wearing safety helmets or lifejackets despite being close to the edge of the vessel. This activity took place in full view of the bridge team, but they were neither challenged nor stopped.

Good equipment design can eliminate operating and maintenance hazards. In this case, it could have been possible to design the crane to be lowered to the deck to allow maintenance to take place without ever sending someone aloft. If that were not possible, the designer could have added hand-holds and connection points for safety harnesses to be attached so that the crew had safe access.

The maintainers are wearing loose plastic overshoes – this is a common (but unsafe) way of keeping your footwear clean and avoiding transferring the grease from the wires

The crew member in white overalls appears to be wearing only a harness around the waist, not a full-body harness. An incorrect or badly fitted harness increases the risk of internal injuries when coming to a sudden stop at the end of the lanyard.

Fall arrestors reduce this shock but need you to fall another 2-4m to work correctly. If there is insufficient clearance to fall this distance without hitting an object or the deck, the wearer could hit these objects at full speed and be seriously injured. In the photograph, the crew members would likely fall onto the crane arms before their safety harnesses could work.

If your ship uses safety harnesses for working aloft, make sure there is a rescue plan in place.

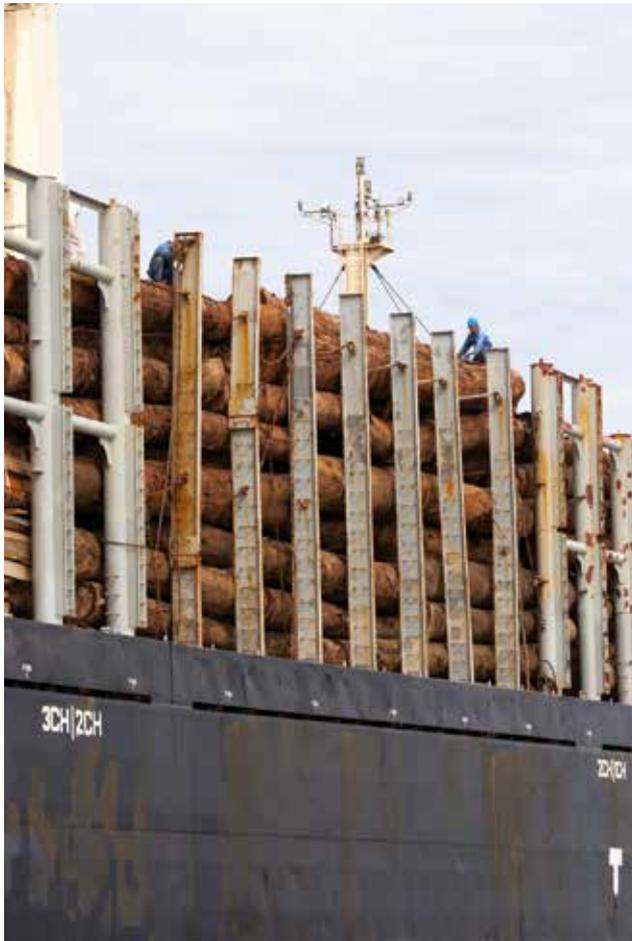
M1912

A bulk carrier was loading a timber deck cargo at anchor. While lashing down the timber, an Ordinary Seaman (OS) fell overboard into the sea. Another crew member jumped

in to search for them but was unsuccessful, and despite an extensive search over several days, the victim was never found. What caused the OS to fall into the water could not be determined as there were no witnesses. The OS was inexperienced yet had not been trained or briefed on the risks of working on timber. He wore coveralls, gloves, a safety helmet, and studded overshoes. Still, the ship's SMS manual did not mention the rigging of safety lines or wearing safety harnesses when working on top of the timber, nor did it require the crew to wear lifejackets or buoyancy aids.

This report raises several organisational safety concerns. There was nothing in the company SMS about working at height on logs, nor any guidance on the rigging of safety lines or the wearing of safety harnesses. It would be impractical to rig a lifeline over the timber because it would interfere with the timber being loaded or unloaded by crane, but alternatives should have been considered. On board, the operational leadership knew of his inexperience, but did not provide a safety briefing or assign the person a 'buddy' or supervisor to ensure his and others' safety.

Working on top of logs to carry out lashings is hazardous and requires experience and training to do the work safely. The average height of a completed stack of logs varies from 5 to 8 meters above the main deck; a fall either overboard or to the deck can be fatal.

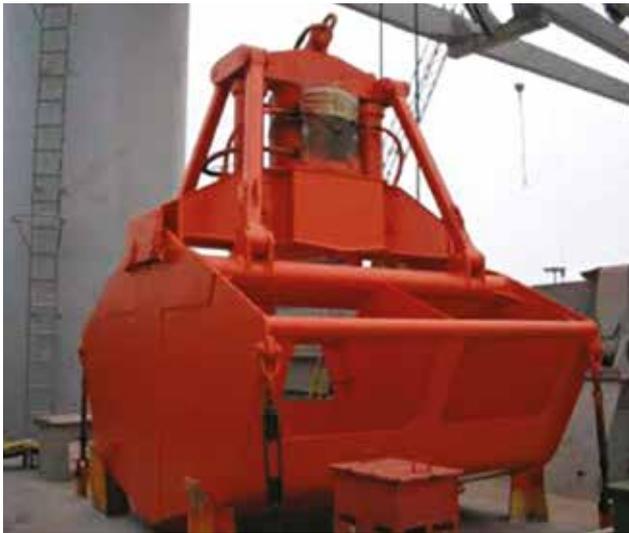
M1908

A three-person crew had been tasked to replace the wire rope of a cargo crane grab stowed on the main deck in its designated storage position. The weather was fair, and working at height precautions, including completing a Permit to Work, had been taken.

The work started in the morning and was completed in the evening. Two seafarers first descended from the grab. The senior crew member then unclipped his safety harness as he prepared to descend. Tragically he lost his footing and fell about 5 metres onto the platform railing and a further 1 metre onto the deck below. He suffered a head injury and was taken to the ship's hospital. The ship's master sought radio medical advice, but the crewman died of his injuries about an hour after the accident.

The grab's shape, size and position meant poor hand and footholds, although it was concluded that the crew member probably perceived the risk involved as acceptable

and within his control. The fall prevention equipment on board was not ideal for vertical movements, so using equipment such as a double-legged energy-absorbing lanyard would have been more appropriate. The equipment was of a type that necessitated unclipping the safety harness lanyard to ascend or descend at the work site.

The ship's SMS procedures did not refer to hazards related to access/egress from a worksite at height, and it could not be determined if the risk of going up and down from the grab had been assessed.

The company have suggested that a double-legged energy-absorbing harness would have been appropriate. CHIRP agrees, because a single-leg harness must be unclipped when climbing, descending, or navigating obstacles, thus removing the benefit of wearing a harness. And in this incident, a fall arrestor would not have worked because the crewman would hit the grab or the deck before it functioned.

Fit for purpose (equipment) – CHIRP recommends that safety harnesses have two lifeline lanyards (also known as double-lanyard harnesses) so that at least one can always be connected when climbing up or down a ladder. For wearers of harnesses fitted with only one lanyard, the ascent or descent to a task is the most hazardous time.

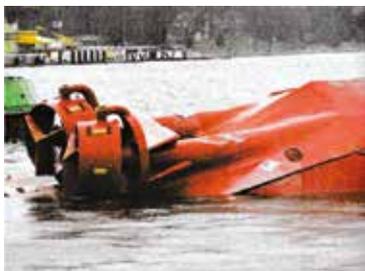
A tug had been engaged to assist a RO-RO passenger ferry in berthing in high winds. The ferry's master held a pilotage exemption certificate for the port, so no pilot was embarked. The tug was manoeuvring close to the port bow of the

ferry and attempting to connect a tow line when its stern collided with the ferry's bulbous bow, where it became pinioned, heeled to port and took on water. This caused the tug to capsize, resulting in the loss of 2 crew.

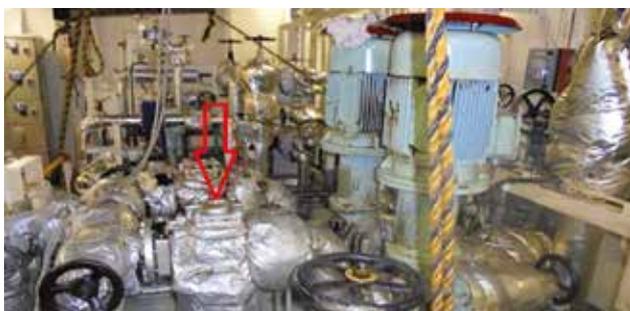
An engine crew suffered burns from the fuel oil pump of the auxiliary boiler

The work commenced after lunch at around 13:40. The senior engineer was about to dismantle and remove the pump's filter cover when hot fuel and gases suddenly escaped.

The senior engineer, two wipers and one engine cadet assigned to the work suffered burns on their faces, skin, neck, and hands from the hot oil spray.

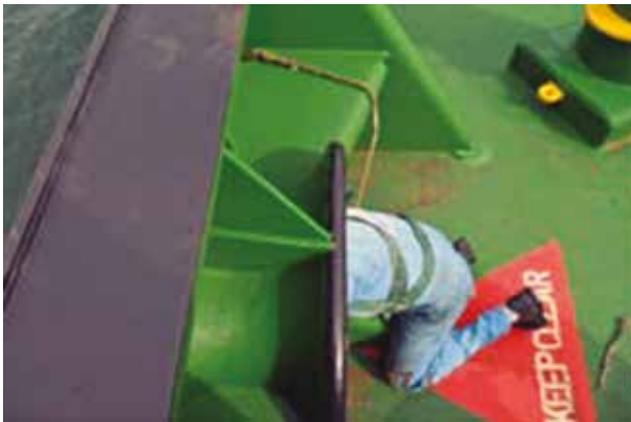
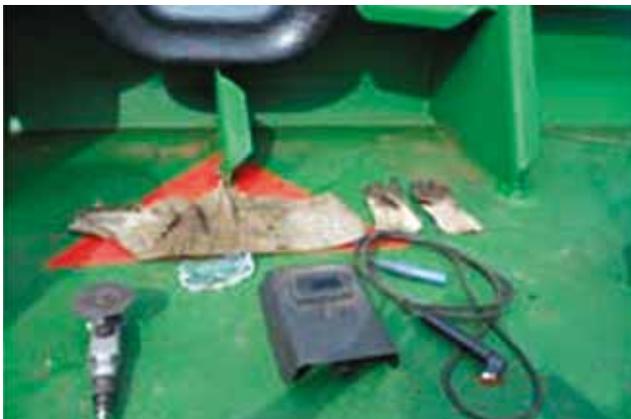
While the vessel was at an anchorage, the Chief Engineer was doing maintenance work in the forecandle deck, building-up the starboard mooring chock by welding. See photos below.

During this activity, he suffered an eye injury when a metal fragment was embedded in his eye. Three days later, the injured Chief Engineer reported the incident to the master, complaining about eye pain and irritation. Fortunately the vessel was near a port and he was transferred xxx ashore for medical treatment. An eye specialist removed the particle and he was able to return on board fit for duty.

From the Chief Engineer's statement, he was wearing eye protection when he started the job. However, as the work was carried out in a restricted place, the goggles were removed later.

The grinding tool also presents a serious hazard and must always be protected; the grinding disk shown in the report does not have a cover installed and should not have been used.

It is well-known that many types of eye protection can mist up with moisture, blurring the worker's vision. Some poor-quality goggles can be poorly fitting which makes them uncomfortable to wear, so the temptation to remove the goggles can be compelling. If this happens, stop the work, clean the goggles or adjust them, but never remove them while the work is still taking place.
