In this bulletin...

MARS 202534

Propeller 68% submerged gives 100% disaster

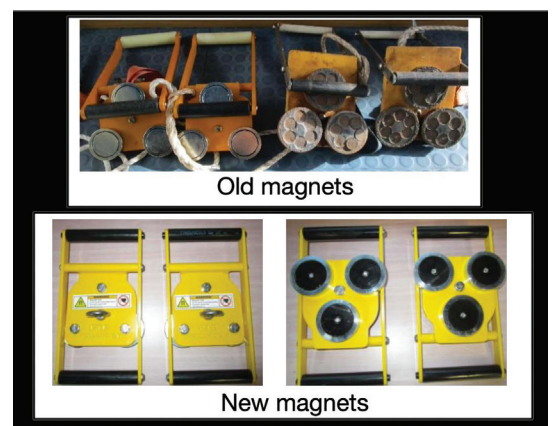
Departure and outbound voyage were without incident but at the pilot disembarkation area the vessel was rolling so heavily that the magnets for the accommodation platform released from the hull. The disembarkation of the pilots was postponed to re-secure the ladder. The magnets were re-attached to the vessel's hull, the accommodation ladder was secured, and one pilot disembarked safely to the pilot boat. The second pilot could not disembark as the magnets were again dislodged from the hull due to rolling. The disembarkation of the second pilot was postponed and the vessel headed towards an area where the weather conditions were deemed more suitable for disembarkation.

Pilot and accommodation ladder magnets, like any magnet, will lose their strength over time. Various factors contribute to the loss in magnetic strength, depending on the type of magnet, including among others:

The Master subsequently ordered new magnets for the vessel.

- Corrosion: Magnets made of iron can rust if not coated or protected. Over time, corrosion can compromise their structure and reduce their magnetism.
 - Keep ladder magnets in a protected environment and if possible one with stable temperature control.
 - Maintain ladder magnets by eliminating rust and protecting them from impacts.
 - When in doubt, since judging magnet strength is difficult under operational conditions, replace old pilot/accommodation ladder magnets with new ones.

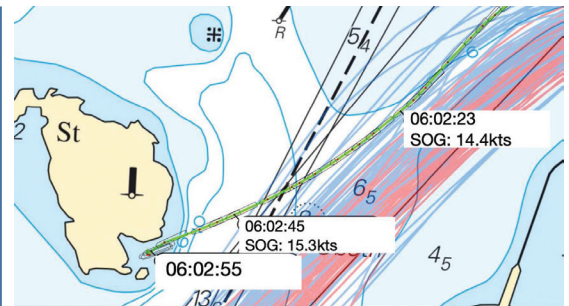
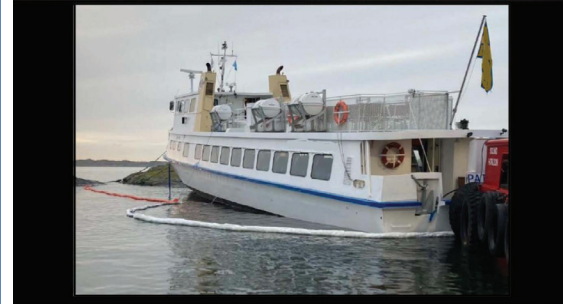
To dim the light on the displays, two buttons had to be pressed simultaneously. The buttons were not backlit, so the captain took out his mobile phone and activated the flashlight function to see better. With the phone in one hand, he pressed two buttons simultaneously with the other hand. On his first attempt the display went completely black instead of dimming. Concentrating on this task for a second time, he saw something appear in front of the ship. With no time to turn away the ferry ran aground on an island at a speed of almost 16 knots.

The investigation found, among other things, that the autopilot's 'change in operating mode' warning was not effective. The autopilot probably became disengaged when the armrest was raised to give the captain access to the engine monitoring displays, without him being aware of this. At nearly 16 knots, it only took a few seconds for the ferry to veer off course and run into danger while the captain was preoccupied with dimming the panels.

- Poor design and ergonomics are nefarious unsafe conditions that often go unnoticed until it is too late.
- In darkness and navigating the vessel in a restricted waterway, the captain was trying to undertake an adjacent task that takes both hands and both eyes.
- Once again speed is an issue. At 16 knots the captain did not put chance on his side when deciding to attend to an adjacent task.
- A seaman was sitting in the aft part of the wheelhouse without duties. He would have been more useful as lookout.
