Mariners' Alerting and Reporting Scheme

MARS Report No 332 June 2020

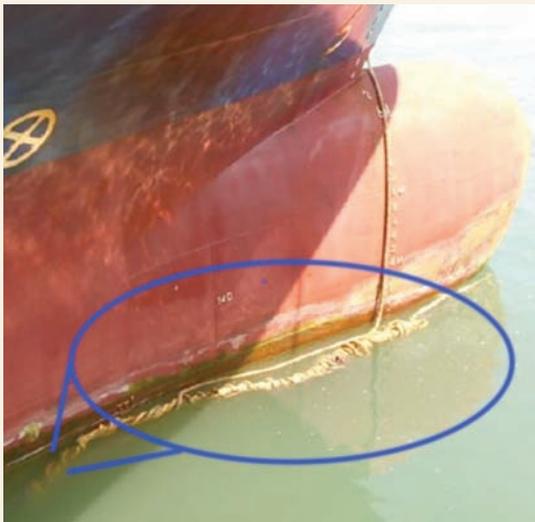
Bow thruster sucks two lines

To begin, forward and aft springs were set using the bow thruster at 70%, with the rudder at port 20° and the main engine running ahead as per pilot's instructions, in order to keep the vessel close to the berth. Next, the three head lines were passed to the line handling boat forward. Two of the head lines slipped off the bollard and more slack was payed out than needed. The lines floated on the water. Before they could be mastered by the launch personnel, they were entrained into the starboard inlet of the thruster tunnel, fouling the propeller blades.

- Due care must always be taken with lines near a working bow thruster. Ideally, lines should not be allowed to float near a working bow thruster.
- Vessels in ballast have their bow thruster tunnels nearer to the waterline than loaded vessels and are at increased risk of mooring lines being sucked in.

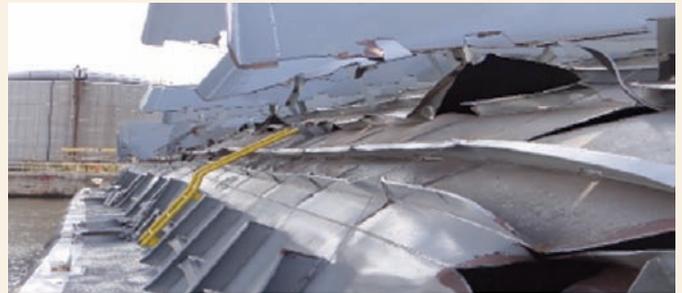
The air blowers that were recovered from the exploded tank barge had either missing or improperly maintained bonding (ground) wires. This was likely the cause of the explosion.

Breached cargo tank

- All personnel should be aware of the critical importance of bonding (grounding) air moving equipment such as blowers or fans before commencing gas freeing operations.
- Proper bonding means the contact point to the vessel or barge is clamped to bare metal, not a painted surface. Simply resting the blower/fan on bare metal is NOT an adequate means of bonding.
- Clamps used with the bonding wire or strap should be free of corrosion, with sufficient tension to ensure a tight connection when clamped to the vessel structure.
- Fans or blowers should be properly secured to prevent movement due to vibration.
- Inspect all air moving equipment before first use each day and ensure that all attached accessories (cones, ducting, etc.) are tightly connected to the blower/fan.

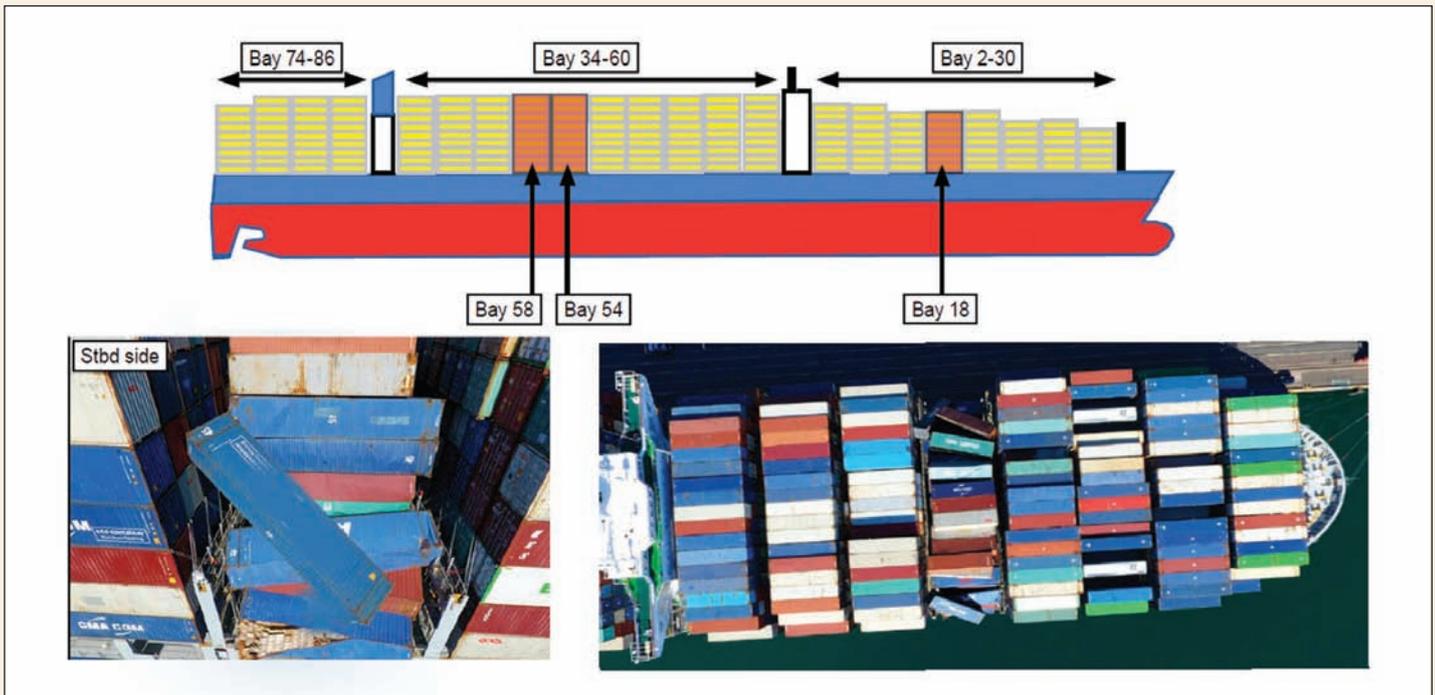
The deck lights were turned on after the large roll, but no damage was seen from the bridge and the container stows appeared to be intact. At daylight, an officer went to the weather deck with the bosun to investigate. They found that bays 18, 54 and 58 had collapsed. It was later determined that 137 containers had been lost overboard and 85 damaged.

- It is likely that the forces generated when the vessel rolled 20° to port and starboard initiated the collapse of the container stows at bays 18, 54 and 58.

- The amplitude of the ship's rolling exceeded the limits set by the company for the class of vessel.
- It is almost certain that the vessel experienced parametric rolling prior to and at the time of the container collapses.

- The cause of the collapse at bay 18 could not be determined. It is most likely that this collapse was initiated following the structural failure of one of its containers, brought about by a combination of factors including: excessive stack loads as a result of mis-stowed or overweight containers; excessive racking loads or contact between containers due to loose lashings; and/or existing damage or poor material condition of a container.

1. the wave crest amidships and the bow and stern in wave troughs.
 2. the ship is supported by a crest at the bow and stern with the trough amidships.
- IMO guidance suggests that parametric rolling may occur when either the period of roll equals the period of encounter, or the period of encounter is approximately half the roll period.
 - The risk of parametric roll in a following sea is very sensitive to minor changes in the relative direction of the sea. Large container ships are particularly vulnerable to parametric rolling due to their length and fine hull form.
 - If you work on a vessel equipped with a motion monitoring, forecasting and decision support tool, ensure you are fully conversant with its functionalities.

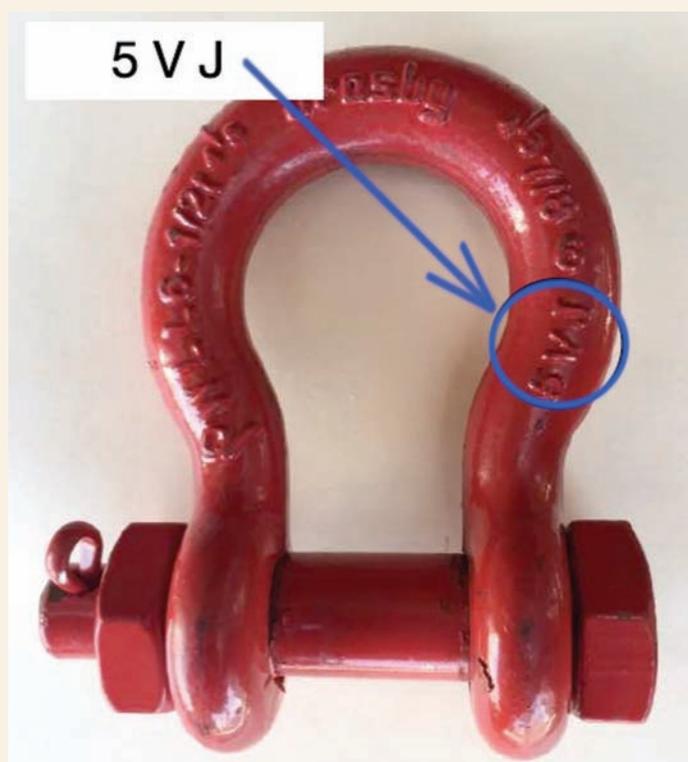
→ The Crosby Group has determined that certain shackles have a condition that can reduce the ultimate load capacity from the published catalogue values. Continued use of these shackles may result in unexpected failure. These products are 7/8" 6.5t shackles with Production Identification Code 5VJ, as illustrated below. These products should be taken out of service immediately.

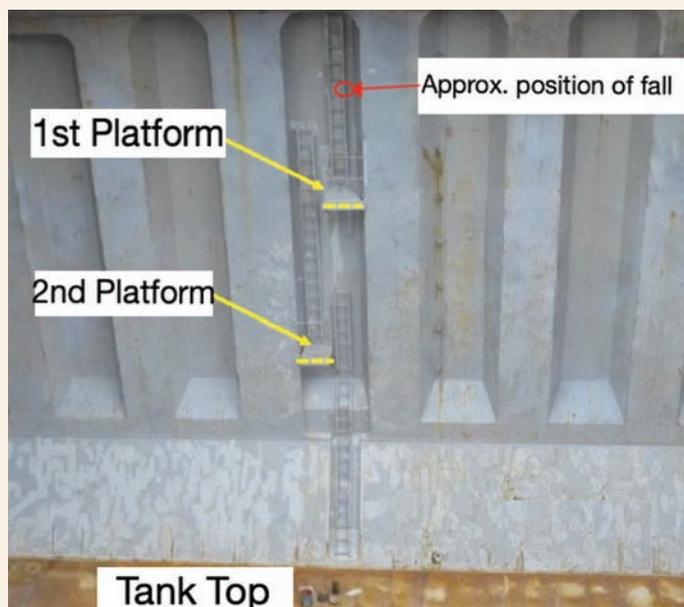
The investigation found that there was no securing arrangement to which to fasten a safety harness lifeline. Because of this, it was common practice for the crew to climb up and down the ladder without securing the safety harness lifeline to any point and without any fall arresting device. A damp and wet cargo hold, wet gloves and a ladder slippery with seawater from the wash were probably contributing factors to the fall. The risk assessment carried out for cargo hold washing operations did not identify the risk of falling from height during climbing up or down the vertical ladder.

- As is often the case, hazards remain in plain sight but go unseen by crew who have become desensitised to them. In this case it was accepted practice to climb up and down the hold ladder, which was not fitted with a cage, without fall arrest or safety lines.
- Another indicator of this particular fall hazard going unseen by crew: the hold washing risk assessment did not mention this risk.
