Mariners' Alerting and Reporting Scheme

MARS Report No 339 January 2021

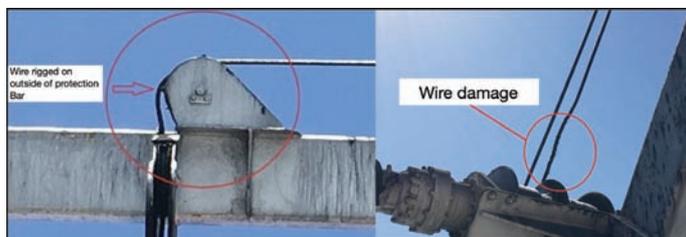
→ The vessel was at anchorage and a lifeboat drill was scheduled. The boat was lowered to the water and completed manoeuvres, the boat crew exited the lifeboat and recovery commenced. As the lifeboat was raised an officer noticed damage to the davit wire near the port side upper sheave.

The investigation found that the davit's wire had been incorrectly fitted to the davit sheave. It had been fitted on the outside of the sheave protection bar instead of between the protection bar and the sheave. This defective rigging had caused the wire rope to rub against the bar, which resulted in damage.

The lifeboat davit wire ropes had been installed two months earlier in dry dock. The defect had gone undetected during the load-test after installation and the boat had not been lowered since the test.

- As lifeboats are raised or lowered it is always prudent to sight the wires and check for defects.
- During dry dock maintenance many projects are often in progress simultaneously and at a rapid pace. In many cases, jobs are undertaken by shipyard crews who have less experience than vessel crews. These factors increase risks, so extra prudence is needed on board in the weeks and months after a dry dock.
- To minimise risks during drills, lifeboats should be raised without crew whenever possible.

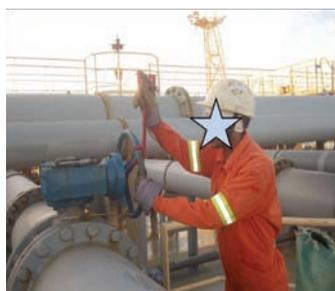
→ A berthed tanker was discharging cargo and a deck crew member was assigned valve operation duties at the manifold. While applying force using an 'f-spanner' on one of the valves he slipped. His face hit the valve spindle with some considerable force causing an injury to his upper lip.

Opening the valve

Slipped

The company investigation found that, among other things, he had not assumed the proper position for the task. This was linked to his lack of experience and inadequate training for this particular job.

- When investigating for cause, always go deeper than the unsafe act. In this case the unsafe act of not being properly positioned was linked to the unsafe condition of inadequate training.
- All hazards related to a particular task should be explained to new crew. Proper training would include the execution of the task while under supervision.

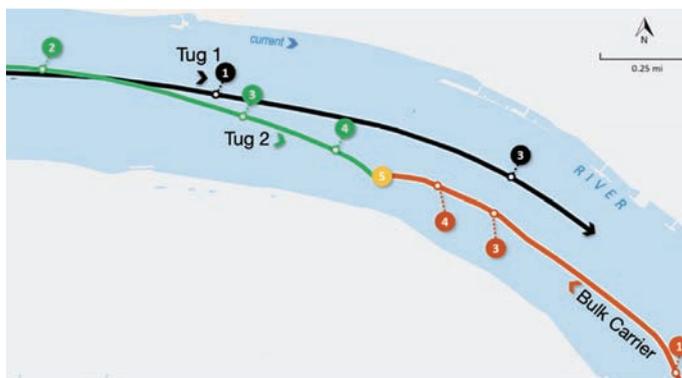
On the bulk carrier, the pilot assumed the second down-bound tug would require the same meeting as did the first, that is starboard-to-starboard. However, this was not the intention of the tug operator and he did not call the bulk carrier to make his intentions clear. For the next

85 seconds the situation continued to develop in an ambiguous manner until the bulk carrier pilot called the tug to confirm what he thought would be a starboard-to-starboard meeting.

The tug operator was taken by surprise by this suggestion, as he had assumed a port-to-port meeting. In his opinion the vessels were now too close to execute a starboard-to-starboard meeting safely. He initiated an emergency avoidance manoeuvre to starboard without informing the bulk carrier's pilot. About 30 seconds later the two vessels collided.

- This is one more example of a vessel operator making an assumption about the intentions of another vessel operator which has led to a bad outcome. To reduce risk in this sort of situation, clear and unambiguous communication is essential.
- Follow the rules! In this case the operator of the second tug should have called the up-bound bulk carrier and confirmed the manner of passage. Had he done so in a timely manner the collision would have been avoided.

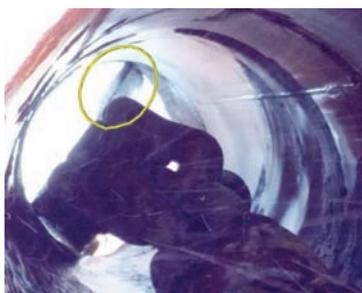
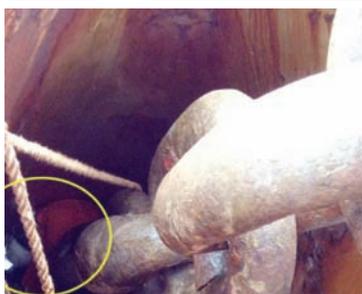
➔ A bulk carrier in ballast weighed the port anchor and departed the anchorage for a sea passage. As the anchor came into view, it was discovered that the flukes were not positioned properly. Heaving was stopped, but not before one of the flukes entered the hawsepipe and became stuck. The anchor was secured in that position and the vessel left the anchorage for the sea passage.

Top: stuck fluke
Bottom: Crew member pinned in hawsepipe

The next day, a support was welded inside the hawsepipe so that a hydraulic jack could be used to move the chain in the hope of dislodging the anchor fluke. A crew member entered the hawsepipe to position the hydraulic jack against the anchor chain and started operating the jack to move the anchor chain. Suddenly, the anchor chain moved with a jerk and pinned the man against the wall of the hawsepipe.

- The early plan of sending a crew member over the side at the bow while underway was a clear signal that improvisational and unsafe practices were being employed.
- Stand your ground. In this case the chief mate was not in agreement with the practices used and refused to participate. The Master, uninhibited by the chief mate's warnings, continued the various attempts that eventually cost the life of a crew member.
- When a new challenge arises it is best to use cool heads to analyse all risks and benefits. In this instance it would have been evident that sending a man over the side at the bow while underway or having someone enter the hawsepipe were dangerous acts that could not be justified.

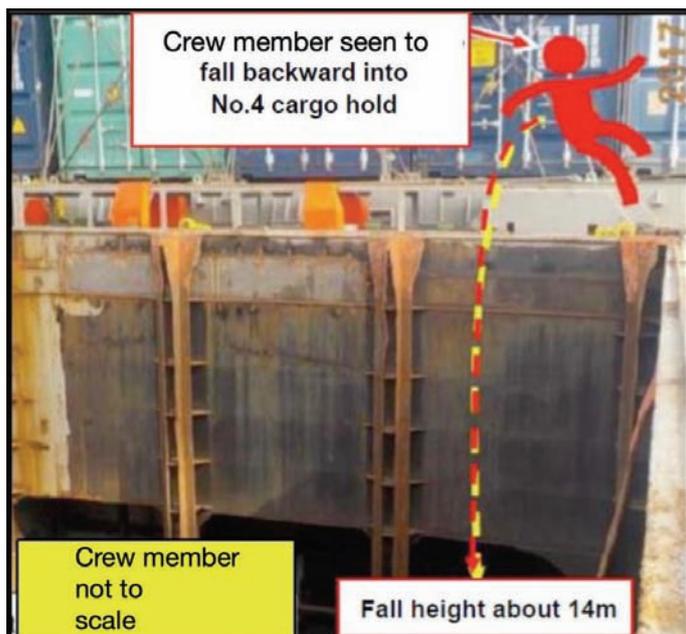
The ensuing investigation was unable to establish why the crew member was walking on the raised catwalk near the open hold. However, it was found that there were no barriers to prevent falling and that the narrow (70cm) catwalk was littered with loose securing gear that made walking on that surface hazardous.

- A combination of wet and cluttered surfaces and a lack of fall barriers resulted in a very hazardous work area. Then, the crew member made his fatal decision to enter that area without fall-arrest equipment.
- We do not always make the best and safest 'on-the-spot' decisions. This is why strong procedural integrity and a robust safety culture are important safeguards against negative outcomes.

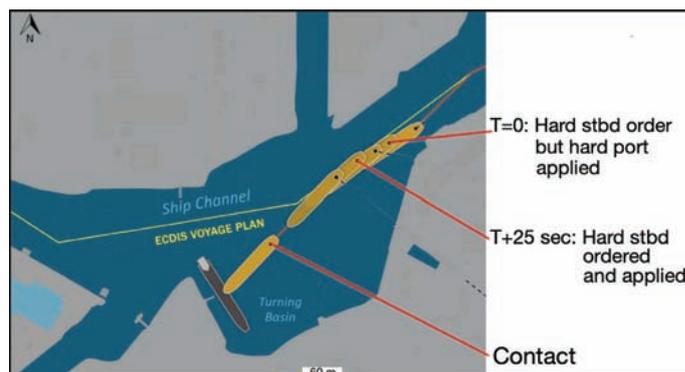
With the port anchor and two shots of chain deployed, the vessel nonetheless collided with the port side of a berthed tank barge while making almost 4 knots.

The investigation found, among other things, that the helmsman had probably been fatigued by carrying out extra duties the day before and that this contributed to the accident.

- When in restricted waterways the helmsman's actions should always be verified by same-time sighting of the rudder angle indicator. A wrong rudder application may be irrecoverable if left for even 10 seconds.

- The OOW was apparently not sighting the indicator at all and, if he was, he did not indicate the wrong rudder application to the pilot. The pilot was sighting the rudder indicator but only after a 10- or 11-second delay. In the first instance they were able to recover, but not in the second.

- The work-rest log did not indicate the helmsman's extra duties the day before. When collecting data for fatigue, investigators should not restrict themselves to looking at the work-rest logbooks, but should also question each person in detail about their previous 72-hour, or preferably 96-hour, work-rest routine.
