MA2017-12

**MARINE ACCIDENT
INVESTIGATION REPORT**

Vessel type and name: Container Vessel MANHATTAN BRIDGE
Vessel number: 142550 (IMO number: 9689615)
Gross tonnage: 152,297 tons

Accident type: Explosion of the Auxiliary Boiler
Date and time: Around 23:04, January 19, 2017 (local time, UTC)
Location: Port of Felixstowe, United Kingdom of Great Britain and Northern Ireland
Around 012° true bearing, 2.0 nautical miles from the Dovercourt High Lighthouse
(approximately 51°57.8'N, 001°17.2E)

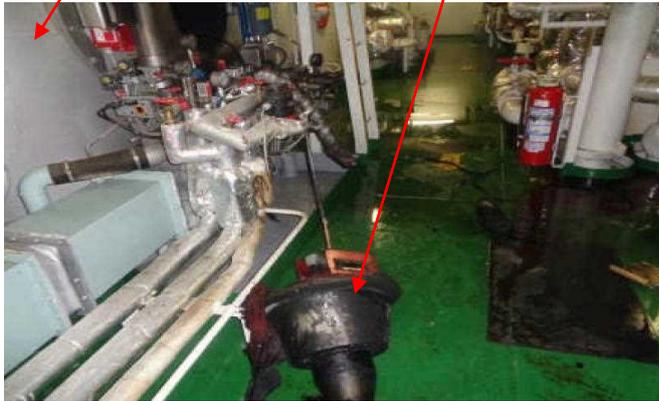
Photo 2.3-1 Burner unit door

According to the on-site investigations, the statement of the person in charge of the Oil Burning Apparatus manufacturing company (hereinafter referred to as “company B”), and replies to the questionnaire by the company A, the burner unit door fell to the deck by the breakage of the burner unit door locking mechanism and its hinge, secondary air nozzle was blown off and bent, therefore a part of burnt boiler suit was sticking to the secondary air nozzle.

Fallen the burner unit door

As described in 2.3, it is probable that the burner unit door of the auxiliary boiler fell to the deck, secondary air nozzle was blown off and bent.

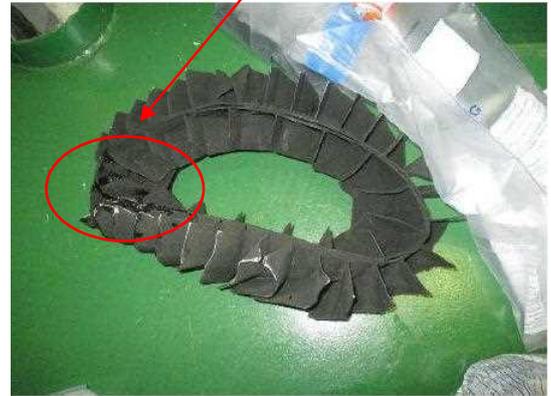
Photo 2.3-2 Secondary air nozzle damage condition

Stuck a part of boiler suit

As described in 2.1~2.3, it is probable that the Oiler A died of multiple injuries as it was hit by the secondary air nozzle blown off by the blast and the Engineer A burned in the right hand and right thigh because of the blast.

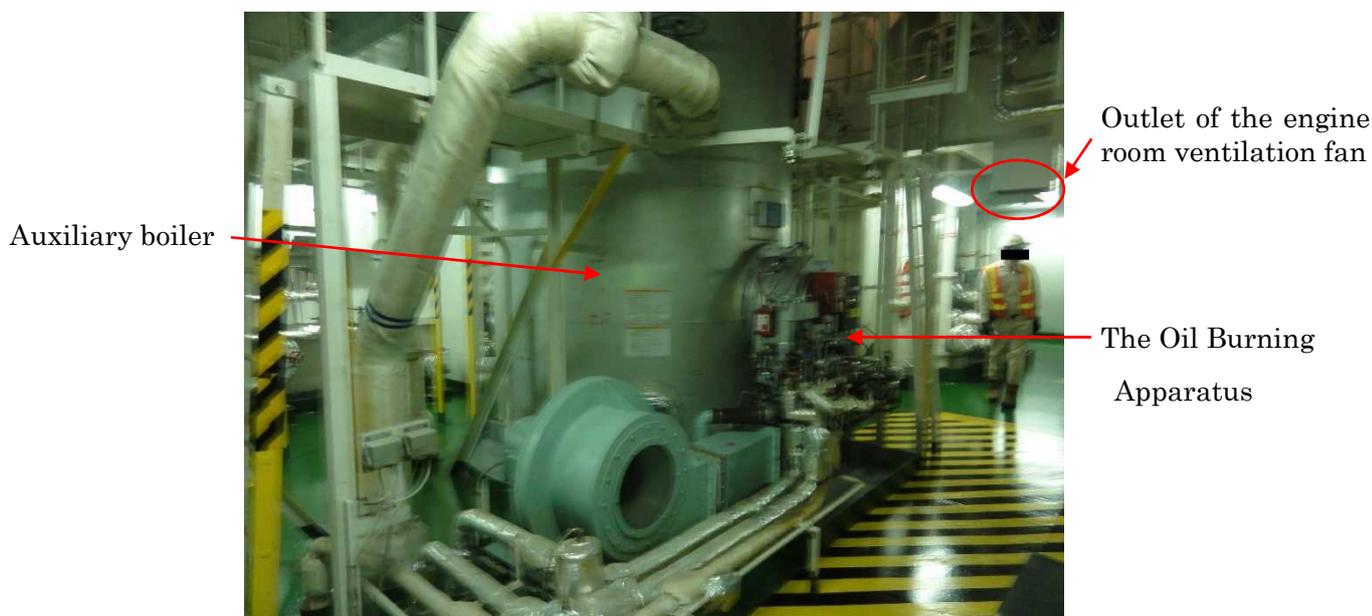
Photo 2.5-5 Outlet of the engine room ventilation fan at port side of the Oil Burning Apparatus

According to the statement of the person in charge at the Company B, when the person in charge at the Company B repaired the Oil Burning Apparatus at the port of Hamburg in Federal Republic of Germany, he felt cold air blowing around the Oil Burning Apparatus. As the outside air came from the outlet of the engine room ventilation fan at port side of the Oil Burning Apparatus, he closed its damper.

Air temperature at the time of the accident at the port of Felixstowe was 4 to 6°C and outside air was blowing downward through the engine room ventilation fan's outlet which was mounted on the ceiling on the port side of the Oil Burning Apparatus.

From these things, the temperature around the Oil Burning Apparatus was estimated to be about 12 to 15 °C, which was the temperature below the Cold Filter Plugging Point of the MGO

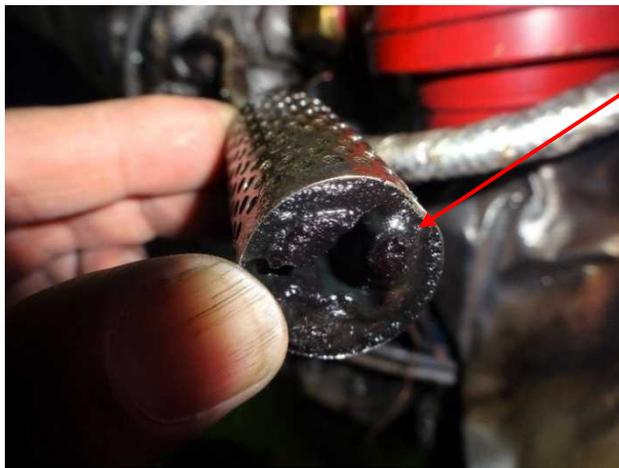
Photo 2.9-1 Clogging condition of strainer②

He opened the strainer② for the confirmation of fuel oil condition, he found slimy wax-like material stuck to strainer②, which was almost clogged. After the strainer② cleaning, once again the fuel oil pump was operating and same clogging condition was occurred after one minute operation. (See Photo 2.9-1)

slimy wax-like material stuck

It is probably that when the Vessel used the MGO containing a large amount of paraffin wax, the temperature around the Oil Burning Apparatus fell to the Cold Filter Plugging Point of the MGO and the paraffin wax precipitated in the strainer① and/or the strainer②. Then the strainer① and/or the strainer② clogged.

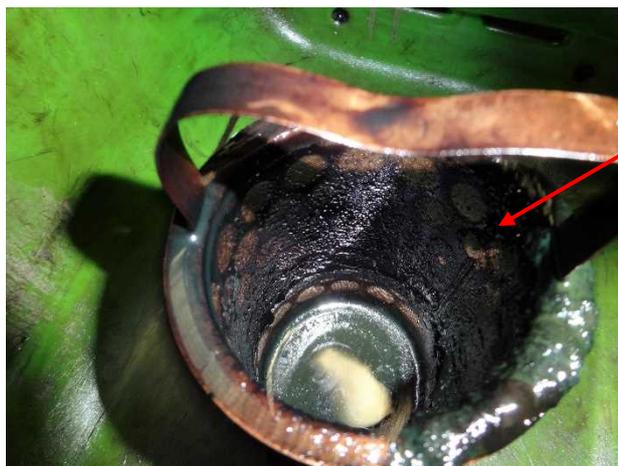
Photo 2.9-2 Clogging condition of strainer①

Opening the strainer②, he found same material stuck to strainer②. He opened the strainer① for the confirmation of fuel oil condition, he found same material stuck to strainer①. (See Photo 2.9-2)

slimy wax-like material stuck
