SB1/2017

**Auxiliary boiler explosion
on board the container ship
Manhattan Bridge
at Felixstowe container terminal, England
resulting in one fatality and one serious injury**

on 19 January 2017

MAIB SAFETY BULLETIN 1/2017

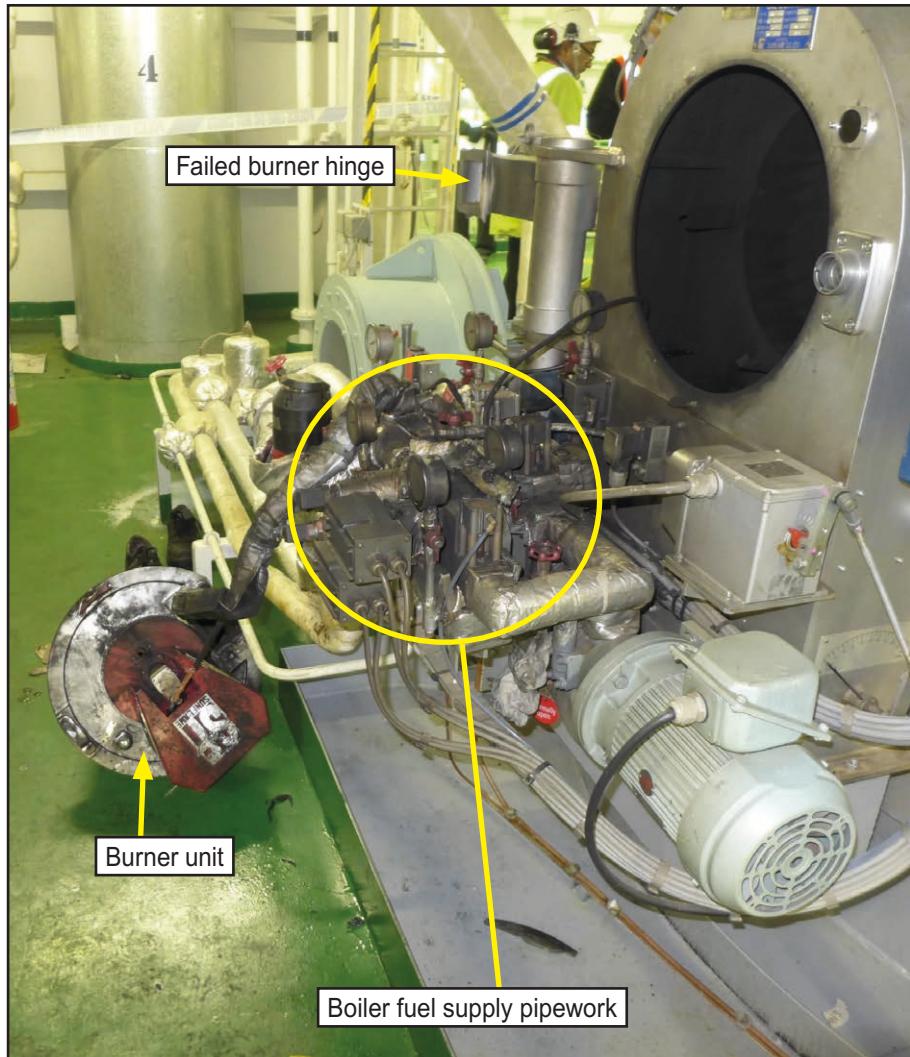
Figure 2: Boiler and burner unit

The boiler explosion occurred while the second engineer and the oiler were trying to restart the boiler burner unit following a flame failure cut-out. The force of the explosion blew open the boiler burner unit door (**Figure 2**) and propelled the burner's air diffuser into the engine room (**Figure 3**). The oiler was standing directly in front of the burner unit and the second engineer was close by.
