Safety Alert

SA 007

Brazil - Sinter Feed from Ponta da Madeira

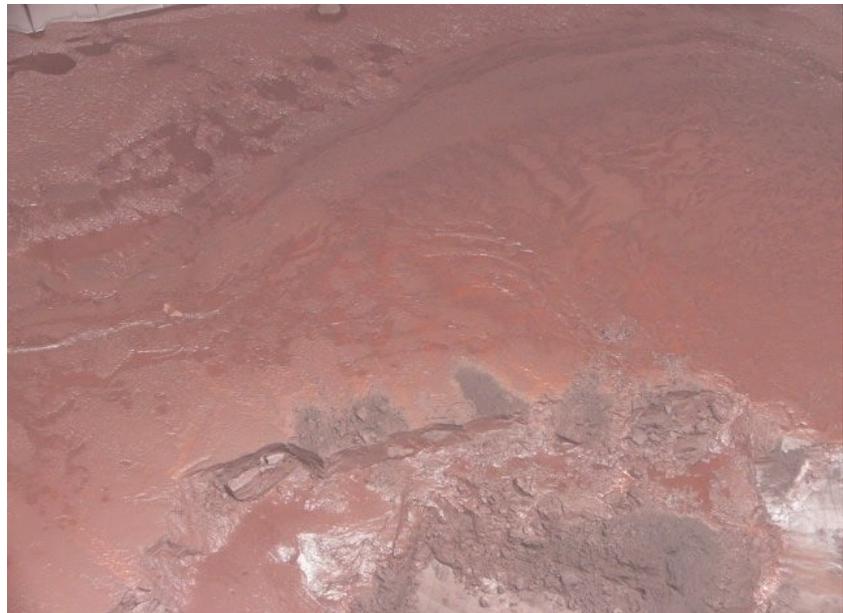
The accompanying cargo declaration may state that the product is a Group C cargo which, according to the International Maritime Solid Bulk Cargoes (IMSBC) Code, applies to “cargoes which are neither liable to liquefy nor to possess chemical hazards”. However, the IMSBC Code lists “Sinter Feed” as an “Iron Concentrate”, classifying it as Group A which applies to “cargoes which may liquefy if shipped at a moisture content in excess of their transportable moisture limit”.

After loading “Sinter Feed” at Ponta da Madeira, at least two ships have experienced cargo liquefaction problems on passage. Although both vessels managed to reach port without the situation becoming critical, significant amounts of free water were found to have accumulated in the corners of each hold, and in certain holds the cargo was completely submerged.

Sinter feed loaded at Ponta da Madeira after liquefaction onboard

Vessels due to load “Sinter Feed” at Ponta da Madeira are advised to treat the product as being a Group A cargo, irrespective of what may be stated on the cargo declaration. All IMSBC Code requirements regarding cargoes

which may liquefy should be observed, and loading should not commence until the shipper has provided the vessel with a Certificate of Test showing the moisture content of the cargo to be less than its Transportable Moisture Limit (TML), and verifying that the moisture content was determined not more than seven days prior to loading. Vessels should also monitor the condition of the cargo by carrying out regular “can” tests throughout loading in accordance with Section 8.4 of the IMSBC Code.

If the shipper fails to provide a Certificate of Test or in the event of any other concerns, loading should be halted and the Club

should be contacted immediately as expert advice may be required.

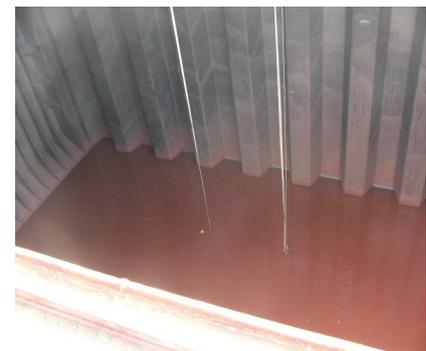
Sinter feed covered by free water which developed on passage
