The Nautical Institute Mariners' Alerting and Reporting Scheme

MARS Report No 227 September 2011

MARS 201152

Dangers of Aluminium Phosphide

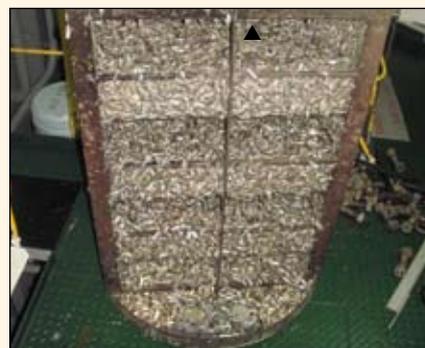
Sea suction choked with fish

Our oil tanker was discharging at an Asian oil terminal. Simultaneously, the vessel was being inspected by a vetting inspector and the owner's superintendent was also attending. The inert gas (IG) plant was in operation. About four hours into the discharge, the C/E was informed that the seawater low pressure alarm had been activated. He came to the engine room and observed that all the sea water pumps were showing inadequate discharge pressure. At the time, the high sea suction was in use, and even though it was well under water, the C/E instructed the duty engineer

to change over to the low sea suction in order to improve the head. Immediately, the pump suction and discharge pressures became normal. After monitoring the system for some time, the C/E left for his cabin. After a few more hours, the problem recurred and the C/E again returned to find all seawater pumps had developed vacuum condition on the suction side and were showing very low discharge pressures. It was immediately suspected that the strainers inside the sea suction chests were clogged. However, with the cargo pumps and IG plant operating at full capacity, it was decided to use both the high and low sea suctions together to avoid stoppage of any of the seawater pumps. It was not possible to open up any of the sea chests to clean the strainer without halting the discharge, with attendant commercial implications. The Master and superintendent were informed of the serious situation, when, by chance, the terminal announced a temporary stop in cargo operation. Until this stoppage time, the engine room had spent a nervous few hours with the pumps struggling to develop adequate water flow.

◀ View of clogged strainer of sea chest

1. The fleet (especially a sister vessel) was advised to use high sea chest in ports as this is generally located close to several overboard discharges; e.g. ballast, condenser sea

water, fire and general service (GS), and IG scrubber pumps. The turbulence created in the vicinity of these overboard discharges may help prevent fish being drawn towards the high sea suction.

2. It was also suggested that regular injection of steam into sea chests might assist in keeping the strainers clear of unwanted fishes and other organisms.

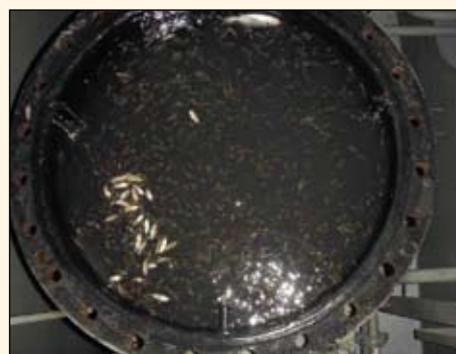
Sea chest with ▶ strainer removed

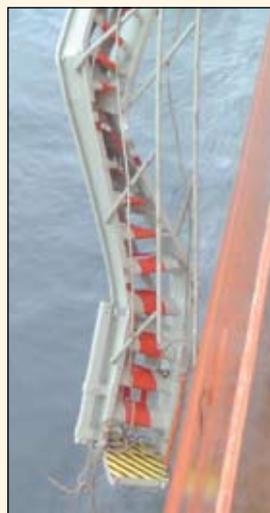
Gangway damaged during unberthing

The A/B indicated the dangerous situation by hand signals to the deck officer, creating some critical seconds' delay in responses and in communicating the information to the bridge. Once aware of the situation, the Master requested the Pilot to instruct the tugs to push the vessel back towards the jetty, but by the time this was done, the entangled gangway had been subject to severe axial, twisting and crushing forces and was severely damaged.

1. The Master failed to effectively use the Pilot and tugs to retain the vessel alongside until all lines were retrieved, especially since there was a strong offshore wind;
2. The Master failed to exercise basic seamanship and wear rain protective clothing and station himself on the bridge wing during the unmooring operations;
3. The unusual layout of the backsprings, gangway and low clearance over the berth should have precluded leaving the gangway suspended overboard;
4. The deck officer at the aft mooring station wrongly assumed the role of winch operator, instead of directly supervising the operation and delegating tasks to his crew.

◀ View of damaged accommodation ladder

1. Masters to always position themselves on the bridge

wings during mooring and unmooring and closely oversee and control operations;

2. Members of the bridge team to always be suitably prepared for exposure to varied weather conditions;
3. Adequate weather-protective gear to be always be available in the wheelhouse;
4. Officer in charge of the mooring station to supervise the operation and effectively communicate with the shore and ship's staff and delegate tasks to his team.

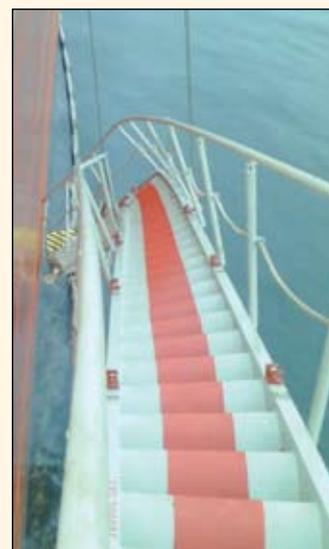
▶ Another view of damaged accommodation ladder
