Providing learning through confidential reports – an international cooperative scheme for improving safety

MARS 201159 Quick-closing valves (QCVs)

Official report edited from USCG Safety Alert 01-11, <http://homeport.uscg.mil>

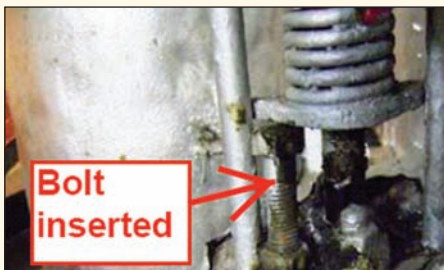
QCVs are positive shutoff valves that are designed to isolate oil tanks in the event of a fire and also prevent fuelling of a fire in circumstances where system piping and components are compromised. These valves are designed to be remotely operated, and are also capable of being operated and reset locally. Inoperable QCVs can put the vessel and its crew at greater risk in the event of a fire and it is absolutely critical that they operate correctly, are properly maintained, and ready for use at all times. Adequate knowledge, training, instructions and stocks of replacement spares must be provided to ship's staff to ensure the reliability of the remote operating arrangements. Intentionally blocking or disabling these valves (as shown in the following photographs) is unacceptable under any circumstance.

◀ QCV disabled by inserting a bolt (Note: The bolt is partly painted, indicating it has possibly been there for some time.)

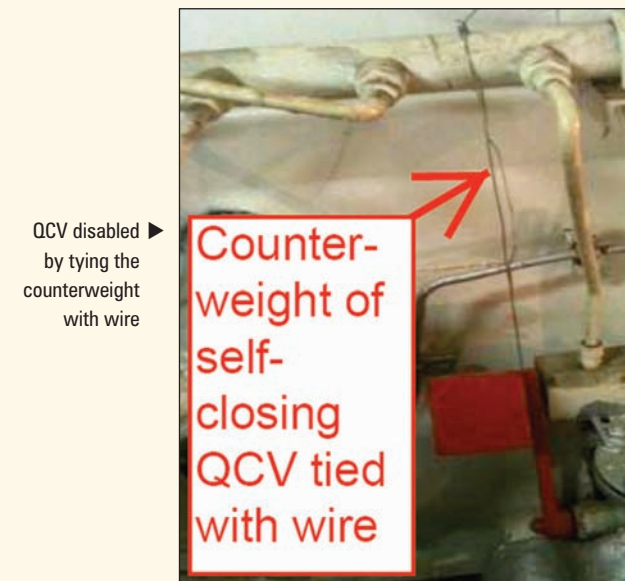
▶ QCV disabled by tying the counterweight with wire

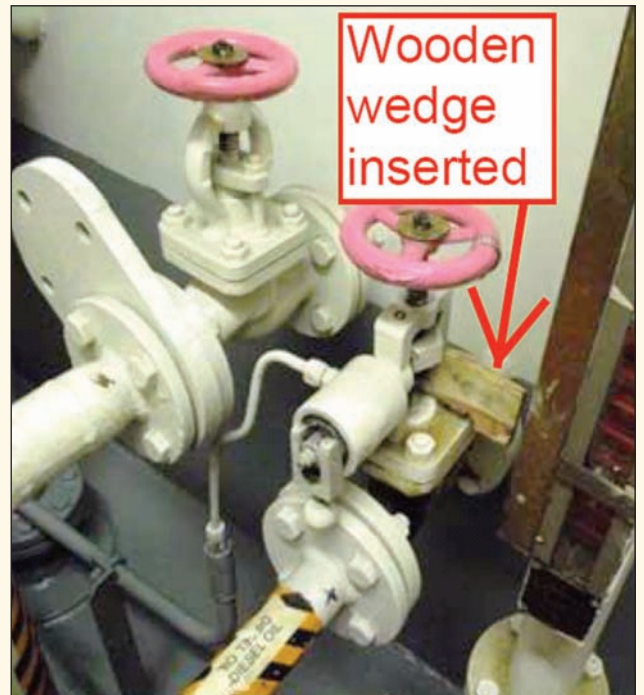
▲ QCV disabled by inserting a wooden wedge
