The Nautical Institute Mariners' Alerting and Reporting Scheme

MARS Report No 229 November 2011

Providing learning through confidential reports – an international cooperative scheme for improving safety

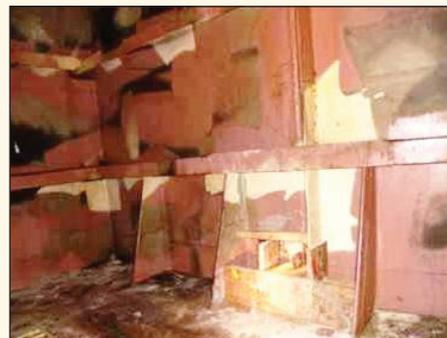
A double-hulled oil tanker with segregated ballast tanks (SBT) was standing by off-limits at a loading port in good weather. In accordance with the pre-arrival schedule and loading plan, extra ballast was being pumped out. When 2S Water Ballast Tank (WBT) was discharged, an oily sheen was observed on the sea surface. Deballasting was immediately stopped and investigations detected an oil layer (innage) of about 15 cm on top of the ballast water in the tank. Shore management was informed, the oily mixture from tank 2S WBT was skimmed off with a portable salvage pump and transferred to 3S cargo oil tank (COT) and from there, to the slop tank. Thereafter, No. 2S WBT was superficially washed and gas freed to make the tank safe for human entry. After complying with all safety procedures, the inspection team entered the tank. They discovered that during the previous loaded voyage, oil from the adjacent cargo tank had leaked into the ballast tank through a crack on a weld seam approximately 3.5 metres below the deckhead, at the intersection of the longitudinal bulkhead and first stringer flat.

Poor standards and improper workmanship / quality control on the part of the shipbuilder.

◀ View of temporary repairs showing cement box within retainer plate wedged between stiffener brackets

1. With approval from shore management and under close monitoring of tank atmosphere, temporary repairs were carried out by drilling crack-arrestor holes, jamming a retaining steel plate between adjacent brackets and casting a cement box over the crack;
2. Risk assessment was carried out for a revised loading condition with reduced quantity of oil in the adjacent cargo tank so as to load to a level below the crack in the weld seam;
3. On the loaded passage, regular atmosphere and content checks were carried out on all ballast tanks. No leakage or ingress of hydrocarbon vapours was observed in any tank;

6. On completion of discharging operations in North Europe, the vessel proceeded to a reputable ship repair yard for permanent repairs which were executed safely and without any incidents.

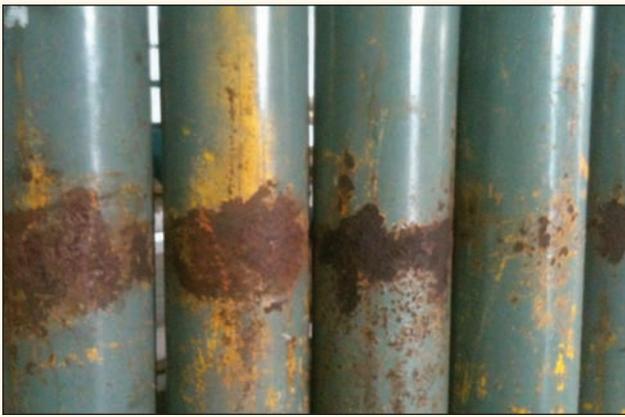
▲ View of localised corrosion on the exterior of air cylinders

the vessel arrived in port, a local lifeboat service company was contracted to investigate the incident and assess the damage with a view to carrying out repairs. In the absence of supporting documents (certificates/ work reports etc.) and from the dates punched on the cylinders, it appeared that it was more than six years since the last hydraulic test of the air cylinders. (IACS Recommendation No.88: Air bottles for air supply in totally enclosed lifeboats should be hydraulic pressure tested by a competent service station recognised by a Recognised Organisation at intervals not exceeding 5 years and the hydrostatic test date must be permanently marked on the bottles.) The substantial corrosion of the cylinders' exteriors suggested that routine inspections and maintenance had also been seriously neglected. After the air cylinders were removed and closely examined, it was ascertained that the cylinder shells had suffered a 50% diminution in thickness in the corroded patches.

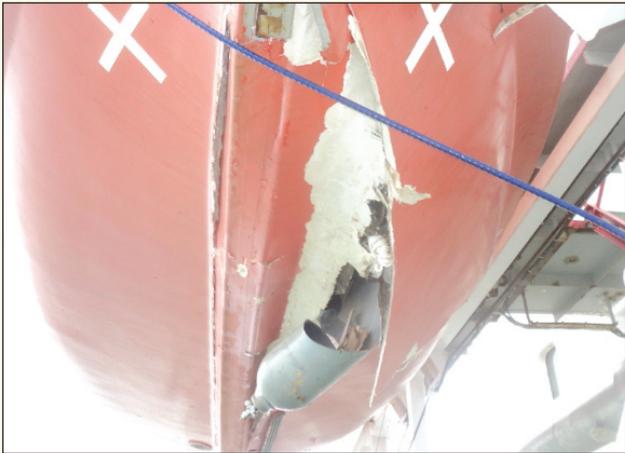
An oil tanker's totally enclosed fibreglass lifeboats were equipped with high-pressure air cylinders stowed beside the keel. One day at sea – shortly after the lifeboats had undergone a 5-yearly inspection by an accredited contractor – one of the compressed air cylinders suddenly and spontaneously burst, resulting in extensive damage to the lifeboat's keel and hull. Fortunately, no-one was injured. Once

▲ View of damaged hull and ruptured air cylinder

After assessing the damage, the lifeboat was deemed to be beyond economical repair. It had to be scrapped and a replacement lifeboat obtained.

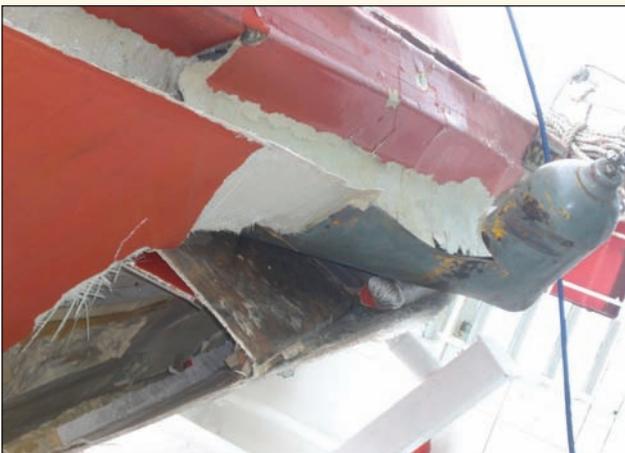
▲ Close-up view of damaged hull and ruptured air cylinder

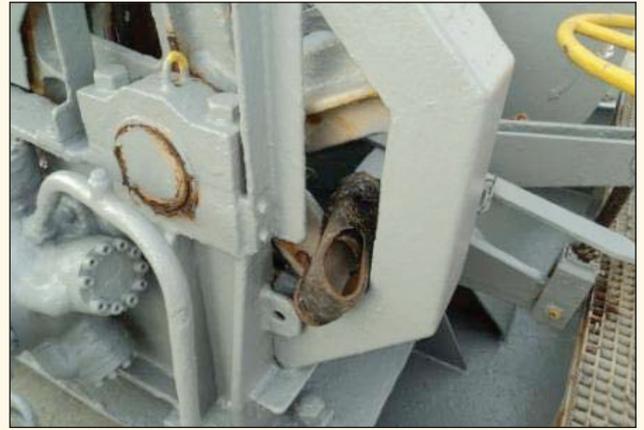
In preparation for arrival in port, two seamen were assigned to bring out mooring ropes from the forward rope store and coil them on the forecabin deck. The OS was operating the windlass/mooring winch control lever, which was at about chest-level for a person of average height, and the AB was handling the rope on the warping barrel, situated about 4 metres outboard. Presumably in order to adopt a more ergonomically efficient stance for holding the control lever in its operating position, the OS placed his right foot on a welded pad eye on the supporting bracket for winch shaft bearing. Inadvertently, he pushed his foot into the gap between this bracket and the circumferential guard of the main driven gear wheel and into the path of the rotating spokes. Instantly, his foot was trapped and crushed. He was given first aid and was hospitalised soon after arrival in port the following day.

▲ Reconstruction of accident showing how OS's right foot was trapped between a rotating spoke, gear wheel guard and winch shaft bearing support bracket

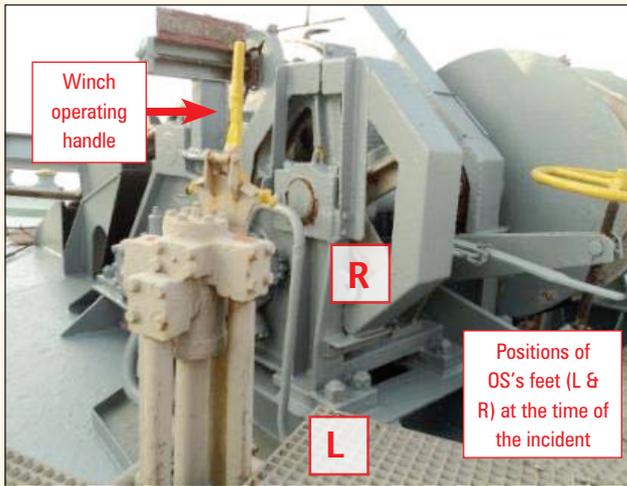
▲ View of accident site

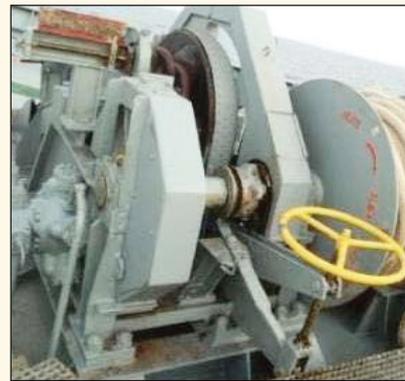
◀ Preventative action completed – steel plate guard made and bolted over gap between gear wheel guard and winch shaft bearing support bracket

A steel guard plate was fabricated and fitted over the gap existing between winch shaft bearing support bracket and peripheral gear wheel guard.
