Providing learning through confidential reports – an international cooperative scheme for improving safety

MARS 201169

Unplanned deviation led to grounding

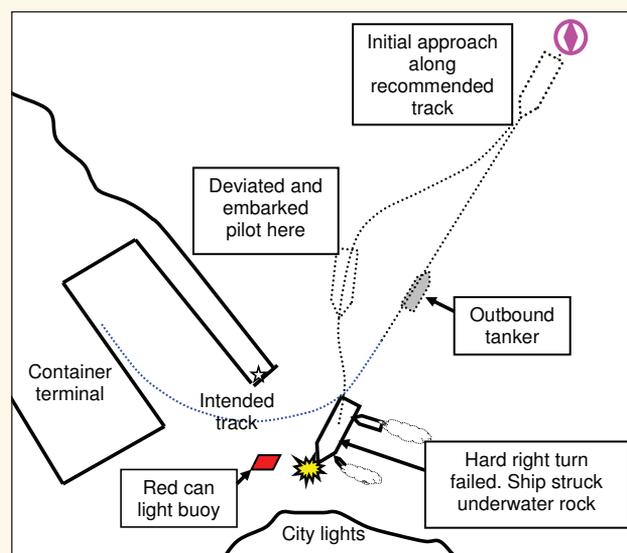
1. Bottom plating on port side of keel buckled extensively for a length of about 15 metres from stem and holed in fore peak tank and bow thruster space;
2. Bow thruster motor windings and wiring damaged by sea water;
3. Forepeak tank vent heads burst and detached from base due to the shock pressure wave generated by the water inside the fully-ballasted forepeak tank.

1. Unplanned deviation from planned track during the critical final stage of the passage;
2. Pilot wrongly gave navigational priority to smaller outbound vessel;

3. Bridge team lost situational awareness and continued to navigate along wrong track;
4. Pilot boarded too close to harbour entrance and failed to recover from a dangerous navigational situation, and compounded the error by ordering half ahead;
5. Failure to understand ship's manoeuvring characteristics;
6. Poorly considered deployment of tugs, which ideally should have made fast on the starboard side before passing the breakwater;
7. Failure to let go anchors in good time;
8. Bright shore lights and reflection on the water affected the efficiency of lookout.

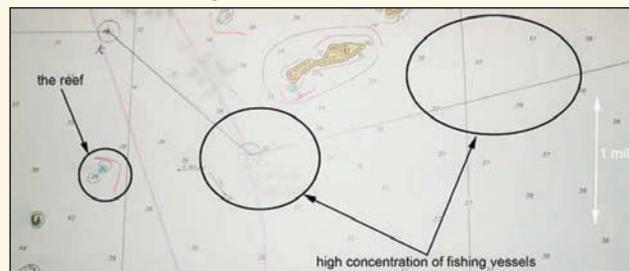
▲ Paper chart showing planned track and the reef
